6th Line Municipal Class Environmental Assessment

County Road 27 to St John's Road
Town of Innisfil, ON

Culvert Inspection Report

October 3, 2015

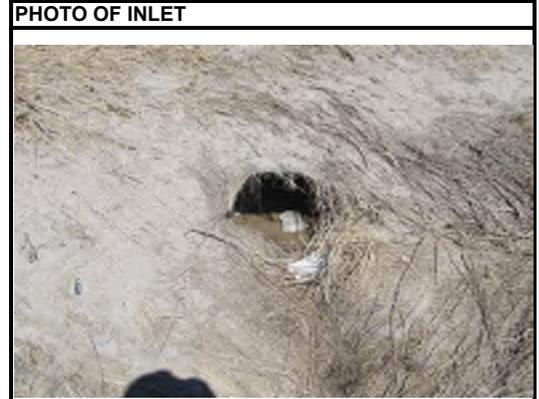
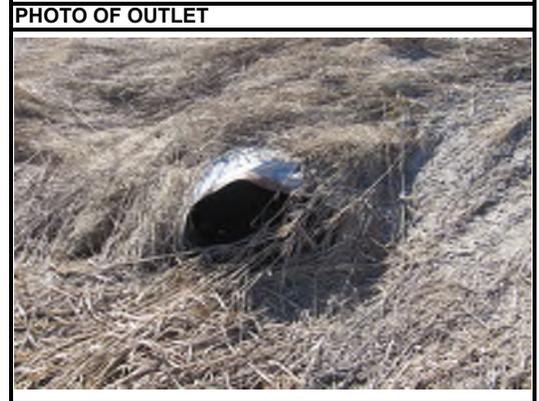
LHRS	10+061	OFFSET	0	km
------	--------	--------	---	----

Inspection Date	02-Apr-15	Culvert No.	01-01	Inspector	M.Darling
Township	Innisfil				
Road	6th Line				
Culvert Crossing Type	HIGHWAY C/L				
Culvert Type	CSP				
Culvert Shape	CIRCLE				
Culvert Bottom	Steel				
Culvert Flow Direction	North				
Culvert Length (m)	19.8				
Culvert Size (mm)	600				
Fill Over Culvert (m)	0.8				
Fill Material Type	Granular				
Depth of Water In Culvert (mm)	0				
Blockage In Culvert	Minor Sediments				
Culvert Condition	Fair				
Inlet Condition	Fair				
Outlet Condition	Bent - Ok

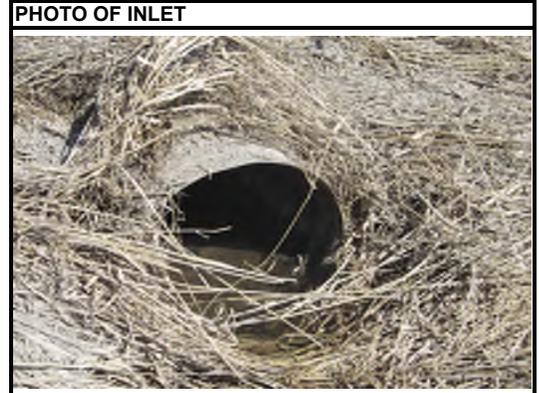
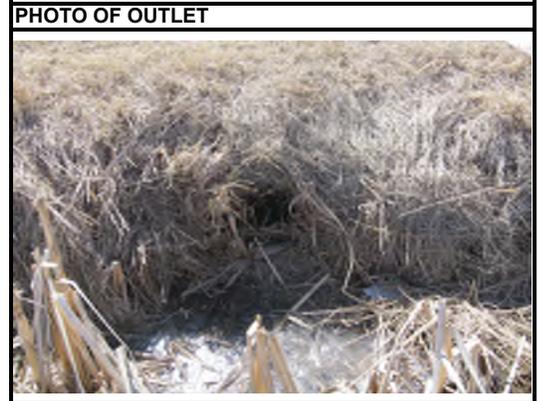
LHRS	10+121	OFFSET	0	km
------	--------	--------	---	----

Inspection Date	02-Apr-15	Culvert No.	01-02	Inspector	M.Darling
Township	Innisfil				
Road	6th Line				
Culvert Crossing Type	HIGHWAY C/L				
Culvert Type	CSP				
Culvert Shape	CIRCLE				
Culvert Bottom	Steel				
Culvert Flow Direction	South				
Culvert Length (m)	12.4				
Culvert Size (mm)	500				
Fill Over Culvert (m)	0.5				
Fill Material Type	Granular				
Depth of Water In Culvert (mm)	100				
Blockage In Culvert	None				
Culvert Condition	Rusted				
Inlet Condition	Good				
Outlet Condition	10% Buried

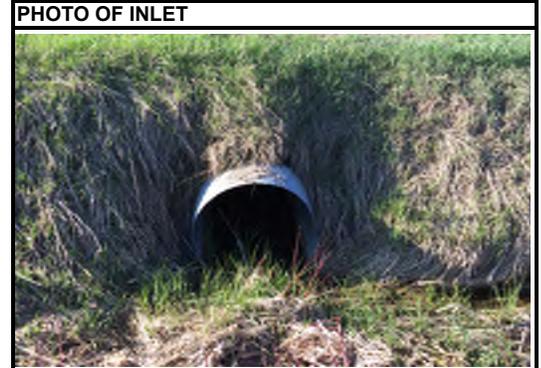
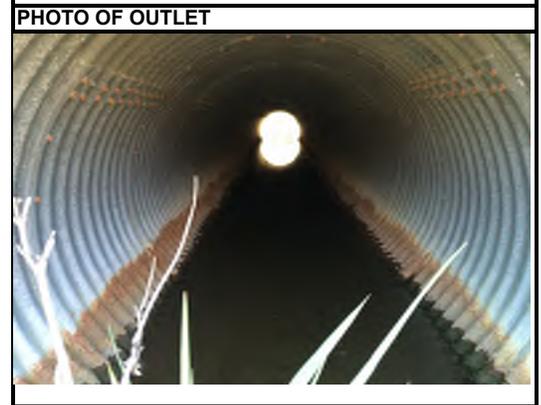
LHRS	10+924	OFFSET	0	km
------	--------	--------	---	----

Inlet Condition	<input type="text" value="Good"/>				
Outlet Condition	<input type="text" value="Good"/>

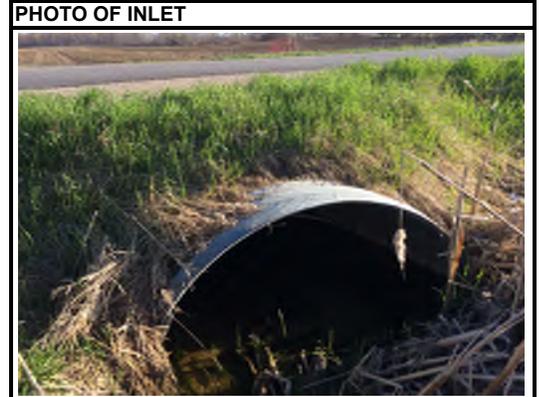
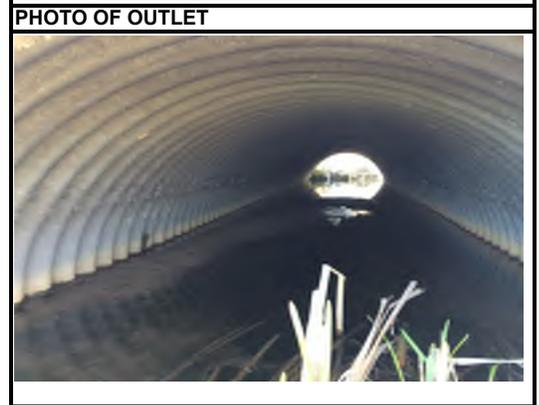
LHRS	11+175	OFFSET	0	km
------	--------	--------	---	----

Inspection Date	02-Apr-15	Culvert No.	01-04	Inspector	M.Darling
Township	Innisfil				
Road	6th Line				
Culvert Crossing Type	HIGHWAY C/L				
Culvert Type	CSP				
Culvert Shape	CIRCLE				
Culvert Bottom	Steel				
Culvert Flow Direction	North				
Culvert Length (m)	12.5				
Culvert Size (mm)	1800				
Fill Over Culvert (m)	0.7				
Fill Material Type	Granular				
Depth of Water In Culvert (mm)	400				
Blockage In Culvert	90% Water				
Culvert Condition	Poor				
Inlet Condition	Poor				
Outlet Condition	Poor

Additional Comments
needs ditches graded

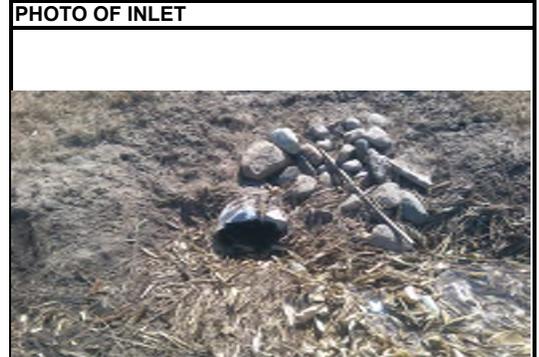
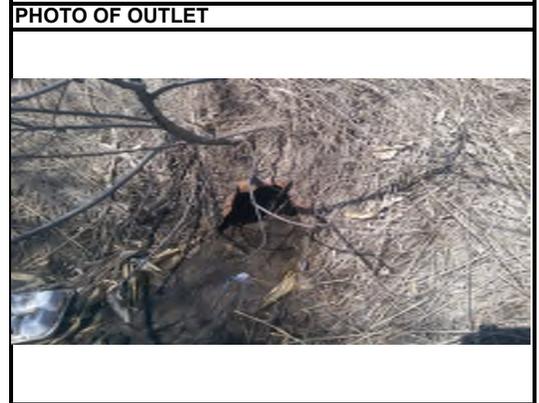
LHRS	12+673	OFFSET	0	km
------	--------	--------	---	----

Inspection Date	02-Apr-15	Culvert No.	01-05	Inspector	M.Darling
Township	Innisfil				
Road	6th Line				
Culvert Crossing Type	HIGHWAY C/L				
Culvert Type	CSP				
Culvert Shape	CIRCLE				
Culvert Bottom	Steel				
Culvert Flow Direction	South				
Culvert Length (m)	12.3				
Culvert Size (mm)	300				
Fill Over Culvert (m)	1.1				
Fill Material Type	Granular				
Depth of Water In Culvert (mm)	50				
Blockage In Culvert	None				
Culvert Condition	Rusted				
Inlet Condition	Fair				
Outlet Condition	Poor - Bent/Rusting				
Additional Comments

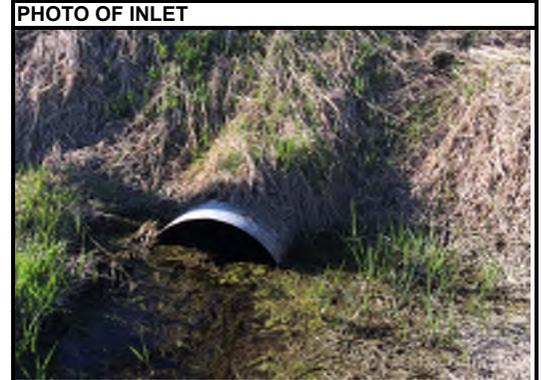
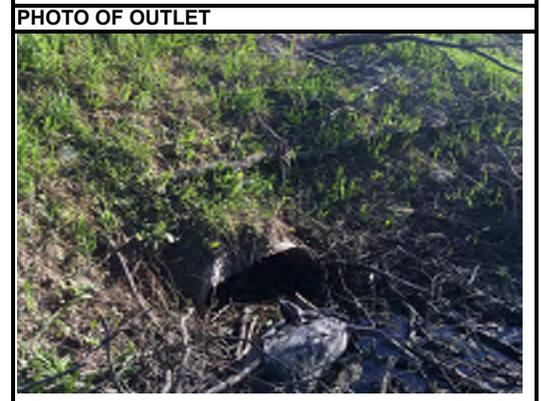
LHRS	13+158	OFFSET	0	km
------	--------	--------	---	----

Inspection Date	02-Apr-15	Culvert No.	01-06	Inspector	M.Darling
Township	Innisfil				
Road	6th Line				
Culvert Crossing Type	HIGHWAY C/L				
Culvert Type	CSP				
Culvert Shape	CIRCLE				
Culvert Bottom	Steel				
Culvert Flow Direction	South				
Culvert Length (m)	13				
Culvert Size (mm)	800				
Fill Over Culvert (m)	2				
Fill Material Type	Granular				
Depth of Water In Culvert (mm)	500				
Blockage In Culvert	90% Water				
Culvert Condition	Poor				
Inlet Condition	Poor				
Outlet Condition	Poor

Additional Comments
needs ditches regraded

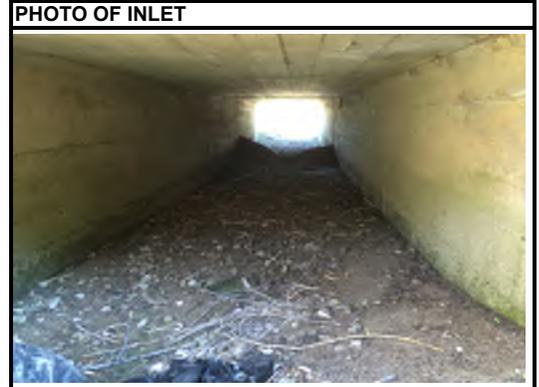
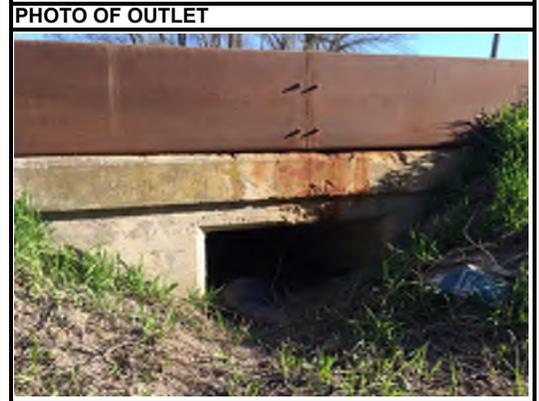
LHRS	13+164	OFFSET	0	km
------	--------	--------	---	----

Inspection Date	02-Apr-15	Culvert No.	01-07	Inspector	M.Darling
Township	Innisfil				
Road	6th Line				
Culvert Crossing Type	HIGHWAY C/L				
Culvert Type	Concrete Box				
Culvert Shape	BOX				
Culvert Bottom	Open				
Culvert Flow Direction	South				
Culvert Length (m)	9.5				
Culvert Size (mm)	1200x800				
Fill Over Culvert (m)	1				
Fill Material Type	Granular				
Depth of Water In Culvert (mm)	0				
Blockage In Culvert	Garbage Bags				
Culvert Condition	Good				
Inlet Condition	Good				
Outlet Condition	Good

Additional Comments
needs channel cleared

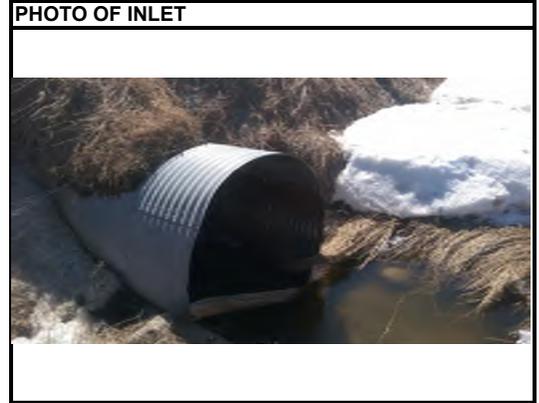
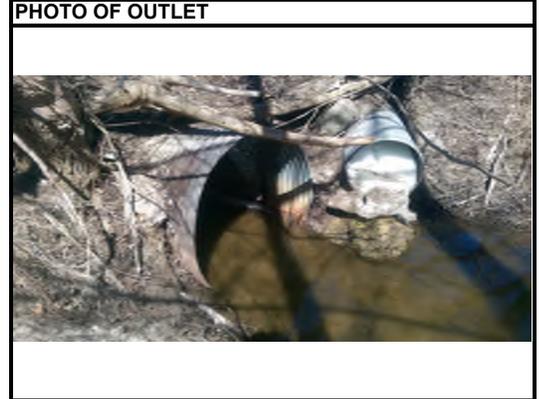
LHRS	13+454	OFFSET	0	km
------	--------	--------	---	----

Inspection Date	02-Apr-15	Culvert No.	01-08	Inspector	M.Darling
Township	Innisfil				
Road	6th Line				
Culvert Crossing Type	HIGHWAY C/L				
Culvert Type	CSP				
Culvert Shape	CIRCLE				
Culvert Bottom	Steel				
Culvert Flow Direction	North				
Culvert Length (m)	17.8				
Culvert Size (mm)	1800				
Fill Over Culvert (m)	2.5				
Fill Material Type	Granular				
Depth of Water In Culvert (mm)	400				
Blockage In Culvert	None				
Culvert Condition	Minor Rusting				
Inlet Condition	Good				
Outlet Condition	Good

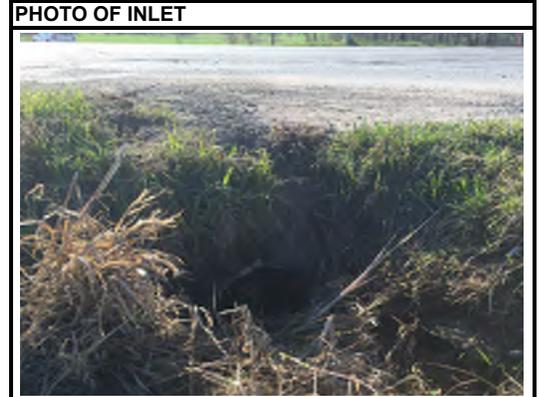
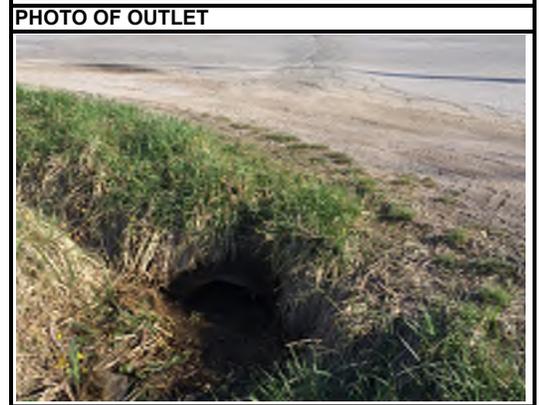
LHRS	16+167	OFFSET	0	km
------	--------	--------	---	----

Inspection Date	19-Jun-15	Culvert No.	01-10	Inspector	S. Percy
Township	Innisfil				
Road	6th Line				
Culvert Crossing Type	HIGHWAY C/L				
Culvert Type	CSP				
Culvert Shape	CIRCLE				
Culvert Bottom	Steel				
Culvert Flow Direction	South				
Culvert Length (m)	17.0				
Culvert Size (mm)	400				
Fill Over Culvert (m)	0.5				
Fill Material Type	Granular				
Depth of Water In Culvert (mm)	50				
Blockage In Culvert	Water/Sediment 70-80%				
Culvert Condition	Poor				
Inlet Condition	80% Buried				
Outlet Condition	70% Buried

Additional Comments
Severe vegetation needs to be cleared.

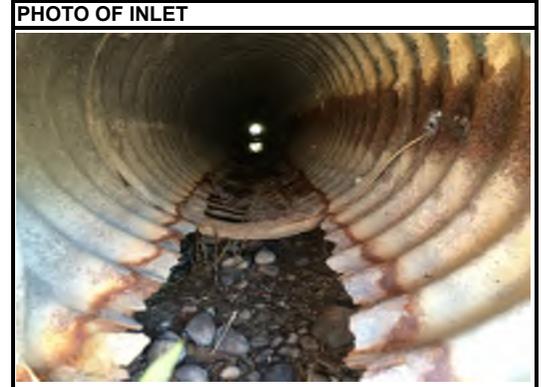
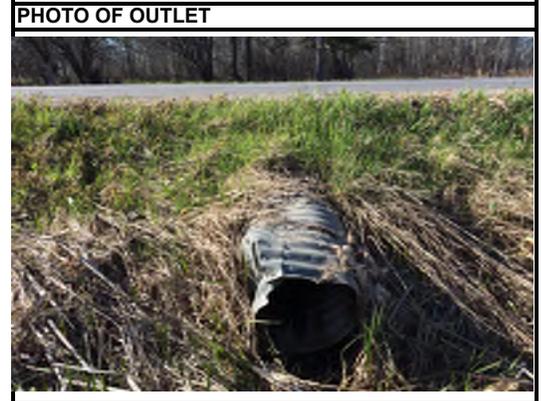
LHRS	16+641	OFFSET	0	km
------	--------	--------	---	----

Inspection Date	02-Apr-15	Culvert No.	01-11	Inspector	M.Darling
Township	Innisfil				
Road	6th Line				
Culvert Crossing Type	HIGHWAY C/L				
Culvert Type	CSP				
Culvert Shape	CIRCLE				
Culvert Bottom	Steel				
Culvert Flow Direction	Equalization				
Culvert Length (m)	12.3				
Culvert Size (mm)	400				
Fill Over Culvert (m)	0.5				
Fill Material Type	Granular				
Depth of Water In Culvert (mm)	10				
Blockage In Culvert	None				
Culvert Condition	Poor - Rusted				
Inlet Condition	Poor - Bent				
Outlet Condition	Poor - Bent

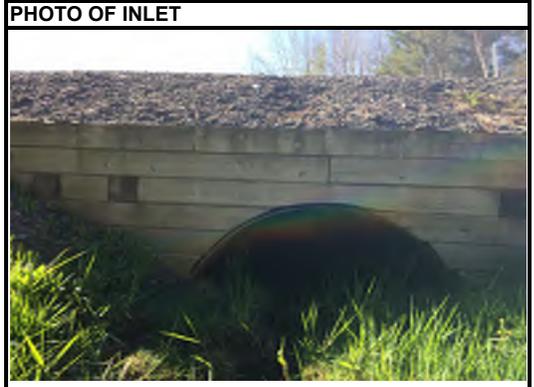
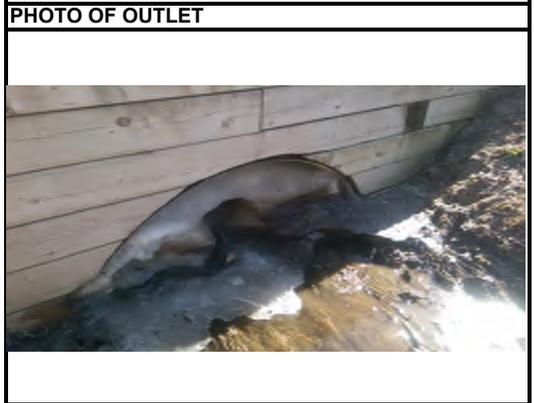
LHRS	17+754	OFFSET	0	km
------	--------	--------	---	----

Inspection Date	02-Apr-15	Culvert No.	01-13	Inspector	M.Darling
Township	Innisfil				
Road	6th Line				
Culvert Crossing Type	HIGHWAY C/L				
Culvert Type	CSP				
Culvert Shape	CIRCLE				
Culvert Bottom	Steel				
Culvert Flow Direction	South				
Culvert Length (m)	10.0				
Culvert Size (mm)	800				
Fill Over Culvert (m)	1				
Fill Material Type	Granular				
Depth of Water In Culvert (mm)	100				
Blockage In Culvert	Ice - 90% Blocked				
Culvert Condition	Fair				
Inlet Condition	Fair				
Outlet Condition	Fair

Additional Comments
channel needs cleared

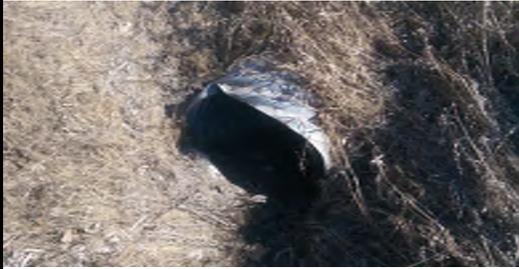
LHRS	19+252	OFFSET	0	km
PHOTO OF INLET

Inspection Date	02-Apr-15	Culvert No.	01-14	Inspector	M.Darling
Township	Innisfil				
Road	6th Line				
Culvert Crossing Type	HIGHWAY C/L				
Culvert Type	CSP				
Culvert Shape	CIRCLE				
Culvert Bottom	Steel				
Culvert Flow Direction	South				
Culvert Length (m)	18.7				
Culvert Size (mm)	600				
Fill Over Culvert (m)	1.5				
Fill Material Type	Granular				
Depth of Water In Culvert (mm)	0				
Blockage In Culvert	Sediments				
Culvert Condition	Fair				
Inlet Condition	20% Buried				
Outlet Condition	90% Buried

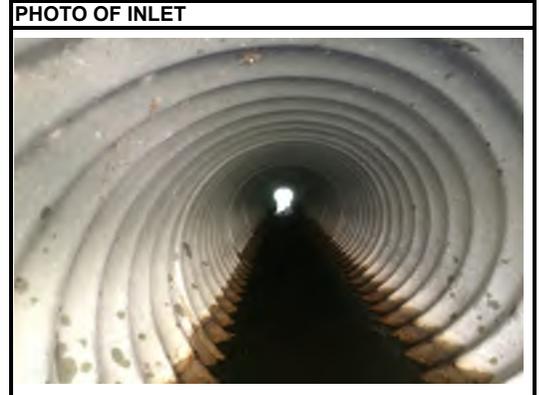
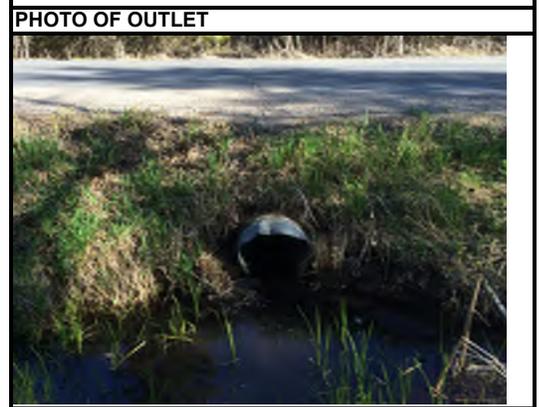
LHRS	20+652	OFFSET	0	km
------	--------	--------	---	----

Inspection Date	02-Apr-15	Culvert No.	01-15	Inspector	M.Darling
Township	Innisfil				
Road	6th Line				
Culvert Crossing Type	HIGHWAY C/L				
Culvert Type	CSP				
Culvert Shape	CIRCLE				
Culvert Bottom	Steel				
Culvert Flow Direction	South				
Culvert Length (m)	10.6				
Culvert Size (mm)	400				
Fill Over Culvert (m)	1				
Fill Material Type	Granular				
Depth of Water In Culvert (mm)	500				
Blockage In Culvert	None				
Culvert Condition	Good				
Inlet Condition	Good				
Outlet Condition	Good

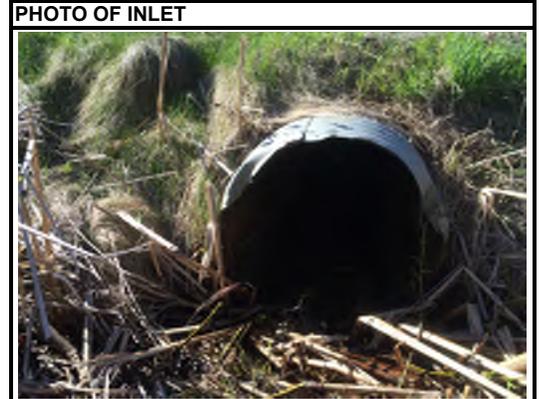
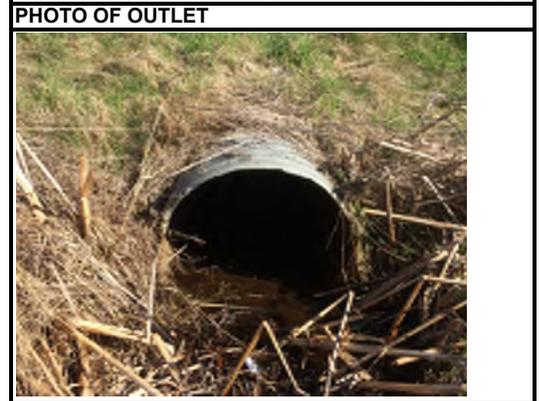
LHRS	20+875	OFFSET	0	km
------	--------	--------	---	----

Inspection Date	02-Apr-15	Culvert No.	01-16	Inspector	M.Darling
Township	Innisfil				
Road	6th Line				
Culvert Crossing Type	HIGHWAY C/L				
Culvert Type	CSP				
Culvert Shape	CIRCLE				
Culvert Bottom	Steel				
Culvert Flow Direction	South				
Culvert Length (m)	13.6				
Culvert Size (mm)	600				
Fill Over Culvert (m)	1.2				
Fill Material Type	Granular				
Depth of Water In Culvert (mm)	200				
Blockage In Culvert	Ice				
Culvert Condition	Good				
Inlet Condition	Fair				
Outlet Condition	Good

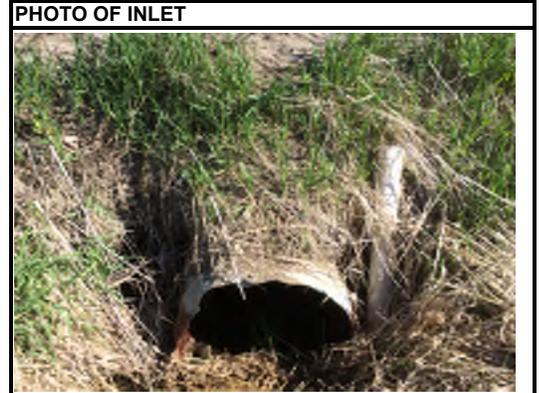
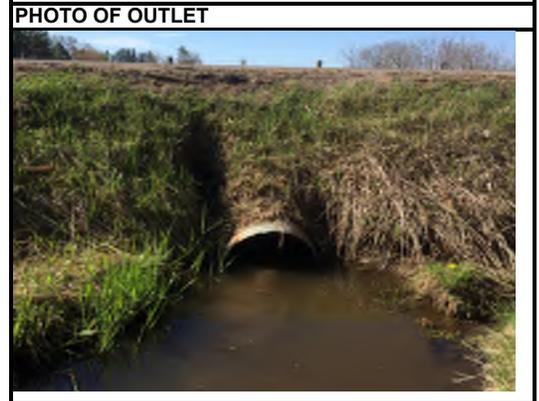
LHRS	21+385	OFFSET	0	km
------	--------	--------	---	----

Inspection Date	19-Jun-15	Culvert No.	01-17	Inspector	S. Percy
Township	Innisfil				
Road	6th Line				
Culvert Crossing Type	HIGHWAY C/L				
Culvert Type	CSP				
Culvert Shape	CIRCLE				
Culvert Bottom	Steel				
Culvert Flow Direction	North				
Culvert Length (m)	12.3				
Culvert Size (mm)	600				
Fill Over Culvert (m)	0.7				
Fill Material Type	Granular				
Depth of Water In Culvert (mm)	300				
Blockage In Culvert	Sediment Water 50%				
Culvert Condition	Good				
Inlet Condition	Fair				
Outlet Condition	Fair

Additional Comments
Both ends are partially submerged in water.

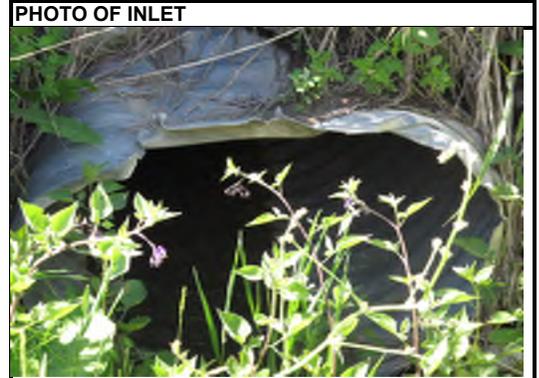
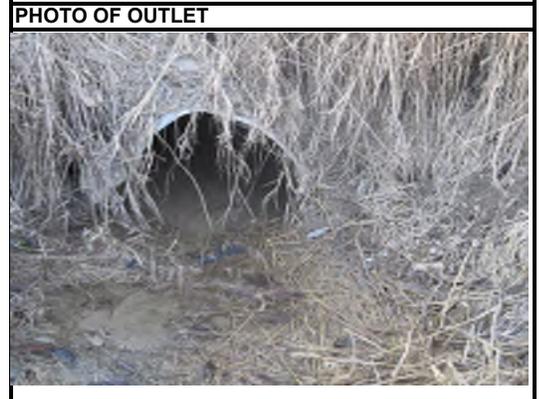
LHRS	22+282	OFFSET	0	km
------	--------	--------	---	----

Inspection Date	19-Jun-15	Culvert No.	01-18	Inspector	S. Percy
Township	Innisfil				
Road	6th Line				
Culvert Crossing Type	HIGHWAY C/L				
Culvert Type	CSP				
Culvert Shape	CIRCLE				
Culvert Bottom	Steel				
Culvert Flow Direction	South				
Culvert Length (m)	16.1				
Culvert Size (mm)	700				
Fill Over Culvert (m)	0.6				
Fill Material Type	Granular				
Depth of Water In Culvert (mm)	100				
Blockage In Culvert	10% Sediment				
Culvert Condition	Poor				
Inlet Condition	Poor-Deformed				
Outlet Condition	Fair - 10% Sediment

Additional Comments
Vegetation needs to be cleared as well as sediment.

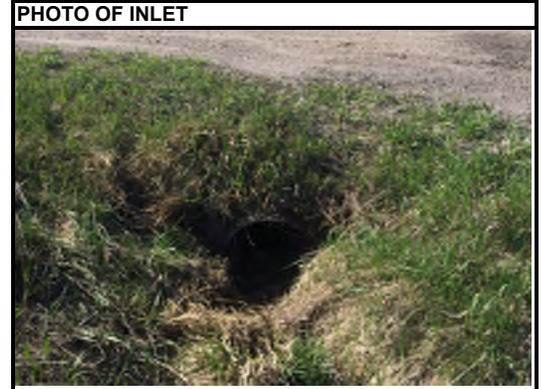
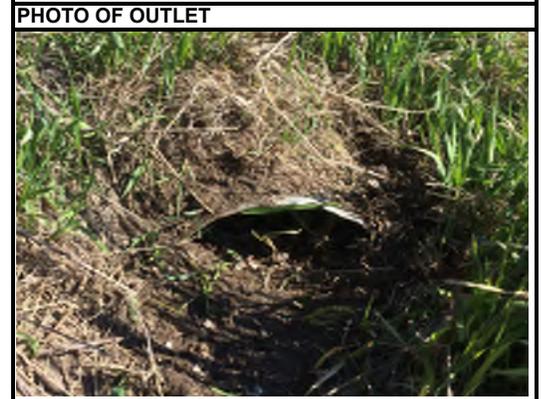
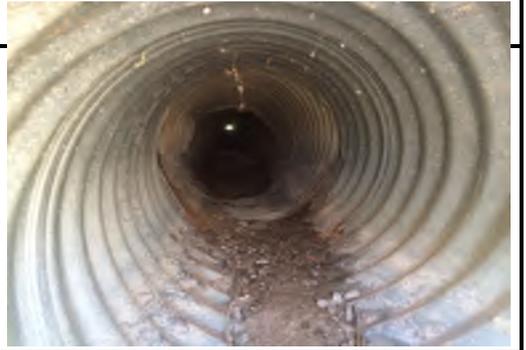
LHRS	22+301	OFFSET	0	km
------	--------	--------	---	----

Additional Comments
 Severe vegetation needs to be cleared

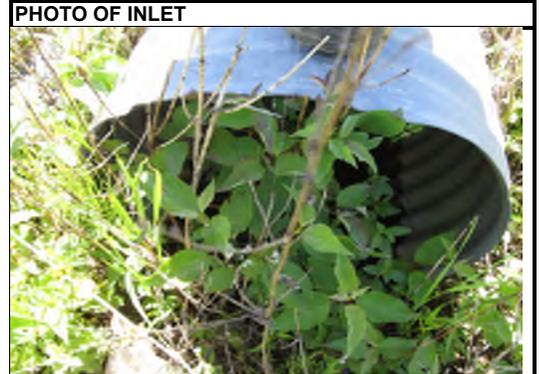
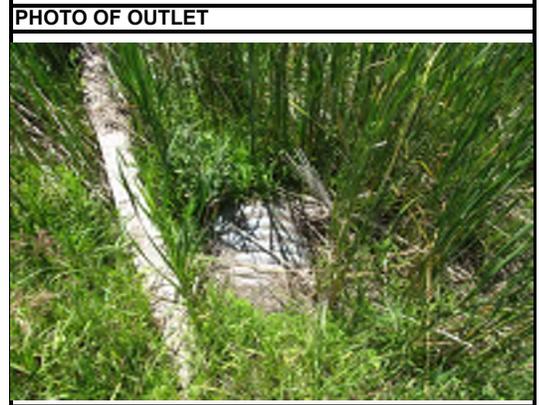
LHRS	23+828	OFFSET	0	km
------	--------	--------	---	----

Inspection Date	19-Jun-15	Culvert No.	01-20	Inspector	S. Percy
Township	Innisfil				
Road	6th Line				
Culvert Crossing Type	HIGHWAY C/L				
Culvert Type	CSP				
Culvert Shape	CIRCLE				
Culvert Bottom	Steel				
Culvert Flow Direction	South				
Culvert Length (m)	15.3				
Culvert Size (mm)	500				
Fill Over Culvert (m)	1				
Fill Material Type	Granular				
Depth of Water In Culvert (mm)	100				
Blockage In Culvert	5% Sediment				
Culvert Condition	Good				
Inlet Condition	Good				
Outlet Condition	Moderate-Severe Vegetation

Additional Comments
Vegetation must be cleared.

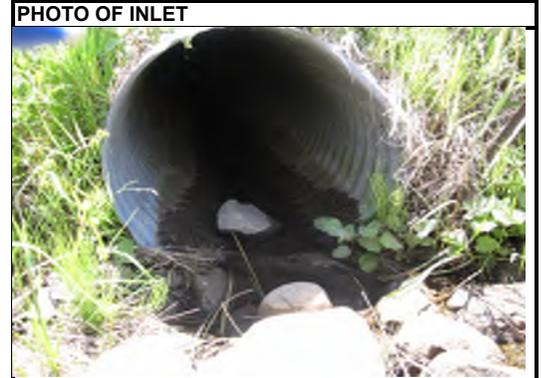
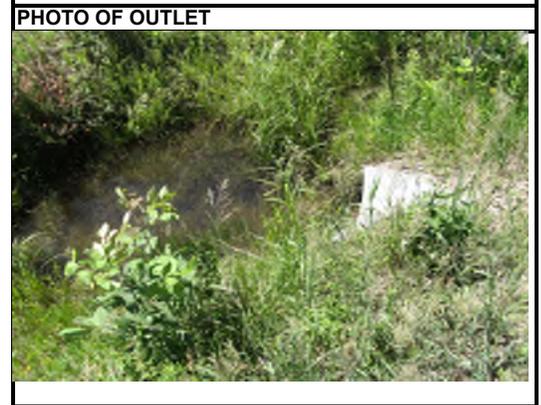
LHRS	24+118	OFFSET	0	km
------	--------	--------	---	----

Additional Comments
0.3m sitting water at outlet

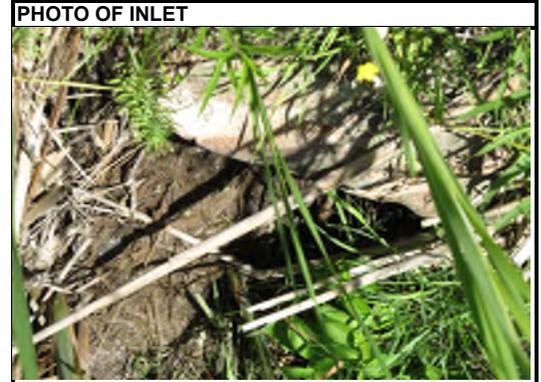
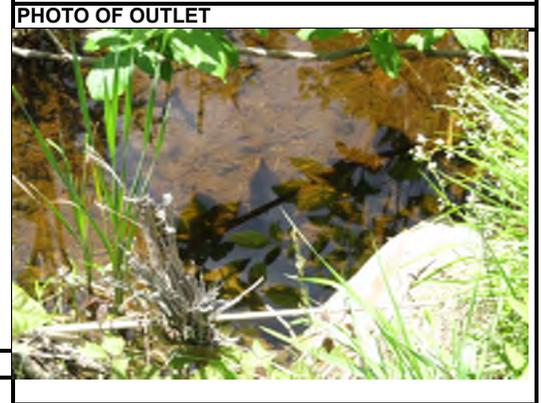
LHRS	24+731	OFFSET	0	km
------	--------	--------	---	----

Additional Comments
 Water flow from nearby field held back by 10-15 ft long stone dam allowing small amount of water to trickle to inlet and through culvert. Standing water at outlet. Culvert likely requires replacement.

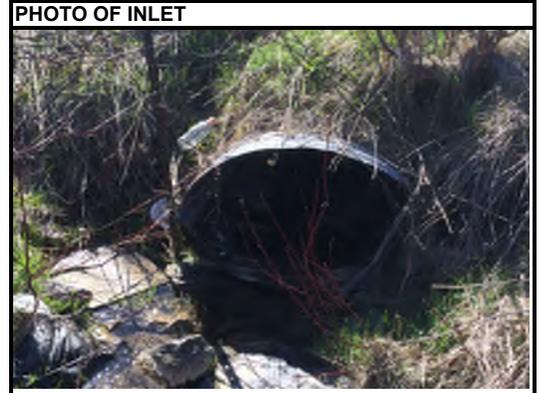
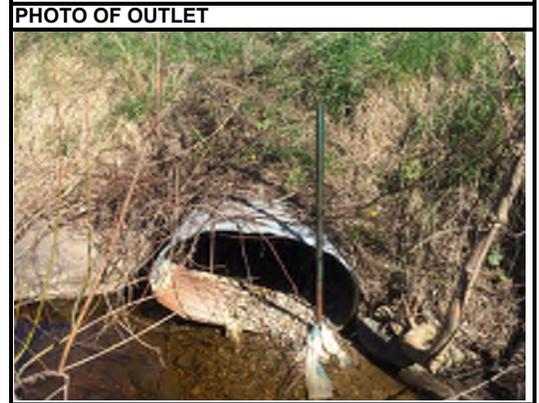
LHRS	24+909	OFFSET	0	km
------	--------	--------	---	----

Additional Comments
 Water courses at each end.
 Seever vegetation must be cleared.

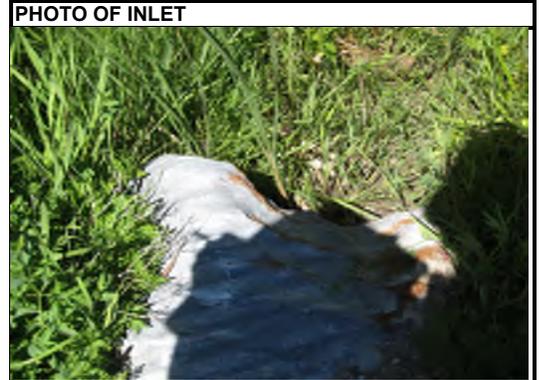
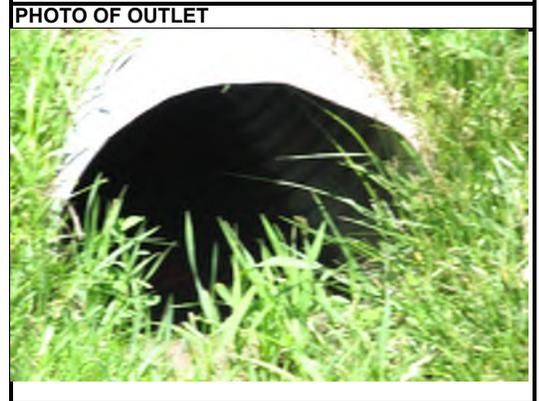
LHRS	25+328	OFFSET	0	km
------	--------	--------	---	----

Additional Comments
Vegetation at Inlet must be cleared.
