Erosion Hazard and Crossing Assessment Leonard's Creek

Multi-Use Trail from Jack Crescent to Goodfellow Public School, Innisfil

May 11, 2020
PN20020

Project Number: PN20020

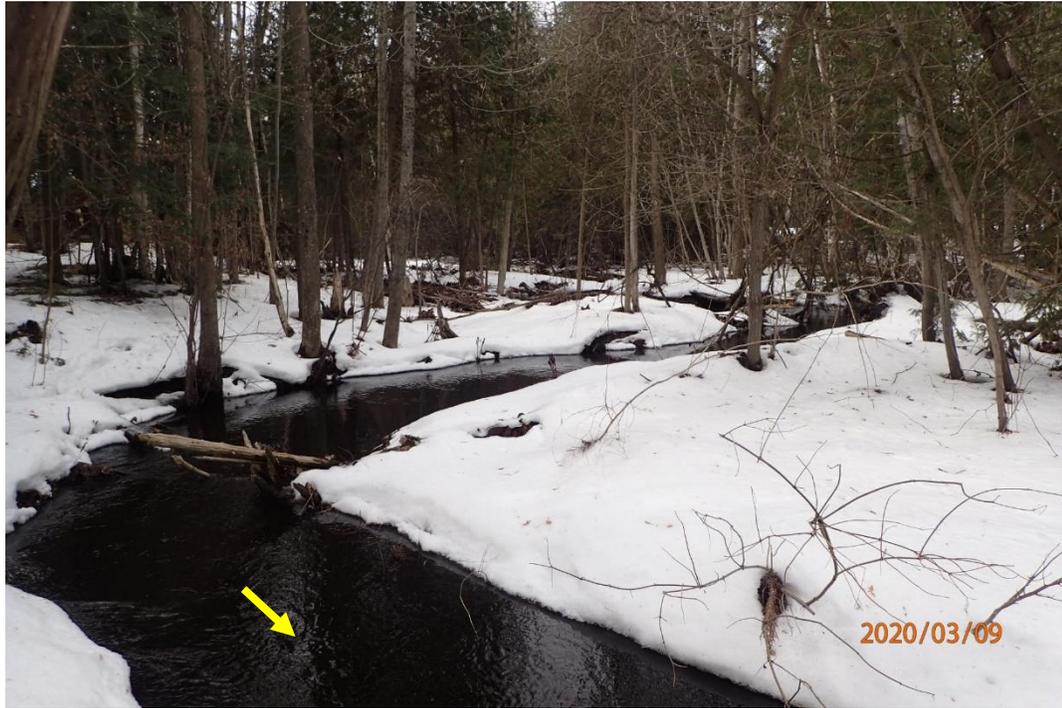
Photo 1
Reach LC-1 – Leonard’s Creek, Innisfil, ON

Photograph taken from the downstream extent of Reach LC-1. Both banks were covered with snow and ice throughout the reach. Water levels were high due to recent snowmelt.

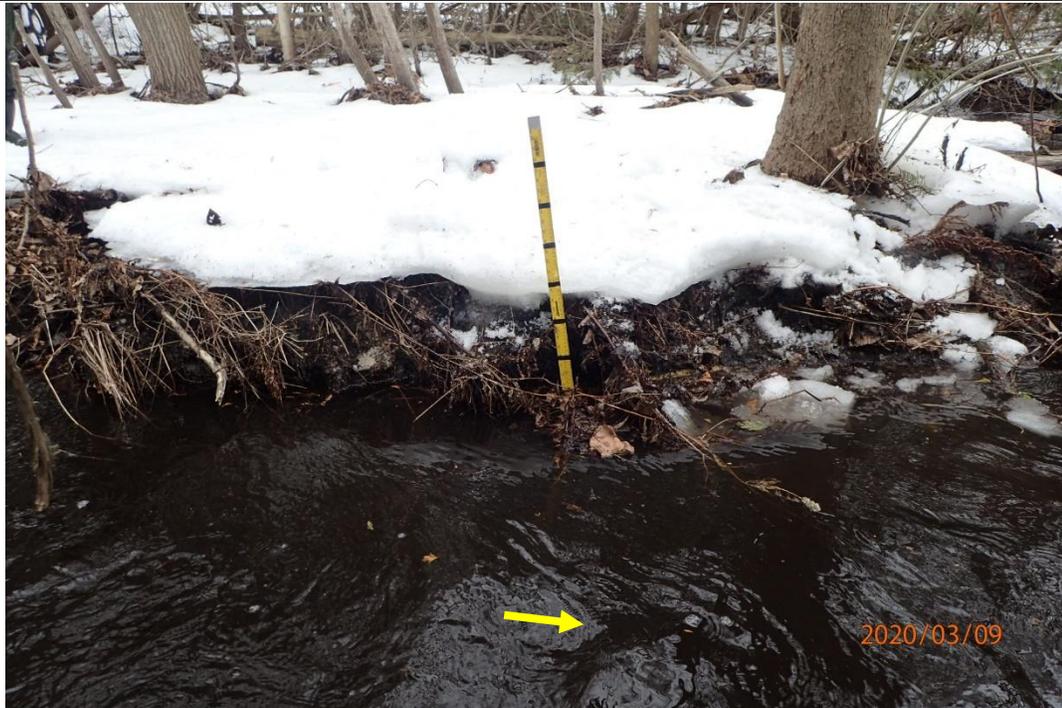
Photo 2
Reach LC-1 – Leonard’s Creek, Innisfil, ON

Photograph taken from the south bank. Exposed tree roots were observed along the entire reach and undercuts up to 0.14 m were measured.

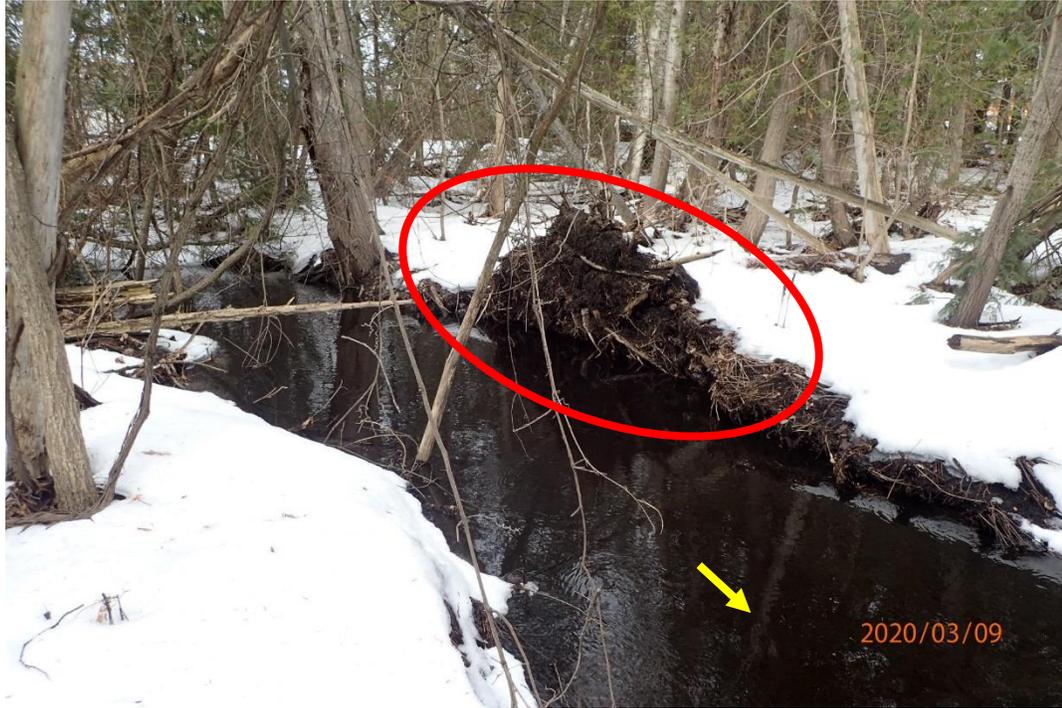
Photo 3
Reach LC-1 – Leonard’s Creek, Innisfil, ON

Photograph looking upstream. An uprooted tree was noted on the outside of this meander bend (left bank) which provides evidence of channel widening.

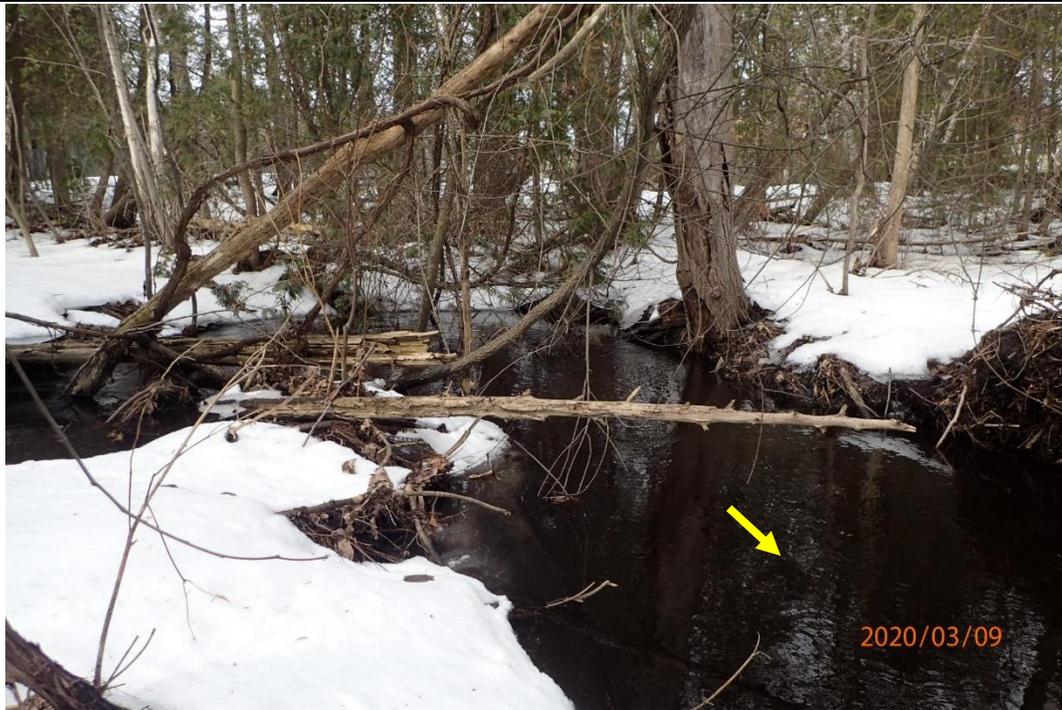
Photo 4
Reach LC-1 – Leonard’s Creek, Innisfil, ON

Photograph looking upstream. Leaning trees and instream logs were decelerating flows as they entered the meander bend.

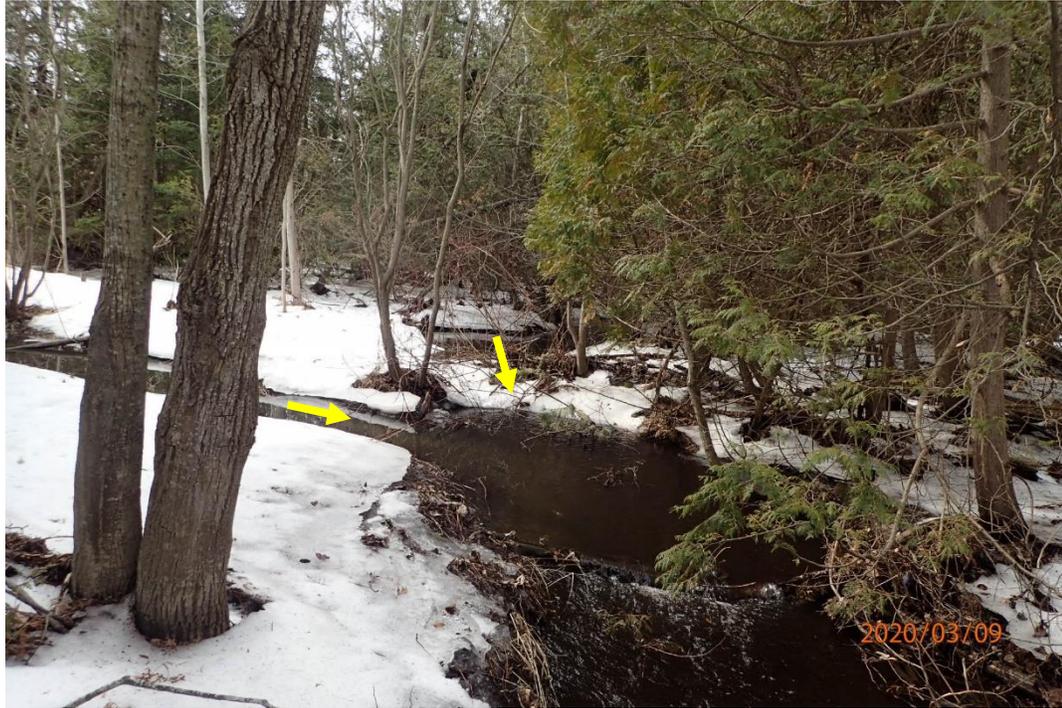
Photo 5
Reach LC-1 – Leonard’s Creek, Innisfil, ON

Photograph looking upstream at Reach LC-1. Outflow from the SWM pond outlet enters Leonard’s Creek from the left. A woody debris jam was causing ice build-up directly upstream of the confluence.

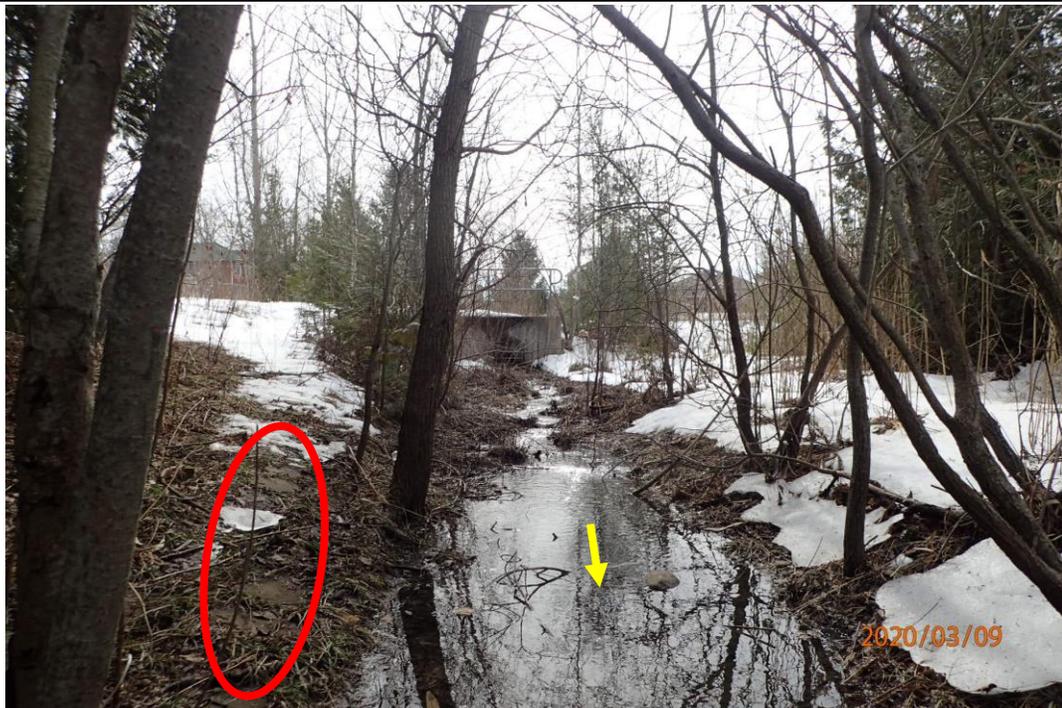
Photo 6
Reach LC-1 – Leonard’s Creek, Innisfil, ON

Photograph of the SWM pond outflow channel, looking upstream. The bed and banks were lined with concrete blocks.

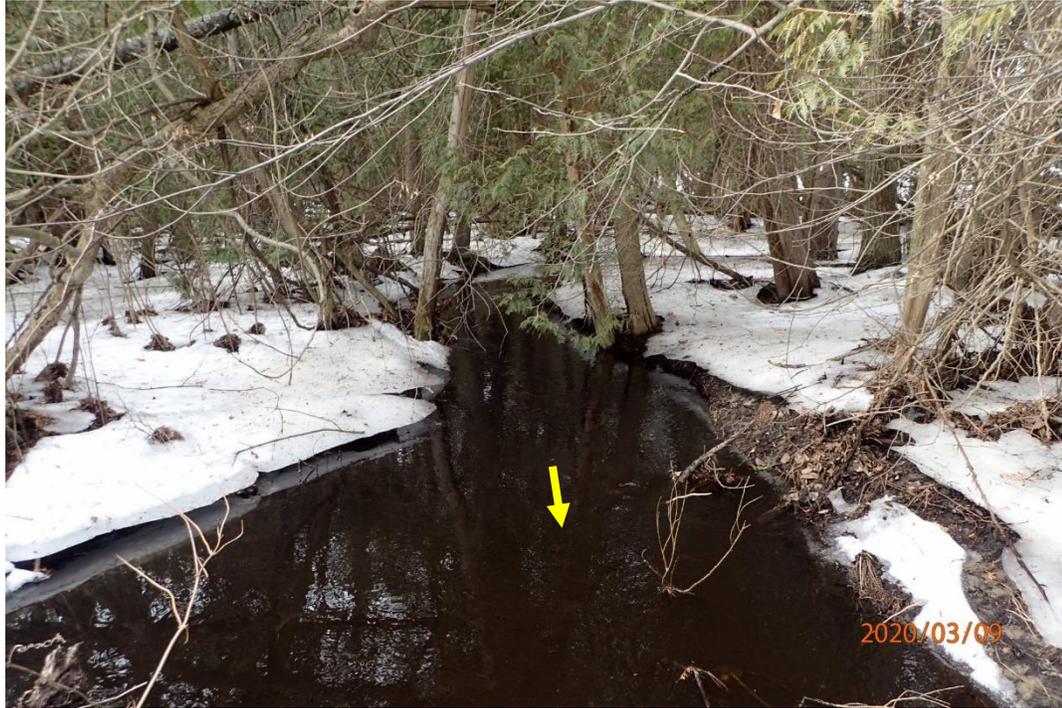
Photo 7
Reach LC-1 – Leonard’s Creek, Innisfil, ON

Photograph looking upstream at Reach LC-1. The channel slightly widened at the right bank (left of photo) prior to reaching the confluence.

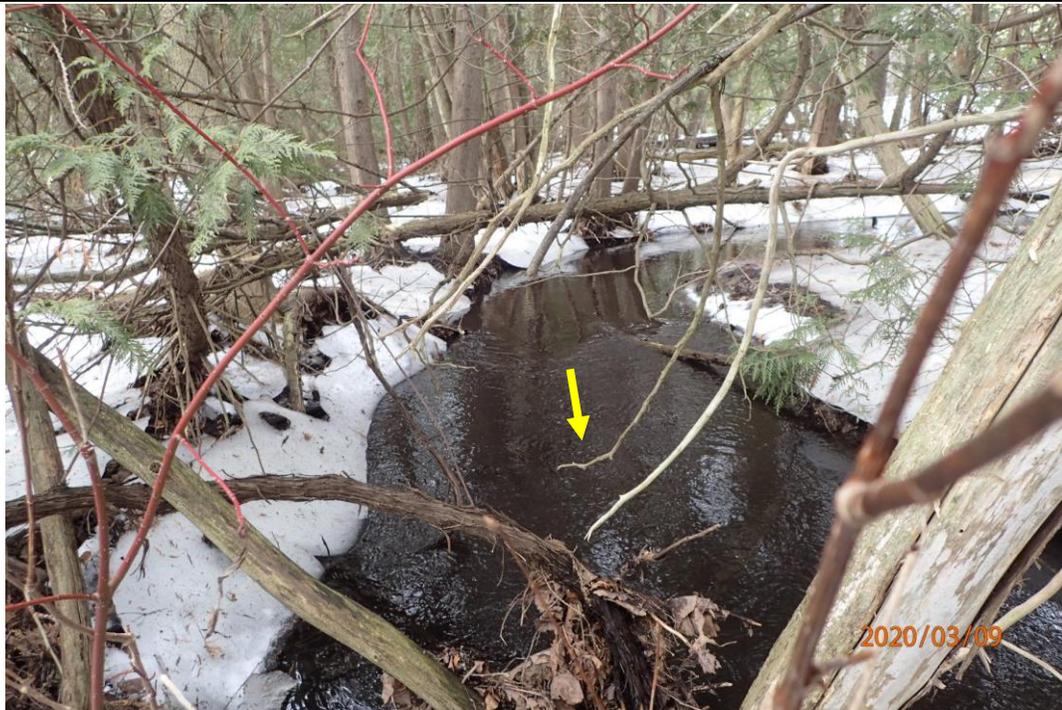
Photo 8
Reach LC-1 – Leonard’s Creek, Innisfil, ON

Photograph looking upstream towards a meander bend. The channel exhibited irregular meanders.

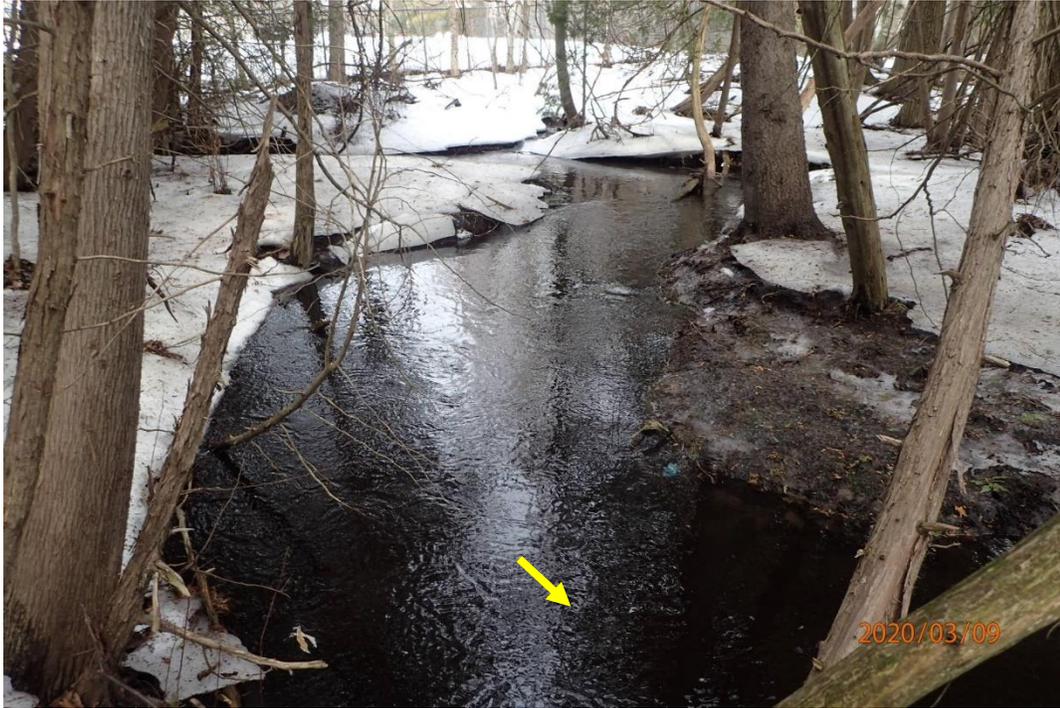
Photo 9
Reach LC-1 – Leonard’s Creek, Innisfil, ON

Photograph looking upstream from the south bank. Channel bank angles ranged from 30° to 90° and consisted of primarily silt/sand and rootlets.

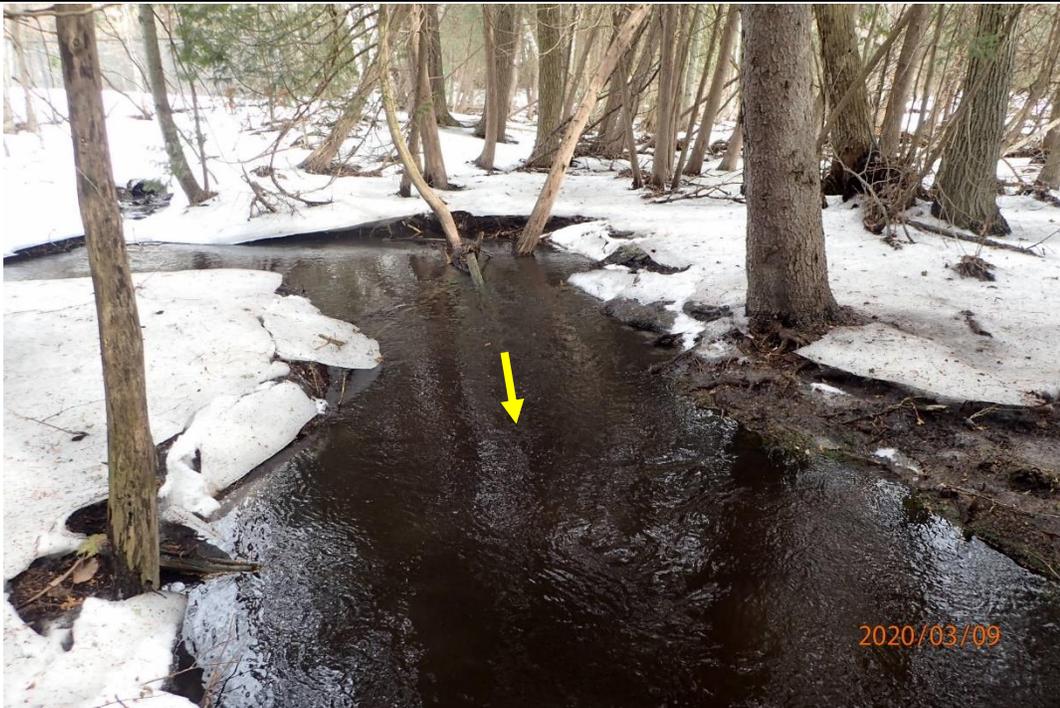
Photo 10
Reach LC-1 – Leonard’s Creek, Innisfil, ON

Photograph taken looking upstream. Average bankfull width and depth were 4.2 m and 0.7 m, respectively.

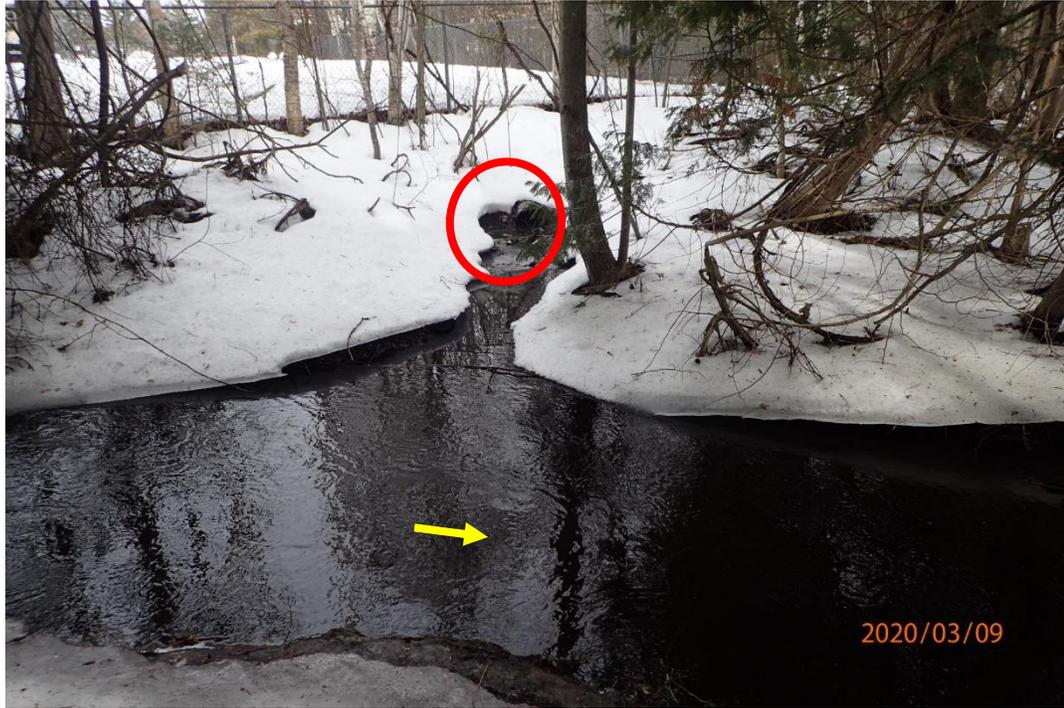
Photo 11
Reach LC-1 – Leonard’s Creek, Innisfil, ON

Photograph taken from the south bank towards Goodfellow Public School’s fence line. A stormwater outfall was visible with flows entering Leonard’s Creek.

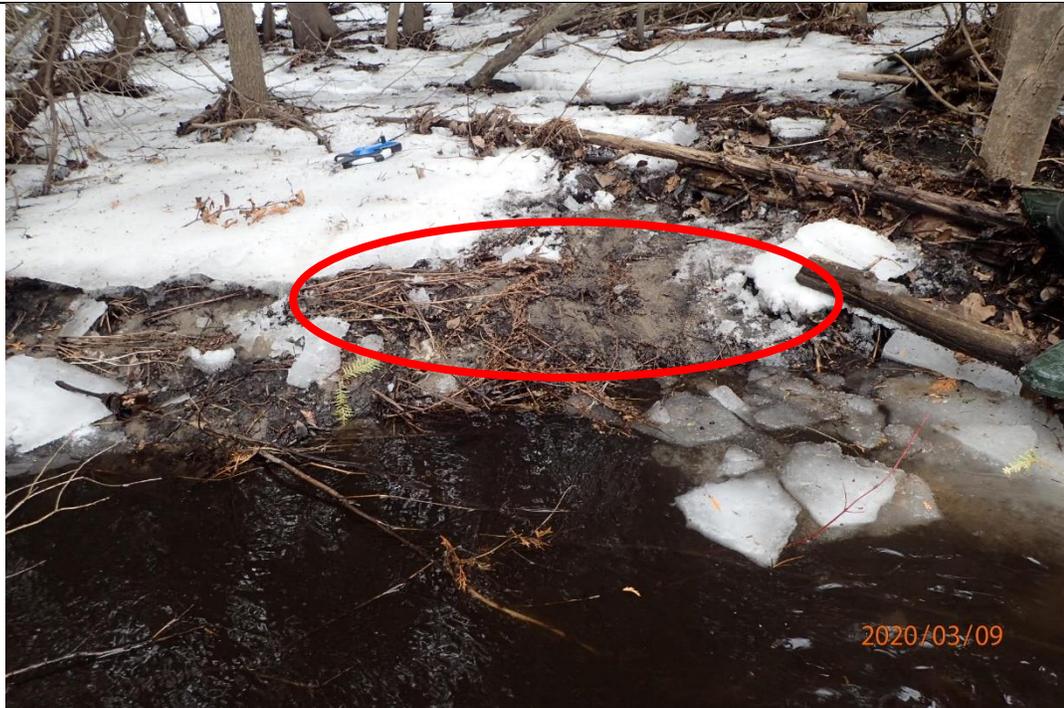
Photo 12
Reach LC-1 – Leonard’s Creek, Innisfil, ON

Photograph taken looking at bank materials upstream of the SWM pond confluence. Fresh deposits of sand were observed in the overbank zone in several locations along the reach, providing evidence of aggradation.

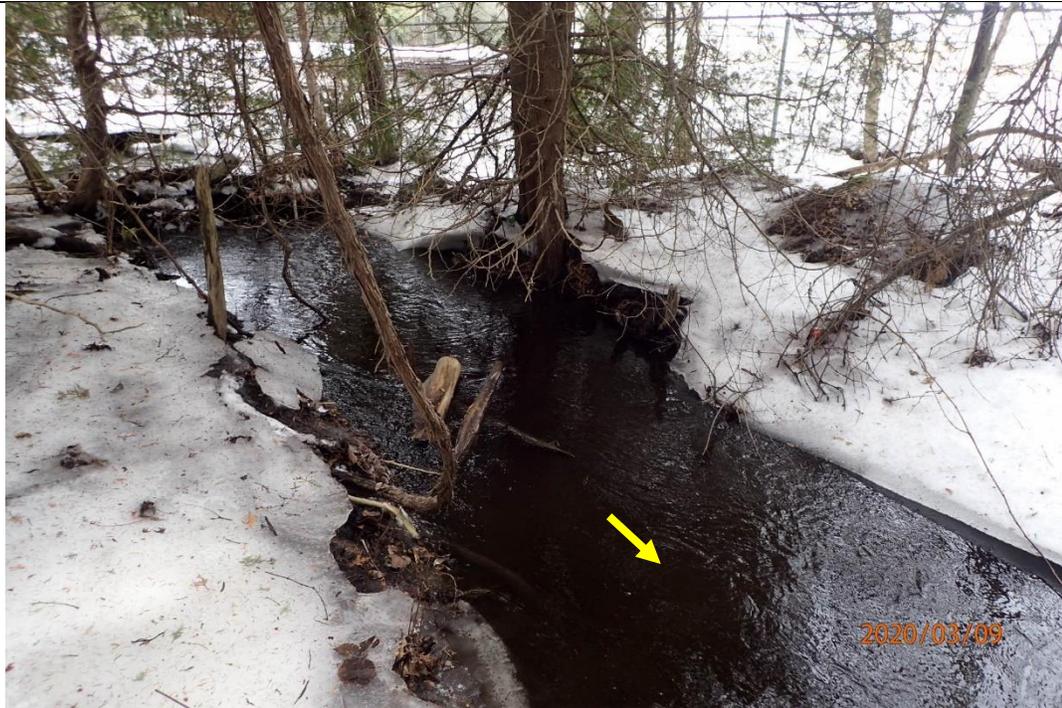
Photo 13
Reach LC-1 – Leonard’s Creek, Innisfil, ON

Photograph looking upstream at Reach LC-1. Riffle-pool sequences were present throughout the reach. Bed materials ranged from silt/sand to small cobble.

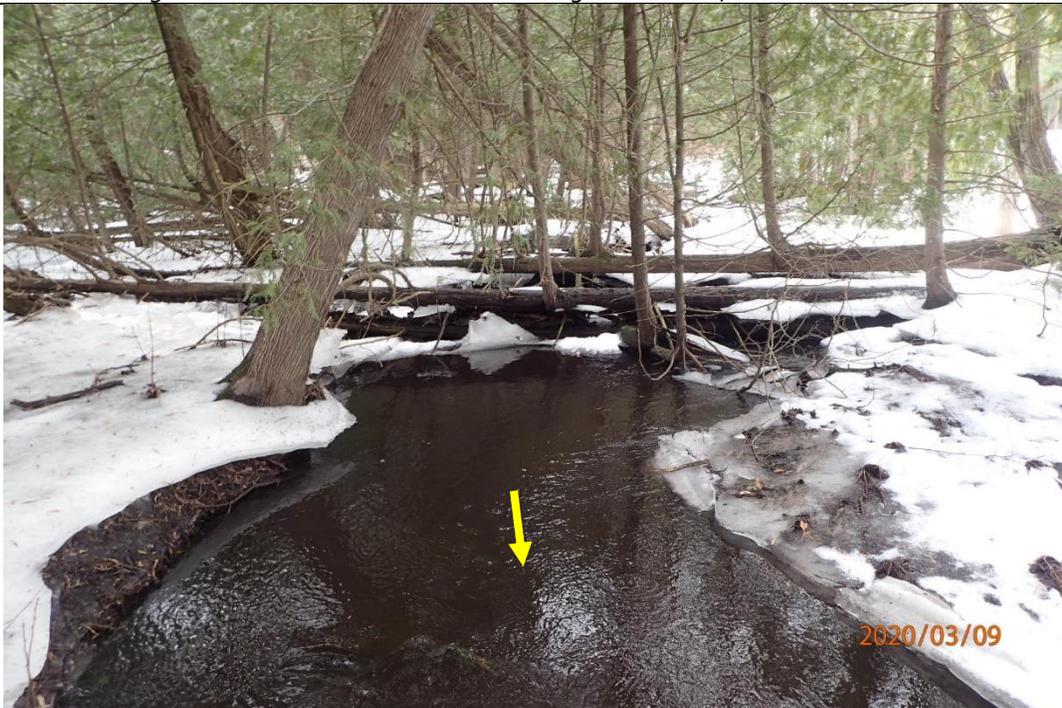
Photo 14
Reach LC-1 – Leonard’s Creek, Innisfil, ON

Photograph taken at the upstream extent of Reach LC-1. Leaning and fallen trees were observed along the entire reach.
