6th Line Municipal Class Environmental Assessment

County Road 27 to St John's Road
Town of Innisfil, ON

**Cultural Heritage Resource Assessment:
Built Heritage Resources and Cultural Heritage Landscapes**

**6th Line (Part A): 20 Sideroad to St. John's Road
Class Environmental Assessment Study**

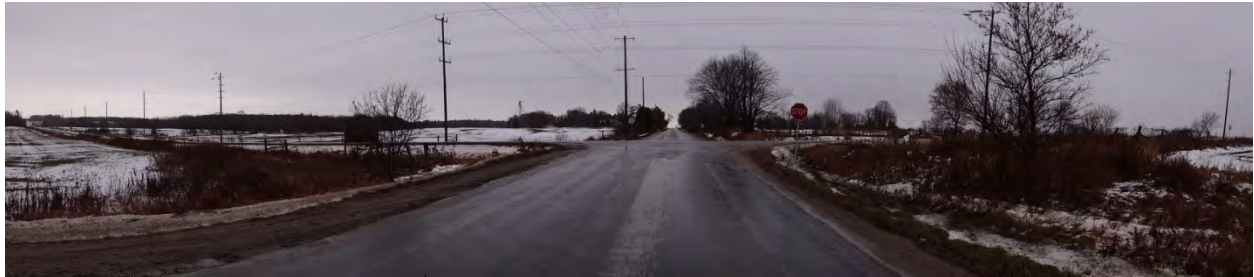
Plate 1: West-southwest view along 6th Line towards 20 Sideroad.

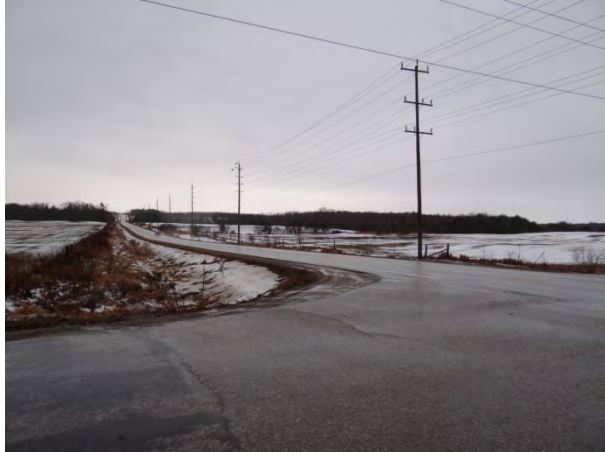
Plate 2: South-southwest view of 20 Sideroad from 6th Line.

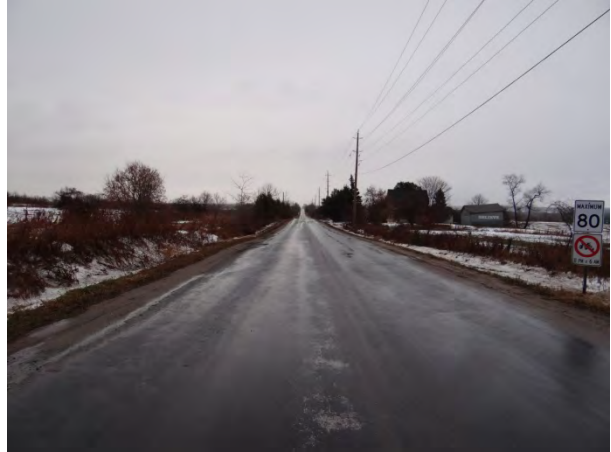
Plate 3: East-northeast view of 6th Line.

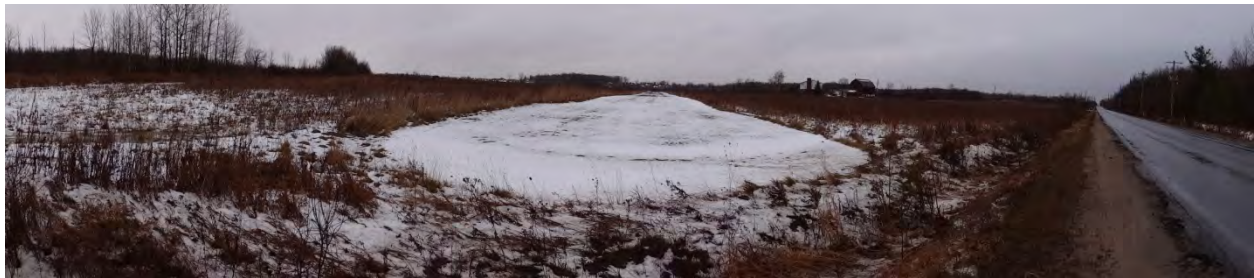
Plate 4: North-northeast view of the airfield located on the north side of 6th Line.

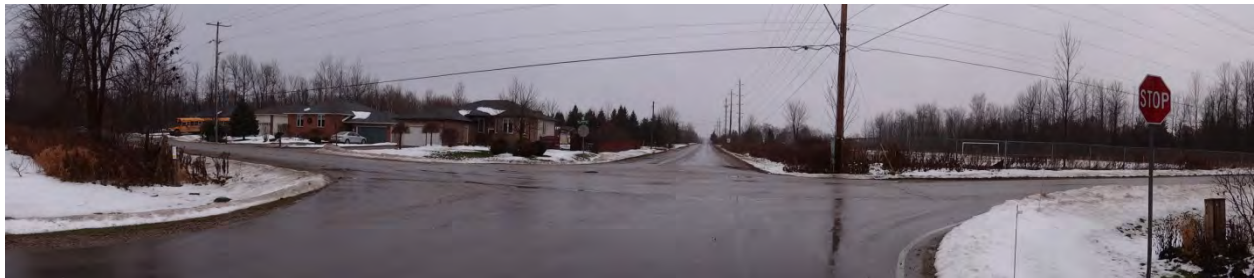
Plate 5: West-southwest view of the intersection of 6th Line and St Johns Road. Note residences on left.

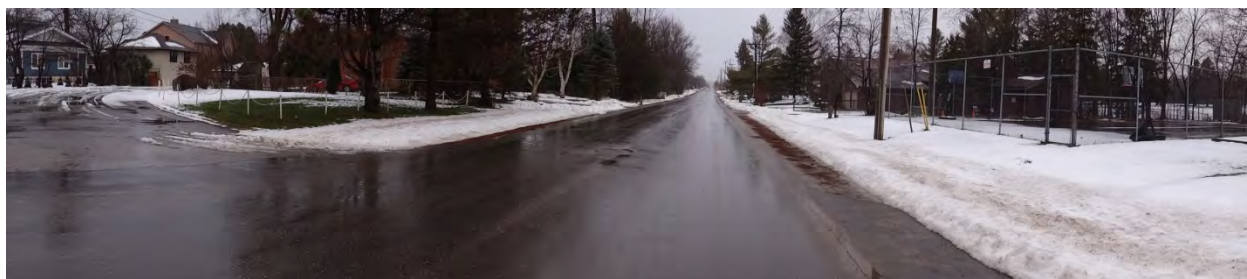
Plate 6: West-southwest view of 6th Line and Point Place. Note residences on left and day camp on right.

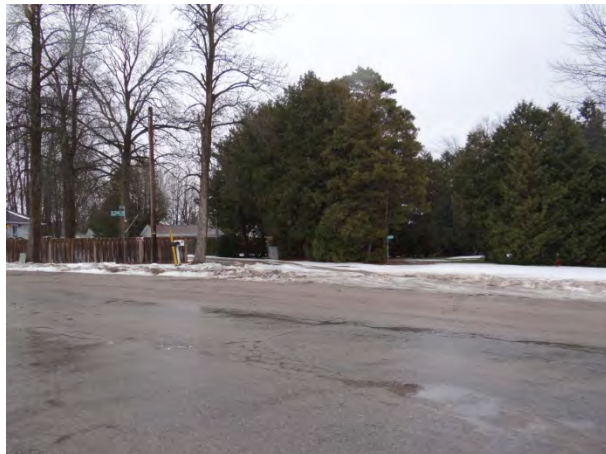
Plate 7: Northeast view towards Button Place. Note residences/cottages in far left.

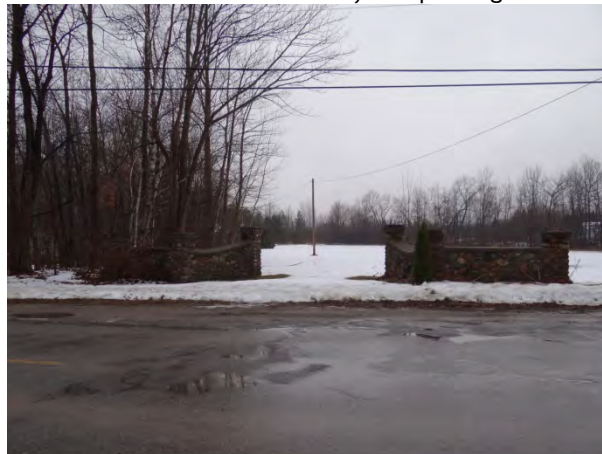
Plate 8: Northwest view of the riverstone gates leading to the Big Cedar Point Association.

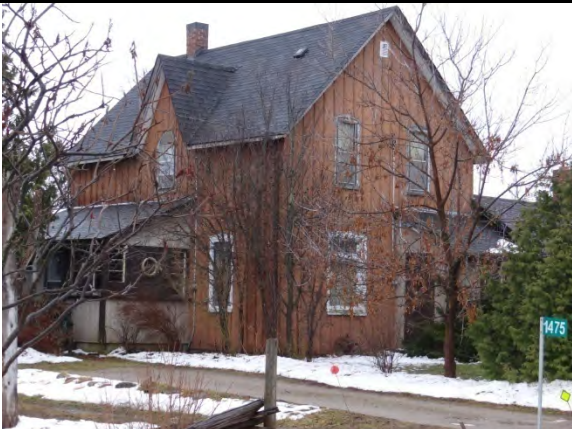
Resource	Type	Address/Location	Recognition	Description	Photos
BHR 1	Residence	1475 6 th Line	Identified during the field review	<p>Historical:</p> <ul style="list-style-type: none"> -Associated with the historical development of the Town of Innisfil -Appears on the 1928 historic topographic map of Barrie <p>Design:</p> <ul style="list-style-type: none"> -One-and-a-half storey Gothic Revival Cottage with a rectangular plan, gable roof, and a centre gable -Exterior clad with board and batten siding and roof is clad with asphalt shingles -One brick interior chimney offset to the south -Centre gable has a semi-circular window and all other windows have triangular structural openings -All window frames appear to be wood -Closed porch located on the east elevation and one storey addition on the west elevation -Landscape features include established trees and a treeline, shrubs, a lawn, two gravel driveways, a lawn, and two sheds <p>Context:</p> <ul style="list-style-type: none"> -Located on the south side of 6th Line -Reflects nineteenth-century settlement along 6th Line through its architectural style, scale/massing, and set back

<p>East and north elevations of 1475 6th Line</p>

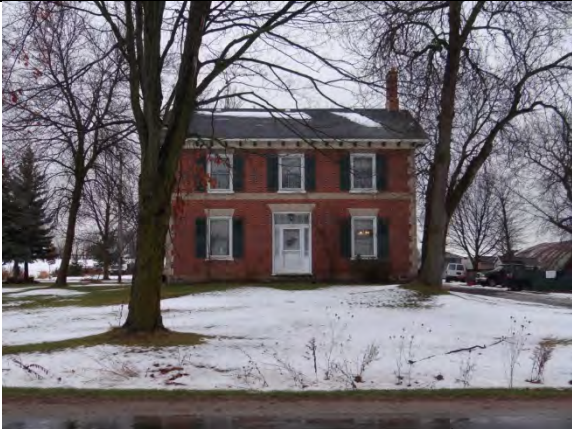
BHR 2	Residence	1350 6 th Line	Designated under Part IV of the <i>Ontario Heritage Act (OHA)</i> (see Town of Innisfil 2009)	<p>Historical:</p> <ul style="list-style-type: none"> -Associated with the historical development of the Town of Innisfil -Built in 1867 and appears on the 1928 historic topographic map of Barrie -Known as the 'Sawyer House' -Owned by the Sawyer family for four generations until 1953; subsequently owned by the McQuarrie and Fermo families. <p>Design:</p> <ul style="list-style-type: none"> -Two storey Georgian-style residence with a T-shaped plan and a gable roof -Regency and Italiante style details -Stone foundations, dichromatic brick exterior, and asphalt shingle roof with decorative brackets -Buff brick quoins, banding, and flat voussoirs on all elevations -Two internal brick chimneys located on the east and west elevations -All windows are sash six-over-six and have decorative wood shutters -Two additions located at the rear of the residence -Landscape features include mature trees and treelines, young trees, a lawn, flower gardens, and two gravel driveways <p>Context:</p> <ul style="list-style-type: none"> -Located on the north side of 6th Line -Reflects nineteenth-century settlement along 6th Line through its architectural style, materials, scale/massing, and set back

<p>Front façade (south elevation) of 1350 6th Line</p>

Resource	Potential Impact(s)	Proposed Mitigation Measure(s)
BHR 1	<ul style="list-style-type: none"> None 	<ul style="list-style-type: none"> None
BHR 2	<ul style="list-style-type: none"> Alteration (III.2) due to encroachment on the property and removal of mature trees due to road widening and construction of multi-use path; and, Soil disturbance (III.7) due to expanded grading limits. 	<ul style="list-style-type: none"> As this property is Designated under Part IV of the OHA, a heritage impact assessment (HIA) should be carried out prior to construction to document the existing conditions of the property, identify any heritage attributes that may be impacted by the proposed work, and develop appropriate mitigation measures; and, Investigate the feasibility of implementing tree protection zones to retain existing trees on the property.
BHR 3	<ul style="list-style-type: none"> Alteration (III.2) due to removal of mature trees, young trees, and shrubs; and, Soil disturbance (III.7) due to expanded grading limits. 	<ul style="list-style-type: none"> Landscape documentation should be carried out prior to construction; Investigate the feasibility of implementing tree protection zones to retain existing trees on the property; and, Post-construction landscaping to re-establish pre-construction conditions.

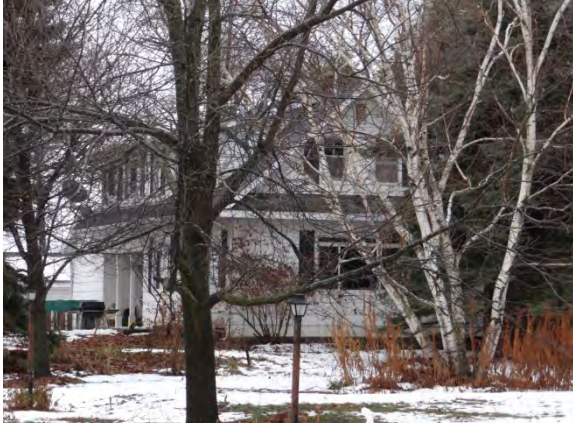
Resource	Type	Address/Location	Recognition	Description	Photos
BHR 3	Residence	1323 6 th Line	Identified during the field review	<p>Historical:</p> <ul style="list-style-type: none"> -Associated with the historical development of the Town of Innisfil -Appears on the 1928 historic topographic map of Barrie <p>Design:</p> <ul style="list-style-type: none"> -This residence was largely screened from view by heavy vegetation cover so observations of the exterior are limited -One-and-a-half storey residence with a rectangular plan, gable roof, and shed-style dormer on the east elevation -Exterior appears to be clad in clapboard siding and roof appears to be clad in asphalt shingles -Front façade (east elevation) features a recessed entrance -Landscape features include mature trees and a treeline, flower gardens, a gravel driveway, and a lawn <p>Context:</p> <ul style="list-style-type: none"> -Located on the south side of 6th Line -Reflects the nineteenth century/early-twentieth century settlement along 6th Line through its scale/massing, set back, and landscape features

<p>Front façade (east elevation) and north elevation at 1323 6th Line</p>

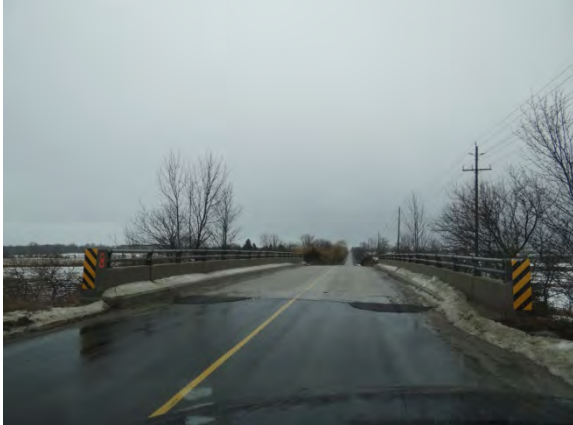
BHR 4	Bridge	6 th Line and the CN Rail Line	Identified during the field review	<p>Historical:</p> <ul style="list-style-type: none"> -Associated with the historical development of the Town of Innisfil -A bridge in this location is depicted on the 1928 historic topographic map of Barrie <p>Design:</p> <ul style="list-style-type: none"> -Observations of this bridge were limited to the public ROW for safety reasons so a full description of this resource is not available -Span is approximately 43 m long and 9 m wide -The deck of the bridge features concrete barriers and metal railings <p>Context:</p> <ul style="list-style-type: none"> -The bridge carries two lanes of traffic over the CN Rail Line -This bridge is functionally and historically linked to its surroundings (i.e. the historical Northern Railway, now the CN Rail Line)

<p>West view across the 6th Line/CN Rail Bridge</p>
BHR 5	Residence	853 6 th Line	Previously identified by ASI (2014)	<p>Historical:</p> <ul style="list-style-type: none"> -Associated with the historical development of the Tent City and the Town of Innisfil -Constructed between 1950 and 1986 -Architectural style of the house suggests that it was built in the 1950s or 1960s <p>Design:</p> <ul style="list-style-type: none"> -Mid-century modern bungalow features a sloped roof, attached garage, and recessed entrance -The roof is clad in asphalt shingles and the exterior walls are clad in painted wood siding -The base of the structure features a plinth that is made of riverstone with a stone sill -The property also has a shed on the east side of the residence that is clad in riverstone, a local building -Landscape features on the property include a paved driveway, lawn, flower garden, flag pole, and mature vegetation <p>Context:</p> <ul style="list-style-type: none"> -Located on the south side of 6th Line -Supports the character of the area through the use of riverstone on the exterior and shed. Riverstone is a local material that is used on other properties in the area to create walls, pillars, and chimneys. -Visually linked to its surroundings through the use of local building materials

Resource	Potential Impact(s)	Proposed Mitigation Measure(s)
BHR 4	<ul style="list-style-type: none"> • Destruction (III.1) due to removal of bridge to accommodate the wider road and multi-use path. 	<ul style="list-style-type: none"> • A heritage impact assessment (HIA) should be carried out prior to construction to document the existing conditions of the property, identify any heritage attributes that may be impacted by the proposed work, and develop appropriate mitigation measures.
BHR 5	<ul style="list-style-type: none"> • Alteration (III.2) due to removal of mature trees, young trees, and shrubs; and, • Soil disturbance (III.7) due to expansion of grading limits. 	<ul style="list-style-type: none"> • Landscape documentation should be carried out prior to construction; • Investigate the feasibility of implementing tree protection zones to retain existing trees on the property; and, • Post-construction landscaping to re-establish pre-construction conditions.

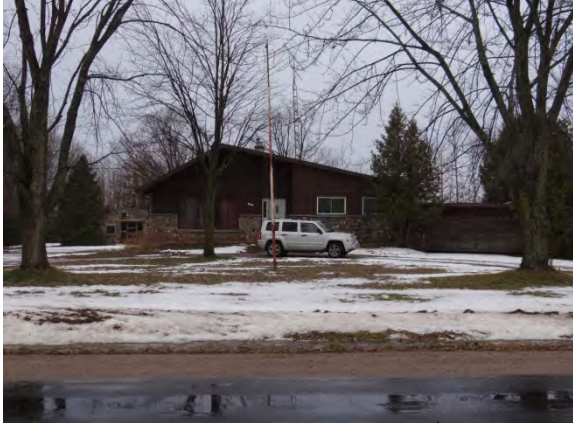
<p>Front façade (north elevation) of 853 6th Line</p>

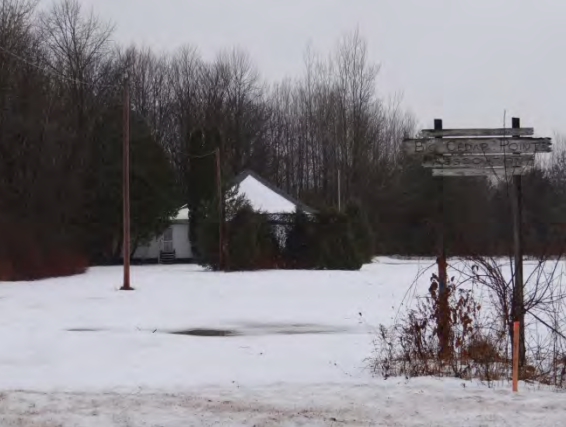
Resource	Type	Address/Location	Recognition	Description	Photos
BHR 6	Dance Hall	1498 Maple Road	Listed by Municipality	<p>Historical:</p> <ul style="list-style-type: none"> -Associated with the historical development of the Tent City and the Town of Innisfil -Built 1925 and shown on the 1932 NTS map of Barrie <p>Design:</p> <ul style="list-style-type: none"> -The Big Cedar Point Association clubhouse is set back approximately 100 m from the public ROW and is screened from view by trees and shrubs. Accordingly, detailed observations of the building are not available -The building appears to be a one storey wooden structure with a rectangular plan and hipped roof -A gate made of riverstone is located at the front of the property -Landscape features include the riverstone gate, lawn, flag pole, and circulation routes <p>Context:</p> <ul style="list-style-type: none"> -Located on the west side of Maple Road -Defines and maintains the character of the area since this is one of the last remaining dance halls in Ontario (Town of Innisfil 2010) -Physically, functionally, and historically linked to its surroundings as a historic dance hall -The riverstone gates at the base of the footpath are a landmark and visually link the property to its surroundings through the use of a local building material

BHR 6	<ul style="list-style-type: none"> • None 	<ul style="list-style-type: none"> • None
CHL 1	<ul style="list-style-type: none"> • Alteration (III.2) and soil disturbance (III.7) due to road widening construction activities and expansion of grading limits. 	<ul style="list-style-type: none"> • Landscape documentation should be carried out prior to construction to create a record of the existing conditions of the roadway; and, • Post-construction landscaping to re-establish pre-construction conditions.
CHL 2	<ul style="list-style-type: none"> • No negative impacts anticipated 	<ul style="list-style-type: none"> • None
CHL 3	<ul style="list-style-type: none"> • Alteration (III.2) due to encroachment on the airfield due to road widening and construction of multi-use trail; and, • Soil disturbance (III.7) expansion of grading limits 	<ul style="list-style-type: none"> • Landscape documentation should be carried out prior to construction; and, • Post-construction landscaping to re-establish pre-construction conditions.

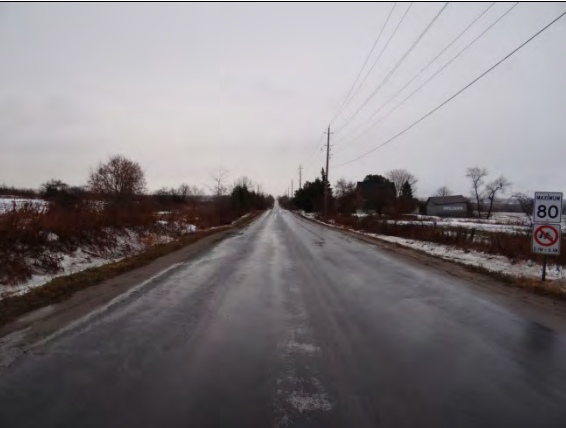
CHL 1	Roadscape 6	6 th Line	Previously identified by ASI (2014)	<p>Historical:</p> <ul style="list-style-type: none"> -Associated with the historical development of the Township of Innisfil and Simcoe County -6th Line is a historically surveyed road that runs in a general east-west direction. -6th Line is the earliest established road in the study area and is shown on the 1881 map of Innisfil <p>Design:</p> <ul style="list-style-type: none"> -The road is paved, two lanes wide, has narrow shoulders, ditching, and culverts -Several stone pillars made of riverstone are located along 6th Line in the vicinity of Houston Avenue and Point Place -Sections of 6th Line are lined with mature trees and tree lines <p>Context:</p> <ul style="list-style-type: none"> -Maintains the historical character of the area through its width and physical characteristics, which are typical of a historical county road

<p>East view along 6th Line</p>

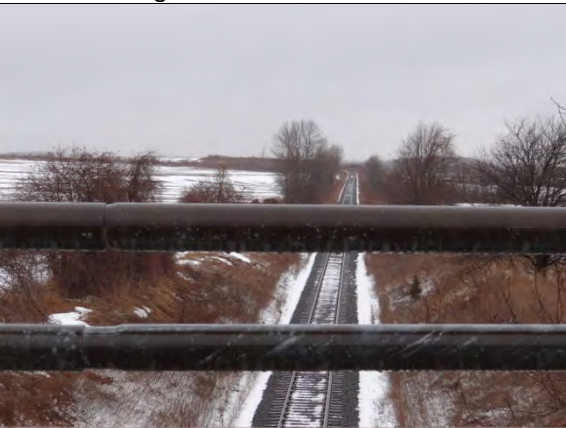
CHL 2	Railscape	CN Rail Line	Identified during the field review	<p>Historical:</p> <ul style="list-style-type: none"> -Associated with the historical development of the Township of Innisfil and Simcoe County -Appears on 1881 historical mapping of the Township of Innisfil <p>Design:</p> <ul style="list-style-type: none"> -Single track that runs in a general north-south direction -Track is laid on a bed of ballast -The rail line is generally bounded by shrubs and agricultural fields <p>Context:</p> <ul style="list-style-type: none"> -Maintains the historical character of the area through its width and physical characteristics, which are typical of a historical rail line

<p>North view along the CN Rail Line</p>

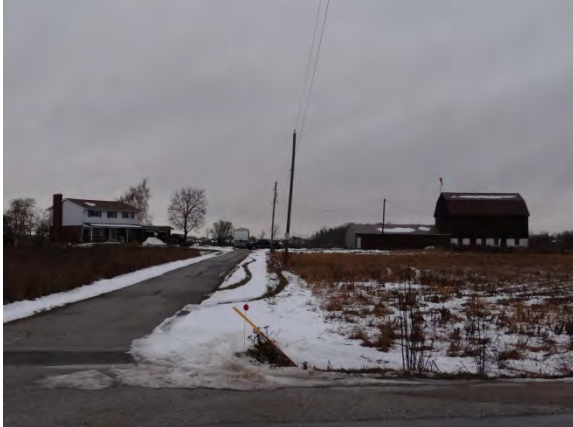
Resource	Type	Address/Location	Recognition	Description	Photos
CHL 3	Farm Complex	1010 6 th Line	Identified during the field review	<p>Historical:</p> <ul style="list-style-type: none"> -Associated with the historical development of the Town of Innisfil -A farmstead in this location is depicted on the 1928 historic topographic map of Barrie -The airfield appears on the 1986 NTS map of Barrie <p>Design:</p> <ul style="list-style-type: none"> -The property includes one residence, a barn, and an airfield -The residence appears to be relatively recent and likely replaced an older structure on the property -The barn appears to date to the late-nineteenth century/early twentieth-century and features a gambrel roof and vertical board siding -The barn foundations are painted white and are not discernible from the public ROW -The airfield crosses the property in a general northeast-southwest direction -The airfield consists of a cleared landing strip in an agricultural field <p>Context:</p> <ul style="list-style-type: none"> -Located on the north side of 6th Line -Reflects the nineteenth century/early-twentieth century settlement along 6th Line through the presence of the barn, the set-back of the buildings, and landscape features (i.e. the airfield)

<p>North view towards 1010 6th Line</p>

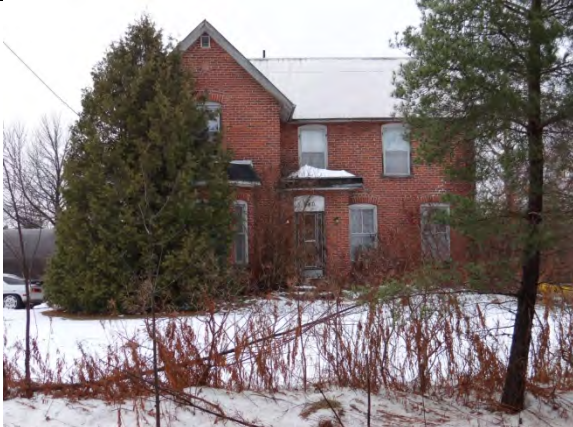
CHL 4	Farm Complex	840 6 th Line	Previously identified by ASI (2014)	<p>Historical:</p> <ul style="list-style-type: none"> -Associated with the historical development of the Town of Innisfil -This farmstead is depicted on the 1928 NTS map of Barrie <p>Design:</p> <ul style="list-style-type: none"> -This two-storey residence features a T-shaped plan and cross gable roof -The roof is clad in metal sheeting and the exterior walls are clad in red brick -All first floor windows and one second floor window feature segmental arched voussoirs with radiating bricks -All windows appear to have wood frames -Aerial imagery indicates that a barn and outbuilding are located northwest of the residence. These structures were screened by vegetation and could not be observed from the public ROW -Landscape features on the property include a gravel driveway, circulation routes, former agricultural fields, tree lines, mature vegetation, and a woodlot <p>Context:</p> <ul style="list-style-type: none"> -Located on the north side of 6th Line -Reflects the nineteenth century/early-twentieth century settlement along 6th Line through its scale/massing, set back, and landscape features

<p>Front façade of 840 6th Line</p>

Resource	Potential Impact(s)	Proposed Mitigation Measure(s)
CHL 4	<ul style="list-style-type: none"> Alteration (III.2) due to removal of established trees, young trees, and shrubs due to road widening and construction of multi-use trail; and, Soil disturbance (III.3) due to expanded grading limits. 	<ul style="list-style-type: none"> Landscape documentation should be carried out prior to construction; Investigate the feasibility of implementing tree protection zones to retain existing trees on the property; and, Post-construction landscaping to re-establish pre-construction conditions.
CHL 5	<ul style="list-style-type: none"> None 	<ul style="list-style-type: none"> None
CHL 6	<ul style="list-style-type: none"> None 	<ul style="list-style-type: none"> None
CHL 7	<ul style="list-style-type: none"> None 	<ul style="list-style-type: none"> None

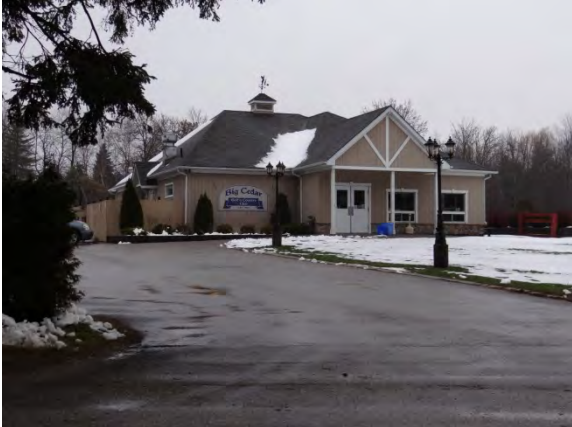
Resource	Type	Address/Location	Recognition	Description	Photos
CHL 5	Golf Course	1590 Houston Avenue	Previously identified by ASI (2014)	<p>Historical:</p> <ul style="list-style-type: none"> -Associated with the historical development of Tent City and the Town of Innisfil -The Big Cedar Golf & Country Club was established in 1931 -The golf course and layout of the greens are visible on the 1950 aerial image of Innisfil <p>Design:</p> <ul style="list-style-type: none"> -The course measures 5430 yards and features a mix of water and trees (Big Cedar Golf Club 2014) -The course has undergone some changes in recent years, including the reconstruction of the 8th green in 2008 and the addition of a pond in the 7th fairway (Big Cedar Golf Club 2014). -The clubhouse also appears to be new <p>Context:</p> <ul style="list-style-type: none"> -Located north of 6th Line, between St Johns Road and Houston Avenue -Contributes to the seasonal cottage character of Tent City, located at the east end of 6th Line

<p>West view of the clubhouse</p>

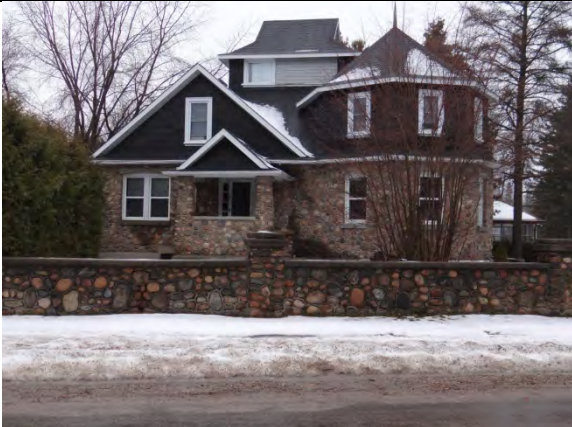
CHL 6	Day Camp	684 6 th Line	Listed by Municipality	<p>Historical:</p> <ul style="list-style-type: none"> -Camp Arrowhead was established in 1956 as a Jewish day camp -The buildings and outdoor space associated with Camp Arrowhead appear on the 1932 NTS map of Barrie <p>Design:</p> <ul style="list-style-type: none"> -The camp spans over 280 feet of the Lake Simcoe shoreline and includes several buildings and facilities for campers -The building located at the northwest corner of the intersection of Houston Avenue and 6th Line is the former residence of Lorne D. Jack, who was the founder of Tent City and established the Tent City Hotel, a hotel and dance hall formerly located on the northeast side of the intersection -Jack's former residence, known as "Castle Hall" was sold to Camp Arrowhead in 1967 by Jack Miller, a descendent of the Jack family -Castle Hall features Arts and Crafts style elements, including the use of local materials (i.e. riverstone) to reflect the natural environment, the orientation of the house towards the lake, the location of the garden at the front of the house, and the positioning of the entrances at the sides of the house -Landscape features include stone walls and pillars along all sides of Castle Hall, mature trees, a basketball court, and sports field <p>Context:</p> <ul style="list-style-type: none"> -Located on the north side of 6th Line -Defines and maintains the character of the area -Physically, functionally, visually, and historically linked to the surrounding area as the former residence of Jack Lorne, the founder of Tent City

<p>South elevation of Castle Hall (648 6th Line)</p>

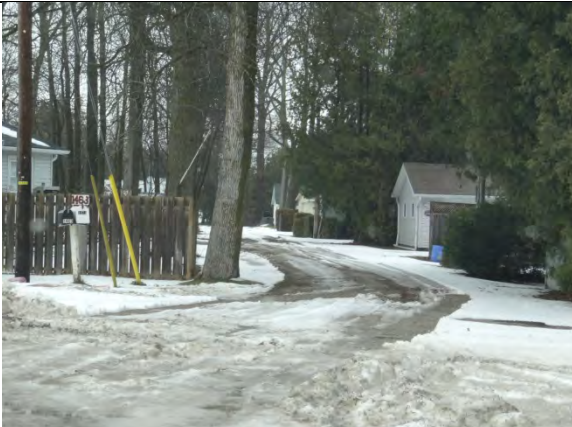
CHL 7	Streetscape	Button Place	Previously identified by ASI (2014)	<p>Historical:</p> <ul style="list-style-type: none"> -Associated with the historical development of Tent City and the Town of Innisfil -Button Place and its associated cottages are depicted on the 1928 NTS map of Barrie <p>-Button Place is a gravel sideroad that is one lane wide</p> <p>-The road has no shoulders or ditching and generally follows the Lake Simcoe shoreline</p> <p>-Landscape features along the road include mature trees and established vegetation</p> <p>-Button Place is bordered on the south by a mix of recent and older cottages</p> <p>-A small boat launch is located at the southwest end of the road</p> <p>Context:</p> <ul style="list-style-type: none"> -Located on east side of St Johns Road -Supports the early-twentieth century character of the area through the unfinished condition of the road and the presence of early-twentieth-century cottages along the shoreline of Lake Simcoe

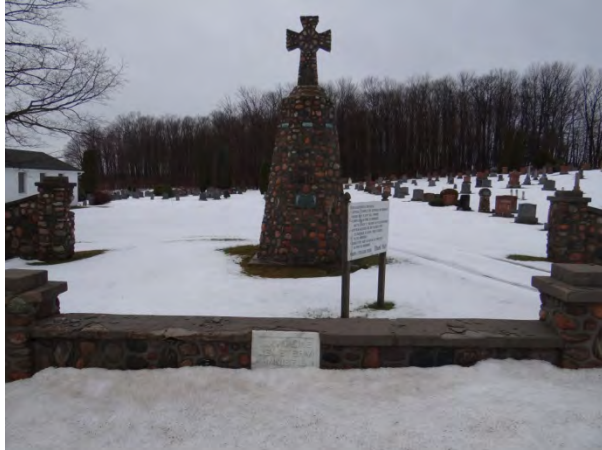
Plate 6: West-southwest view of the Sixth Line Cemetery (CHL 18).

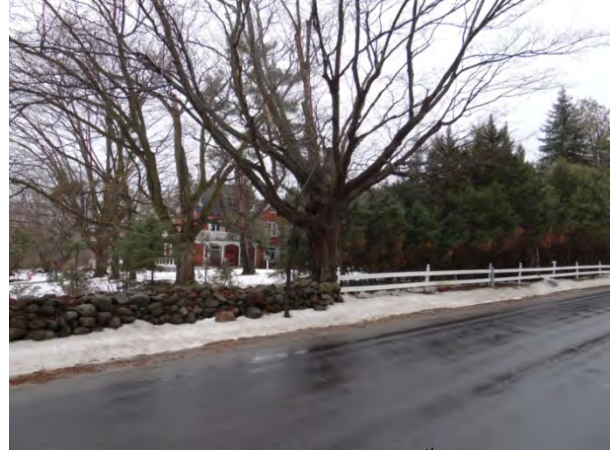
Plate 7: South-southwest view from 6th Line towards CHL 22. Note stone wall and post-and-rail fencing.

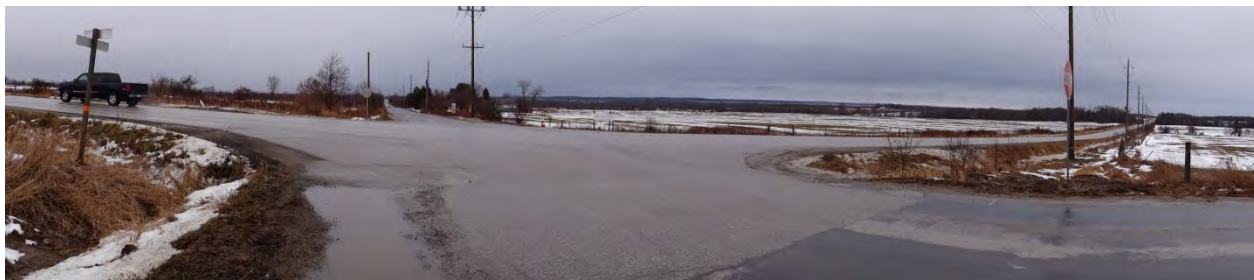
Sideroad 20 is two lanes wide with a painted centreline, gravel shoulders, and ditching. The intersection of 6th Line and Sideroad 20 is bordered by a historical farm complex and agricultural fields (Plate 8).

Plate 8: West-southwest view towards the intersection of 6th Line and Sideroad 20.

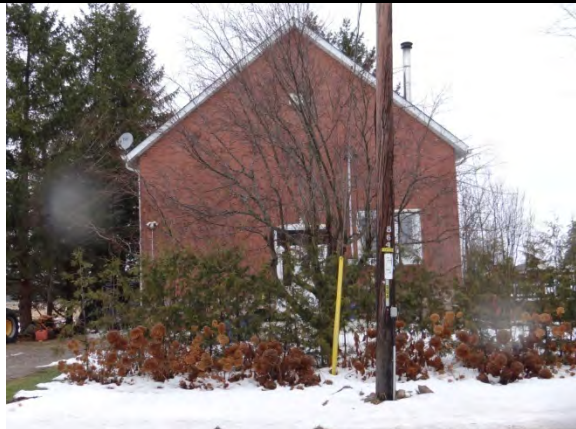
Resource	Type	Address/Location	Recognition	Description	Photos
BHR 1	Schoolhouse	3654 6 th Line	Identified during the field review	<p>Historical:</p> <ul style="list-style-type: none"> -The property is associated with the historical development of the Town of Innisfil -A schoolhouse in this location appears on the 1881 map of the Township of Innisfil -The building dates to 1910 <p>Design:</p> <ul style="list-style-type: none"> -A date stone reads “S.S. No. 6, 1910” -The property features a one-storey schoolhouse with a rectangular plan and gable roof -The structure has stone foundations, a red brick exterior, an asphalt shingle roof, and two external chimneys -Two tie rods are visible on the front façade (south elevation) -Landscape features include a dirt driveway, mature trees, shrubs, and a flower garden <p>Context:</p> <ul style="list-style-type: none"> -The schoolhouse is located on the north side of 6th Line -The property reflects nineteenth and early-twentieth century settlement along 6th through its architectural style and materials

<p>Front façade (south elevation) of 3654 6th Line</p>

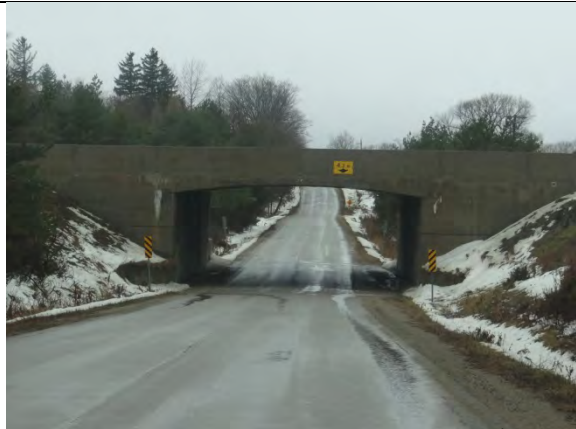
BHR 2	Bridge	6 th Line and Highway 400	Identified during the field review	<p>Historical:</p> <ul style="list-style-type: none"> -This property is associated with the historical development of the Town of Innisfil and the construction of Highway 400 -A bridge in this location is shown on the 1954 aerial of Innisfil <p>Design:</p> <ul style="list-style-type: none"> -This bridge is a single span concrete reinforced slab bridge -The bridge is approximately 32 m long and 30 m wide (including abutments) <p>Context:</p> <ul style="list-style-type: none"> -The bridge provides passage over 6th Line for vehicles travelling north and south along Highway 400 and reflects mid-twentieth century transportation development

<p>West view of the Highway 400 Bridge over 6th Line</p>
CHL 1	Roadscape	6 th Line	Previously identified by ASI (2014)	<p>Historical:</p> <ul style="list-style-type: none"> -6th Line is associated with the historical development of the Township of Innisfil and Simcoe County -6th Line is a historically surveyed road that runs in a general east-west direction. -6th Line is the earliest established road in the study area and is shown on the 1881 map of Innisfil <p>Design:</p> <ul style="list-style-type: none"> -The road is paved, two lanes wide, has narrow shoulders, ditching, and culverts -Sections of 6th Line are lined with mature trees, tree lines, stone walls, and fencing associated with historical farm complexes <p>Context:</p> <ul style="list-style-type: none"> -This roadscape maintains the historical character of the area through its width and physical characteristics, which are a typical of a historical county road

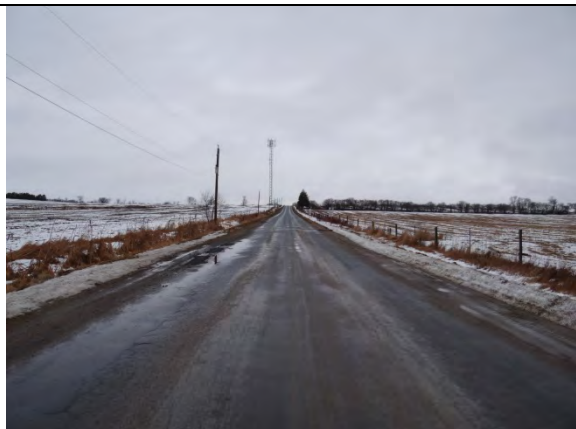
<p>East view along 6th Line</p>

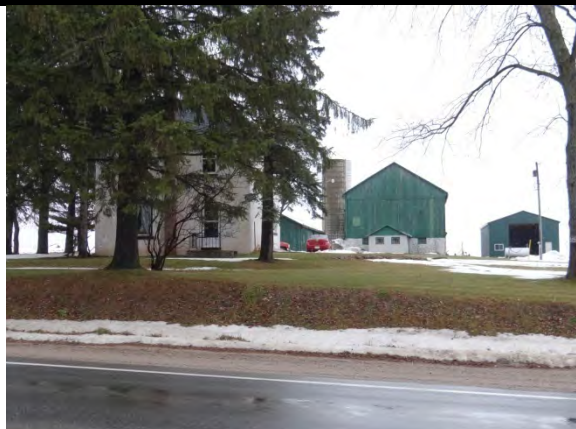
Resource	Type	Address/Location	Recognition	Description	Photos
CHL 2	Farm Complex	6831 Country Road 27	Identified during the field review	<p>Historical: -This property is associated with the historical development of the Town of Innisfil -A farm complex in this location appears on the 1928 topographic map of Barrie</p> <p>Design: -The property contains one residence, one barn, outbuildings, and a silo -The residence is largely screened from view by vegetation so detailed observations are not available -The house appears to have a rectangular plan with additions at the rear and the exterior is clad in stucco. -The barn has stone foundations, a rectangular plan, and a gable roof -Landscape features includes a treeline, lawn, trees, fields, and circulation routes</p> <p>Context: -This property is located on the east side of Country Road 27 -Reflects nineteenth and early-twentieth century settlement along 6th Line through the arrangement of buildings, architectural style and materials, and landscape features</p>

<p>Front façade (west elevation) of 6831 Country Road 27</p>

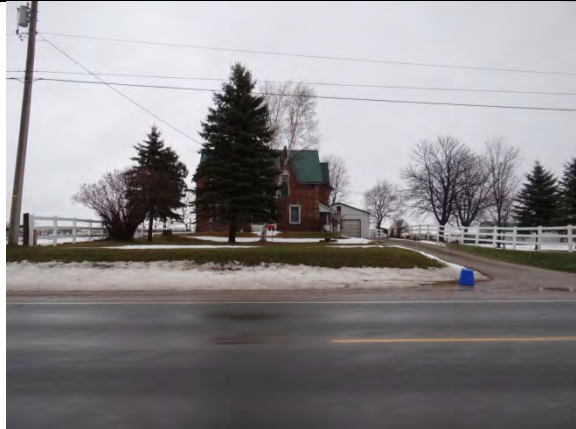
CHL 3	Farm Complex	6711 Country Road 27	Identified during the field review	<p>Historical: -This property is associated with the historical development of the Town of Innisfil -A farm complex in this location appears on the 1928 topographic map of Alliston</p> <p>Design: -The property features a residence, barn, and outbuildings -The farmhouse consists of a one-and-a-half storey Ontario Victorian style residence with an L-shaped plan and a cross gable roof -The residence has stone foundations, red brick exterior with buff banding and quoins, metal sheet roof -The barn has stone foundations, vertical wood plank siding, and a gable roof -Landscape features include trees, white post-and-board fencing, post-and-wire fencing, lawns, circulation routes, and agricultural fields</p> <p>Context: -This property is located on the east side of Country Road 27 -This property reflects late-nineteenth and early-twentieth century settlement along 6th Line through the arrangement of buildings, architectural style and materials, and landscape features</p>

<p>Front façade (west elevation) of 6711 Country Road 27</p>

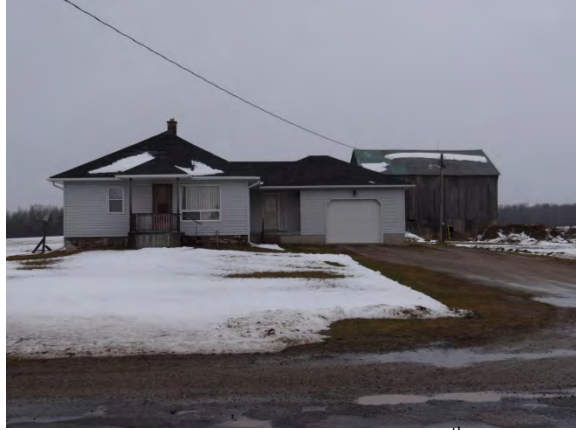
CHL 4	Farm Complex	4100 6 th Line	Identified during the field review	<p>Historical: -This property is associated with the historical development of the Town of Innisfil -A farm complex in this location is shown on the 1928 topographic map of Barrie</p> <p>Design: -The property features a residence, barn, and outbuildings -The residence is one storey residence and has a rectangular plan and hipped roof -The residence has stone foundations, vinyl siding, new/replaced doors and windows, an asphalt roof, and an attached garage on the east elevation -The barn has vertical wood plank siding and a gable roof -Landscape features include circulation routes, lawns, agricultural fields,</p> <p>Context: -This property is located on the north side of 6th Line -This property reflects late-nineteenth and early-twentieth century settlement along 6th Line through its arrangement of buildings, architectural style and materials, and landscape features</p>

<p>Front façade (south elevation) of 4100 6th Line</p>

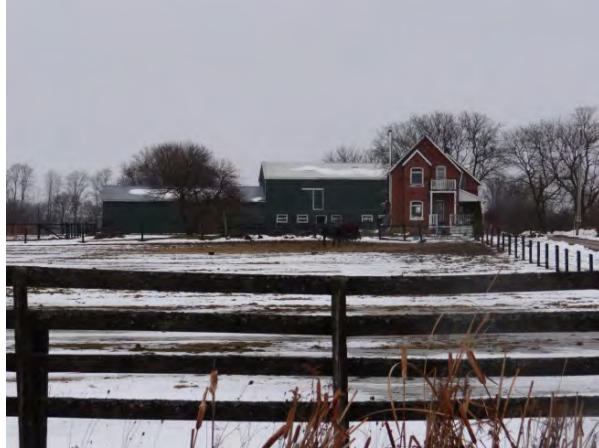
Resource	Type	Address/Location	Recognition	Description	Photos
CHL 5	Farm Complex	3996 6 th Line	Identified during the field review	<p>Historical: -This property is associated with the historical development of the Town of Innisfil -A farm complex in this location is depicted on the 1881 map of the Township of Innisfil</p> <p>Design: -This property contains a residence, a barn, horse pens, and pastures -The farmhouse consists of a one-and-a-half storey residence with an irregular plan, and gable roofs -The residence features stone foundations, red brick exterior, and segmental brick voussoirs over window and door openings -The front façade of the residence features a two storey, open porch -The barn appears to be new and is clad in metal sheeting. The barn foundations were not visible from the public ROW. -Landscape features include horse pens, pastures, circulation routes, mature trees, and post-and-board fencing</p> <p>Context: -This property is located on the north side of 6th Line -This property reflects late-nineteenth and early-twentieth century settlement along 6th Line through its arrangement of buildings, architectural style and materials, and landscape features</p>

<p>Front façade (south elevation) of 3996 6th Line</p>

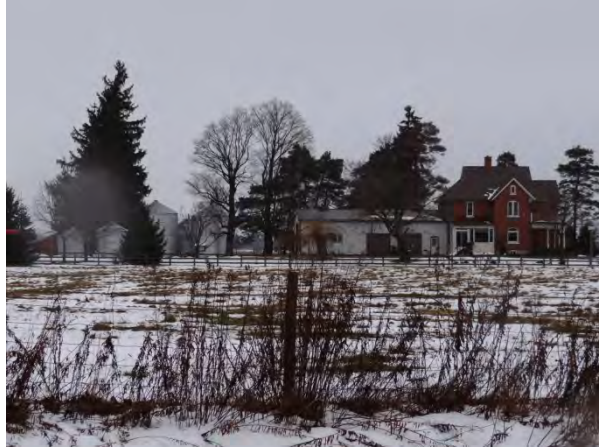
CHL 6	Farm Complex	6784 5 Sideroad	Identified during the field review	<p>Historical: -This property is associated with the historical development of the Town of Innisfil -A structure in this location is depicted on the 1881 map of the Township of Innisfil (the Killyleagh Post Office)</p> <p>Design: -This property contains one residence, outbuildings, and silos -The residence is two-and-a-half storeys and has an irregular plan -The residence exterior is clad in red brick and the roof is clad in asphalt shingles -All outbuildings and silos appear to be new/recent -Landscape features include mature trees, tree lines, a gravel driveway, lawn, post-and-board fencing, post-and-wire fencing, and pastures</p> <p>Context: -This property is located on the west side of 5 Sideroad -This property reflects late-nineteenth and early-twentieth century settlement along 6th Line through the arrangement of buildings, architectural style and materials, and landscape features</p>

<p>Front façade (east elevation) of 6784 5 Sideroad</p>

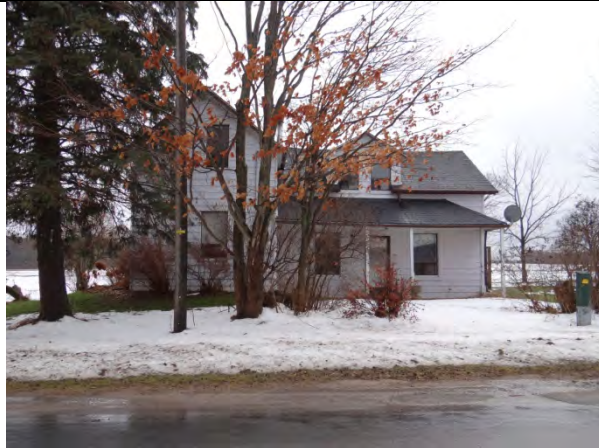
CHL 7	Farm Complex	3653 6 th Line	Identified during the field review	<p>Historical: -This property is associated with the historical development of the Town of Innisfil -A structure in this location is depicted on the 1928 topographic map of Barrie</p> <p>Design: -The property contains one residence and two outbuildings -The residence is one-and-a-half storeys and has an L-shaped plan and a gable roof -The residence exterior is clad in vinyl siding and the roof is clad in asphalt shingles -The front façade (north elevation) of the residence features an open verandah and a gable dormer with projecting eaves -The outbuildings are located in close proximity to the road and both feature board-and-batten siding and metal sheet roofing</p> <p>Context: -This property is located on the south side of 6th Line -This property reflects late-nineteenth and early-twentieth century settlement along 6th Line through the arrangement of buildings, architectural style and materials, and landscape features</p>

<p>Front façade (north elevation) of 3653 6th Line</p>

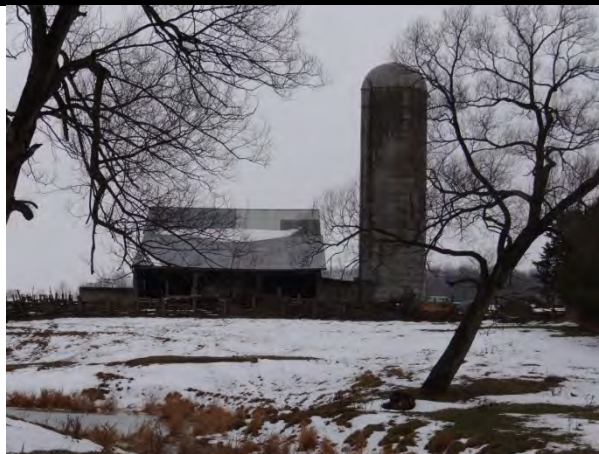
Resource	Type	Address/Location	Recognition	Description	Photos
CHL 8	Historical Agricultural Landscape	No address	Identified during the field review	<p>Historical: -This property is associated with the historical development of the Town of Innisfil -A farm complex in this location is depicted on the 1928 historic topographic map of Barrie</p> <p>Design: -This property contains a barn with an attached shed and a silo -The barn features stone foundations, vertical wood plank siding, and a gable roof. The attached shed is clad in metal sheeting -The silo appears to be made of cast-in-place concrete and is connected to the barn -Landscape features include a gravel driveway, a watercourse, mature trees, tree lines, pastures, post-and-wire fencing, and split rail fencing</p> <p>Context: -This property is located on the north side of 6th Line -This property reflects late-nineteenth and early-twentieth century settlement along 6th Line through the arrangement of buildings, architectural materials, and landscape features</p>

<p>North view of CHL 8</p>

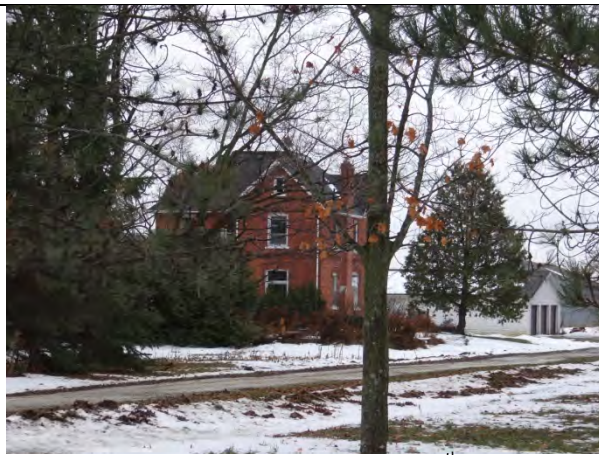
CHL 9	Farm Complex	3573 6 th Line	Identified during the field review	<p>Historical: -This property is associated with the historical development of the Town of Innisfil -A farm complex in this location is depicted on the 1928 historic topographic map of Barrie</p> <p>Design: -This property contains a residence, barn, silo, and outbuildings -The residence is two-and-a-half storeys with an irregular plan, truncated roof, and gable bays -The exterior is clad in red brick and the roof is clad in asphalt shingles -The barn is not visible from the public ROW so a description is not available at this time -Landscape features include mature trees, a woodlot, agricultural fields, a watercourse, and circulation routes</p> <p>Context: -This property is located on the south side of 6th Line -This property reflects late-nineteenth and early-twentieth century settlement along 6th Line through its arrangement of buildings, architectural style and materials, and landscape features</p>

<p>Front façade (north elevation) of 3573 6th Line</p>

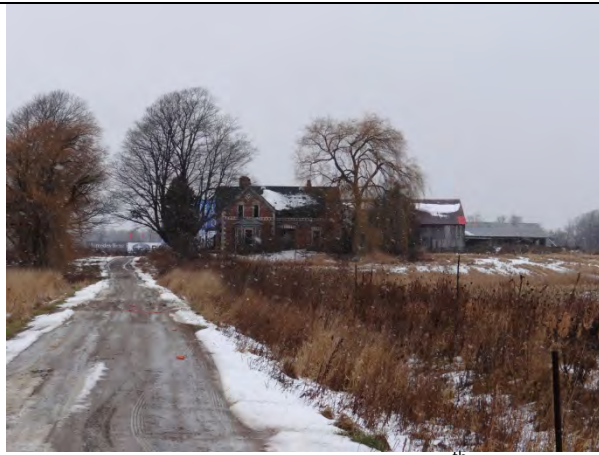
CHL 10	Farm Complex	3424 6 th Line	Identified during the field review	<p>Historical: -This property is associated with the historical development of the Town of Innisfil -A farm complex in this location is depicted on the 1928 historic topographic map of Barrie</p> <p>Design: -This property contains a residence, barn, and outbuildings -The residence is one-and-a-half storeys with a L-shaped plan and cross gable roof -The residence is clad in red brick with decorative buff brick banding, quoins, voussoirs, and detailing -A bay window is offset to the left on the front façade (south elevation) -The barn and outbuildings were not visible from the public ROW so descriptions are not available at this time -Landscape features include mature trees, tree lines, a gravel driveway, post-and-wire fencing, and pastures</p> <p>Context: -This property is located on the north side of 6th Line -This property reflects late-nineteenth and early-twentieth century settlement along 6th Line through its arrangement of buildings, architectural style and materials, and landscape features</p>

<p>Front façade (south elevation) of 3424 6th Line</p>

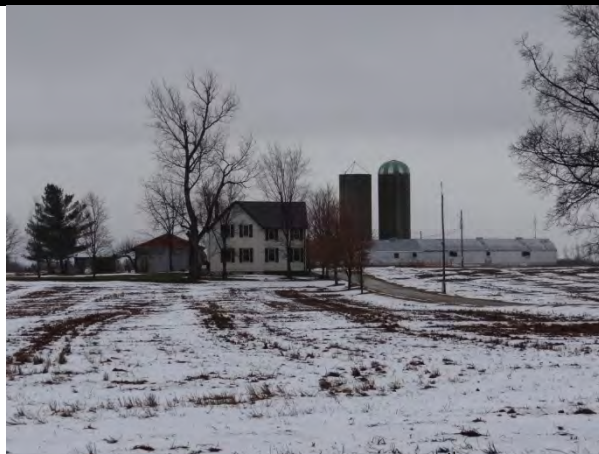
Resource	Type	Address/Location	Recognition	Description	Photos
CHL 11	Farm Complex	3325 6 th Line	Identified during the field review	<p>Historical: -This property is associated with the historical development of the Town of Innisfil -A farmstead in this location is depicted on the 1928 historic topographic map of Barrie</p> <p>Design: -This property contains a residence, silos, and outbuildings -The residence is one-and-a-half storeys and has an L-shaped plan and cross gable roof -The residence features stone foundations, clapboard siding, and asphalt shingle roof -All windows on the front façade of the residence feature decorative shutters -Landscape features include a wood lot, mature trees, agricultural fields, and circulation routes</p> <p>Context: -This property is located on the south side of 6th Line -This property reflects late-nineteenth and early-twentieth century settlement along 6th Line through its arrangement of buildings, architectural style and materials, and landscape features</p>

<p>Front façade (north elevation) of 3325 6th Line</p>

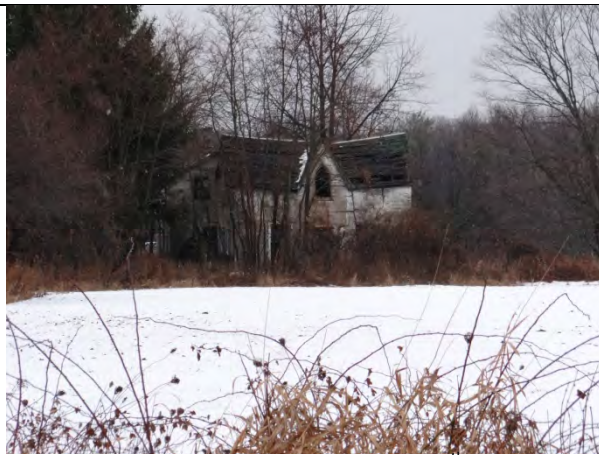
CHL 12	Farm Complex	3190 6 th Line	Identified during the field review	<p>Historical: -This property is associated with the historical development of the Town of Innisfil -A farmstead in this location is depicted on the 1928 historic topographic map of Barrie</p> <p>Design: -This property contains a new/recent residence, an early-twentieth century Gothic Revival Cottage, and a barn -The Gothic Revival Cottage is one-and-a-half storeys and is mainly screened from the public ROW by vegetation so descriptions are limited at this time -The cottage appears to be clad in stucco and features a wood plank roof and pointed arch window on the front façade -The cottage is in poor condition and appears to be structurally unsound -The barn has vertical plank siding and a gable roof -Landscape features on the property include mature trees, shrubs, tree lines, agricultural fields, and a gravel driveway</p> <p>Context: -This property is located on the north side of 6th Line -This property reflects late-nineteenth and early-twentieth century settlement along 6th Line through its arrangement of buildings, architectural style and materials, and landscape features</p>

<p>Front façade (south elevation) of 3190 6th Line</p>

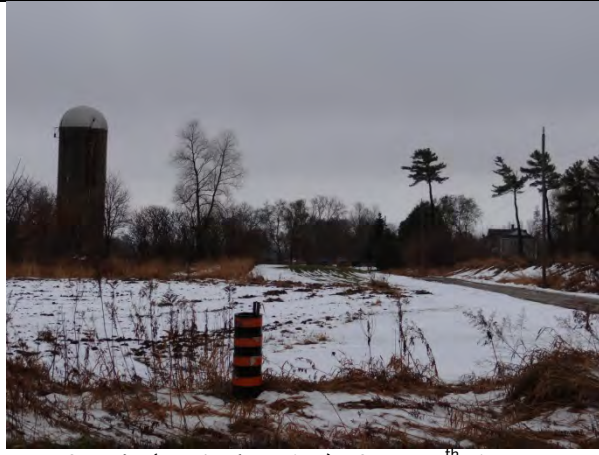
CHL 13	Farm Complex	3179 6 th Line	Identified during the field review	<p>Historical: -This property is associated with the historical development of the Town of Innisfil -A farm complex in this location is depicted on the 1928 historic topographic map of Barrie</p> <p>Design: -This property contains a residence, outbuilding, and a silo -The residence is largely screened from view by vegetation so only a basic description is available -The residence is two storeys with an irregular plan, clapboard siding, and a gable roof -The outbuilding is not visible due to vegetation cover but it appears to be a rectangular structure with a gable roof -Landscape features include mature trees, agricultural fields, and a dirt driveway</p> <p>Context: -This property is located on the south side of 6th Line -This property reflects late-nineteenth and early-twentieth century settlement along 6th Line through its arrangement of buildings, architectural style and materials, and landscape features</p>

<p>Front façade (north elevation) of 3179 6th Line</p>

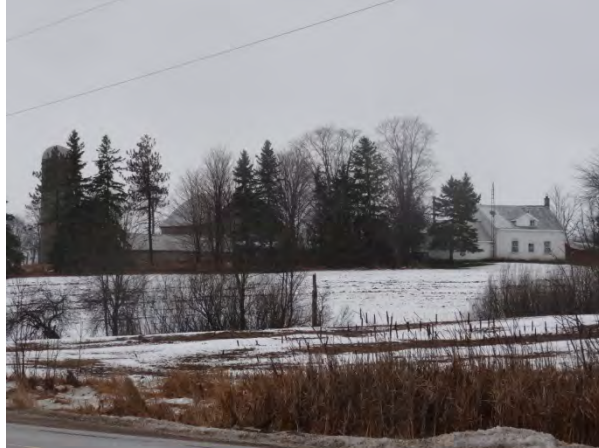
Resource	Type	Address/Location	Recognition	Description	Photos
CHL 14	Farm Complex	6906 10 Sideroad	Identified during the field review	<p>Historical: -This property is associated with the historical development of the Town of Innisfil -A farm complex in this location is depicted on the 1928 historic topographic map of Barrie</p> <p>Design: -This property features a residence, barn, outbuildings, and a silo -The residence is one-and-a-half storeys with a gable roof, rectangular plan, and an addition on the east elevation -The main section of the residence is clad in stucco while the addition is clad in clapboard siding; Both sections feature metal sheet roofing -The barn was largely screened from view by vegetation but it appears to have a gambrel roof and a rectangular plan -Landscape features include a tree lines, watercourse, agricultural fields, circulation routes, and a woodlot</p> <p>Context: -This property is located on the west side of 10 Sideroad -This property reflects late-nineteenth and early-twentieth century settlement along 6th Line through its arrangement of buildings, architectural style and materials, and landscape features</p>

<p>South-south west view towards 6906 10 Sideroad</p>

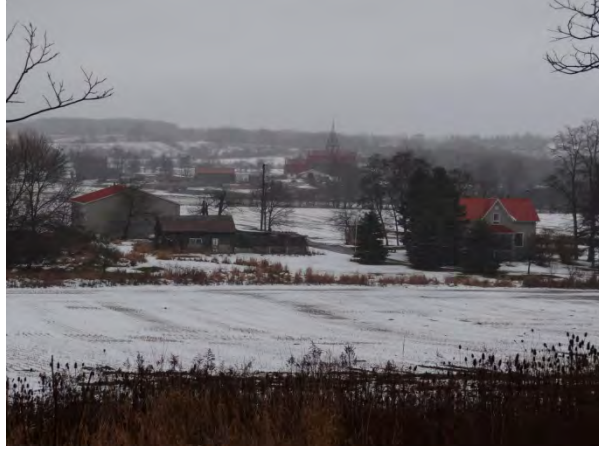
CHL 15	Farm Complex	6875 10 Sideroad	Identified during the field review	<p>Historical: -This property is associated with the historical development of the Town of Innisfil -A farm complex in this location is depicted on the 1928 historic topographic map of Barrie</p> <p>Design: -This property features a residence, barn, and outbuilding -This Gothic Revival Cottage is one-and-a-half storeys with a rectangular plan, gable roof, and centre gable -The residence exterior appears to be clad in vinyl siding and the roof is clad in red, metal sheeting -The barn appears to be new/recent and features a rectangular plan and gable roof -Landscape features include mature trees, treelines, a watercourse, agricultural fields, and circulation routes</p> <p>Context: -This property is located on the east side of 10 Sideroad -This property reflects late-nineteenth and early-twentieth century settlement along 6th Line through its arrangement of buildings, architectural style and materials, and landscape features</p>

<p>East view towards 6875 10 Sideroad</p>
