6th Line Municipal Class Environmental Assessment

County Road 27 to St John's Road
Town of Innisfil, ON

**Cultural Heritage Resource Assessment:
Built Heritage Resources and Cultural Heritage Landscapes**

**6th Line (Part A): 20 Sideroad to St. John's Road
Class Environmental Assessment Study**

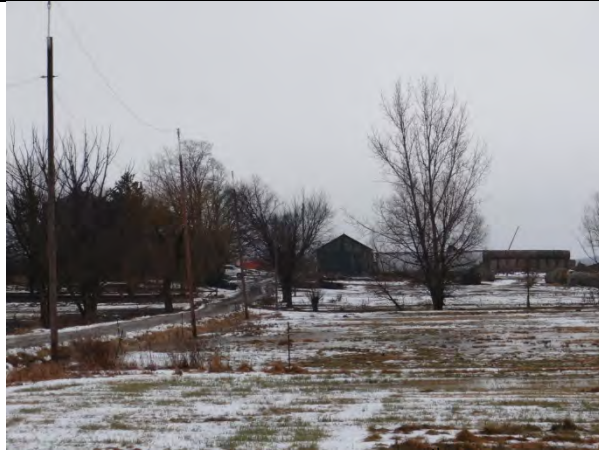
CHL 16	Farm Complex	2693 6 th Line	Identified during the field review	<p>Historical: -This property is associated with the historical development of the Town of Innisfil -A farm complex in this location is depicted on the 1928 historic topographic map of Barrie</p> <p>Design: -This property features a residence, barn, and outbuildings -The residence is screened from view by heavy vegetation cover: accordingly, a description of the residence is not available at this time -The barn features a rectangular plan, gable roof, and vertical plank siding -Landscape features include mature trees, circulation routes, pastures, agricultural fields, and a watercourse</p> <p>Context: -This property is located on the south side of 6th Line -This property reflects late-nineteenth and early-twentieth century settlement along 6th Line through its arrangement of buildings, architectural style and materials, and landscape features</p>

<p>South-southeast view towards 2692 6th Line</p>

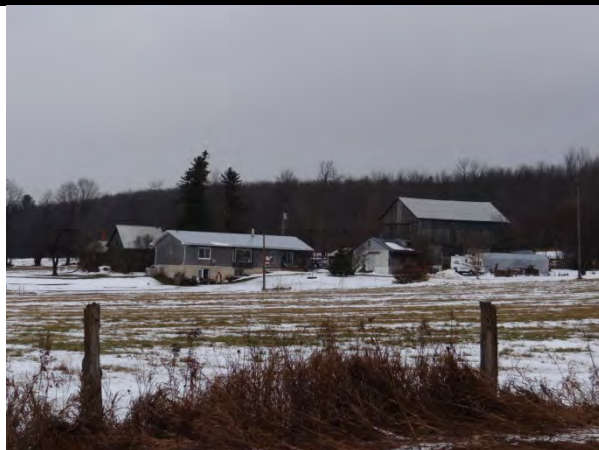
Resource	Type	Address/Location	Recognition	Description	Photos
CHL 17	Farm Complex	2386 6 th Line	Identified during the field review	<p>Historical:</p> <ul style="list-style-type: none"> -This property is associated with the historical development of the Town of Innisfil -A farm complex in this location is depicted on the 1928 historic topographic map of Barrie <p>Design:</p> <ul style="list-style-type: none"> -This property features a new/recent residence, historical residence, barn, and outbuildings -The historical residence is largely blocked from view by the new residence and recent vegetation: accordingly, detailed descriptions are not available -The historical residence appears to be a one-and-a-half storey structure with a rectangular plan, gable roof, and half timbering. -The barn features vertical plank siding and a gable roof that is clad in metal sheeting -Landscape features include mature tree, tree lines, agricultural fields, a gravel driveway, and post-and-wire fencing <p>Context:</p> <ul style="list-style-type: none"> -This property is located on the north side of 6th Line -This property reflects late-nineteenth and early-twentieth century settlement along 6th Line through its arrangement of buildings, architectural style and materials, and landscape features

<p>North-northeast view of 2386 6th Line</p>

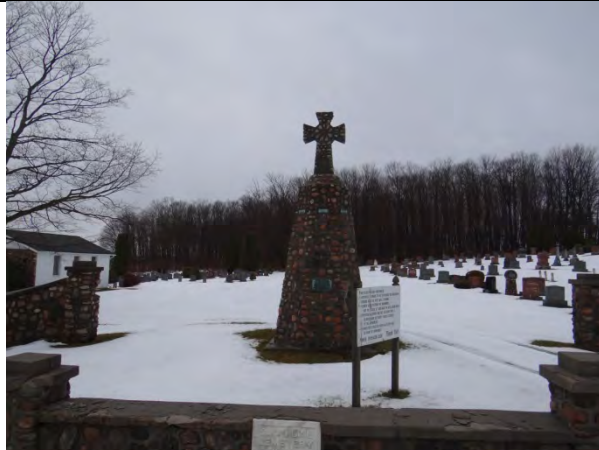
CHL 18	Cemetery	No Address – Southwest corner of 6 th Line and Yonge Street	Listed by Municipality	<p>Historical:</p> <ul style="list-style-type: none"> -This property is associated with the historical development of the Town of Innisfil -Known as the “Sixth Line Cemetery Innisfil”, this cemetery was established in 1832 -A church at this location is depicted on the 1881 map of the Township of Innisfil <p>Design:</p> <ul style="list-style-type: none"> -This cemetery features a small church, a cenotaph, stone walls at the entrance, stone row markers, and numerous headstones -Riverstone, a local building material, is used throughout the cemetery, most notably on the front façade of the church, and on the cenotaph, stone walls, and row markers -Landscape features in the cemetery include wire fencing, shrubs, and mature trees <p>Context:</p> <ul style="list-style-type: none"> -The cemetery is located on the southwest side of the intersection of 6th Line and Yonge Street -The cemetery reflects the early-nineteenth century settlement along 6th Line and is physically, functionally, visually, and historically linked to its surroundings -The cemetery acts as a landmark at this intersection

<p>East-southeast view of the cenotaph at the Sixth Line Cemetery</p>

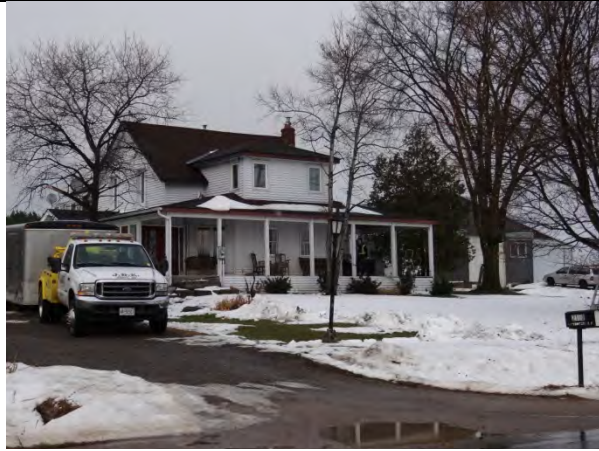
CHL 19	Farm Complex	2150 6 th Line	Identified during the field review	<p>Historical:</p> <ul style="list-style-type: none"> -This property is associated with the historical development of the Town of Innisfil -A residence in this location is depicted on the 1928 historical topographic map of Barrie <p>Design:</p> <ul style="list-style-type: none"> -This property features a residence, pool, and outbuildings -The residence is one-and-a-half storeys and has an irregular plan -The residence appears to have a historical core that has been altered through recent additions -The front façade (south elevation) of the residence features a two storey addition and a verandah that wraps around the west, south, and east elevations -The residence is clad in vinyl siding and the roof is clad in asphalt shingles -The outbuilding appear to be relatively recent -Landscape features include mature trees, tree lines, circulation routes, agricultural fields, and post-and-board fencing <p>Context:</p> <ul style="list-style-type: none"> -This property is located on the north side of 6th Line -This property reflects late-nineteenth and early-twentieth century settlement along 6th Line through its arrangement of buildings, architectural style and materials, and landscape features

<p>Front façade (south elevation) and west elevation of 2150 6th Line</p>

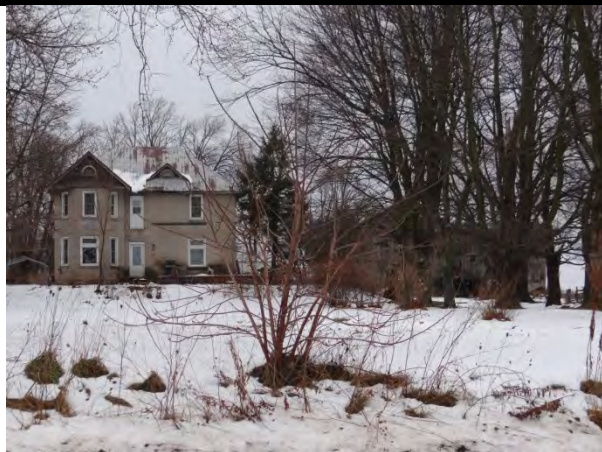
Resource	Type	Address/Location	Recognition	Description	Photos
CHL 20	Farm Complex	2062 6 th Line	Identified during the field review	<p>Historical: -This property is associated with the historical development of the Town of Innisfil -A farm complex in this location is depicted on the 1928 historic topographic map of Barrie</p> <p>Design: -This property features a residence, barn, and outbuildings -The residence is two-and-a-half storeys, has an L-shaped plan and a hipped roof -The residence features stone foundations, a cut stone exterior, and a roof clad in metal sheeting -The front façade (south elevation) of the residence has a two-storey bay with a gable roof and a gable dormer -The two storey bay features wood shingles and a semi-circular window -The front façade also features a suicide door and ghosting, suggesting that a balcony or double storey porch was once included on the front façade. -The barn is an L-shaped structure with stone foundations, vertical board siding, and a metal roof -Landscape features include mature trees, tree lines, agricultural fields, and a gravel driveway</p> <p>Context: -This property is located on the north side of 6th Line -This property reflects late-nineteenth and early-twentieth century settlement along 6th Line through its arrangement of buildings, architectural style and materials, and landscape features</p>

<p>Front façade (south elevation) of 2062 6th Line</p>

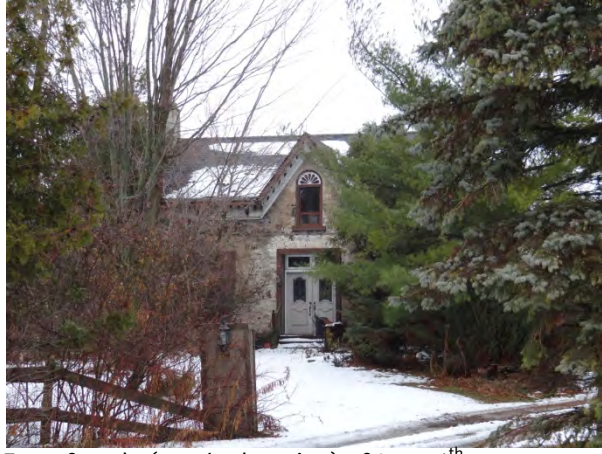
CHL 21	Farm Complex	1778 6 th Line	Identified during the field review	<p>Historical: -This property is associated with the historical development of the Town of Innisfil -A farm complex in this location is depicted on the 1928 historic topographic map of Barrie</p> <p>Design: -This property contains a residence and a barn -The residence is a one-and-a-half storey stone Gothic Revival Cottage -The front façade (south elevation) of the residence features a decorated frieze and decorative brackets -The barn is not visible from the public ROW so descriptions are not available -Landscape features include mature trees, circulation routes, and split rail fencing</p> <p>Context: -This property is located on the north side of 6th Line -This property reflects late-nineteenth and early-twentieth century settlement along 6th Line through its arrangement of buildings, architectural style and materials, and landscape features</p>

<p>Front façade (south elevation) of 1778 6th</p>

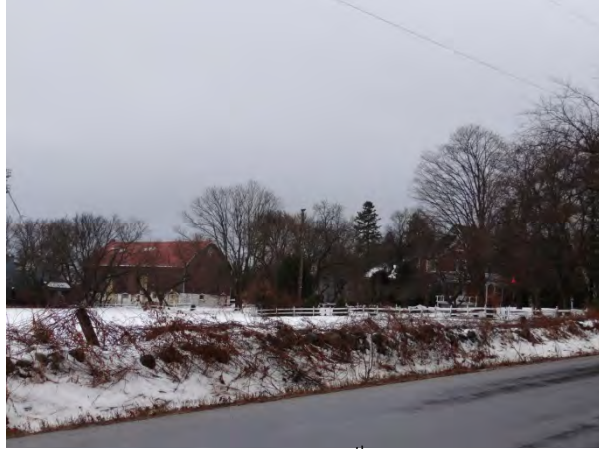
Resource	Type	Address/Location	Recognition	Description	Photos
CHL 22	Farm Complex	1617 6 th Line	Identified during the field review	<p>Historical: -This property is associated with the historical development of the Town of Innisfil -A farm complex in this location is depicted on the 1928 historic topographic map of Barrie</p> <p>Design: -This property contains a residence, barn, silos, and outbuildings -The residence is largely screened from view by vegetation; accordingly, only basic descriptions are available. -The residence is a two-and-a-half storey red brick structure with an irregular plan -The front façade (north elevation) of the residence features decorative vergeboard and an open verandah that wraps around the north and east elevations -The barn features a rectangular plan, stone foundations, vertical plank siding, and a gambrel roof -Landscape features include stone walls and posts, post-and-chain fencing, post-and-rail fencing, mature trees, treelines, circulation routes, and agricultural fields</p> <p>Context: -This property is located on the south side of 6th Line -This property reflects late-nineteenth and early-twentieth century settlement along 6th Line through its arrangement of buildings, architectural style and materials, and landscape features</p>

<p>Southwest view towards 1617 6th Line</p>

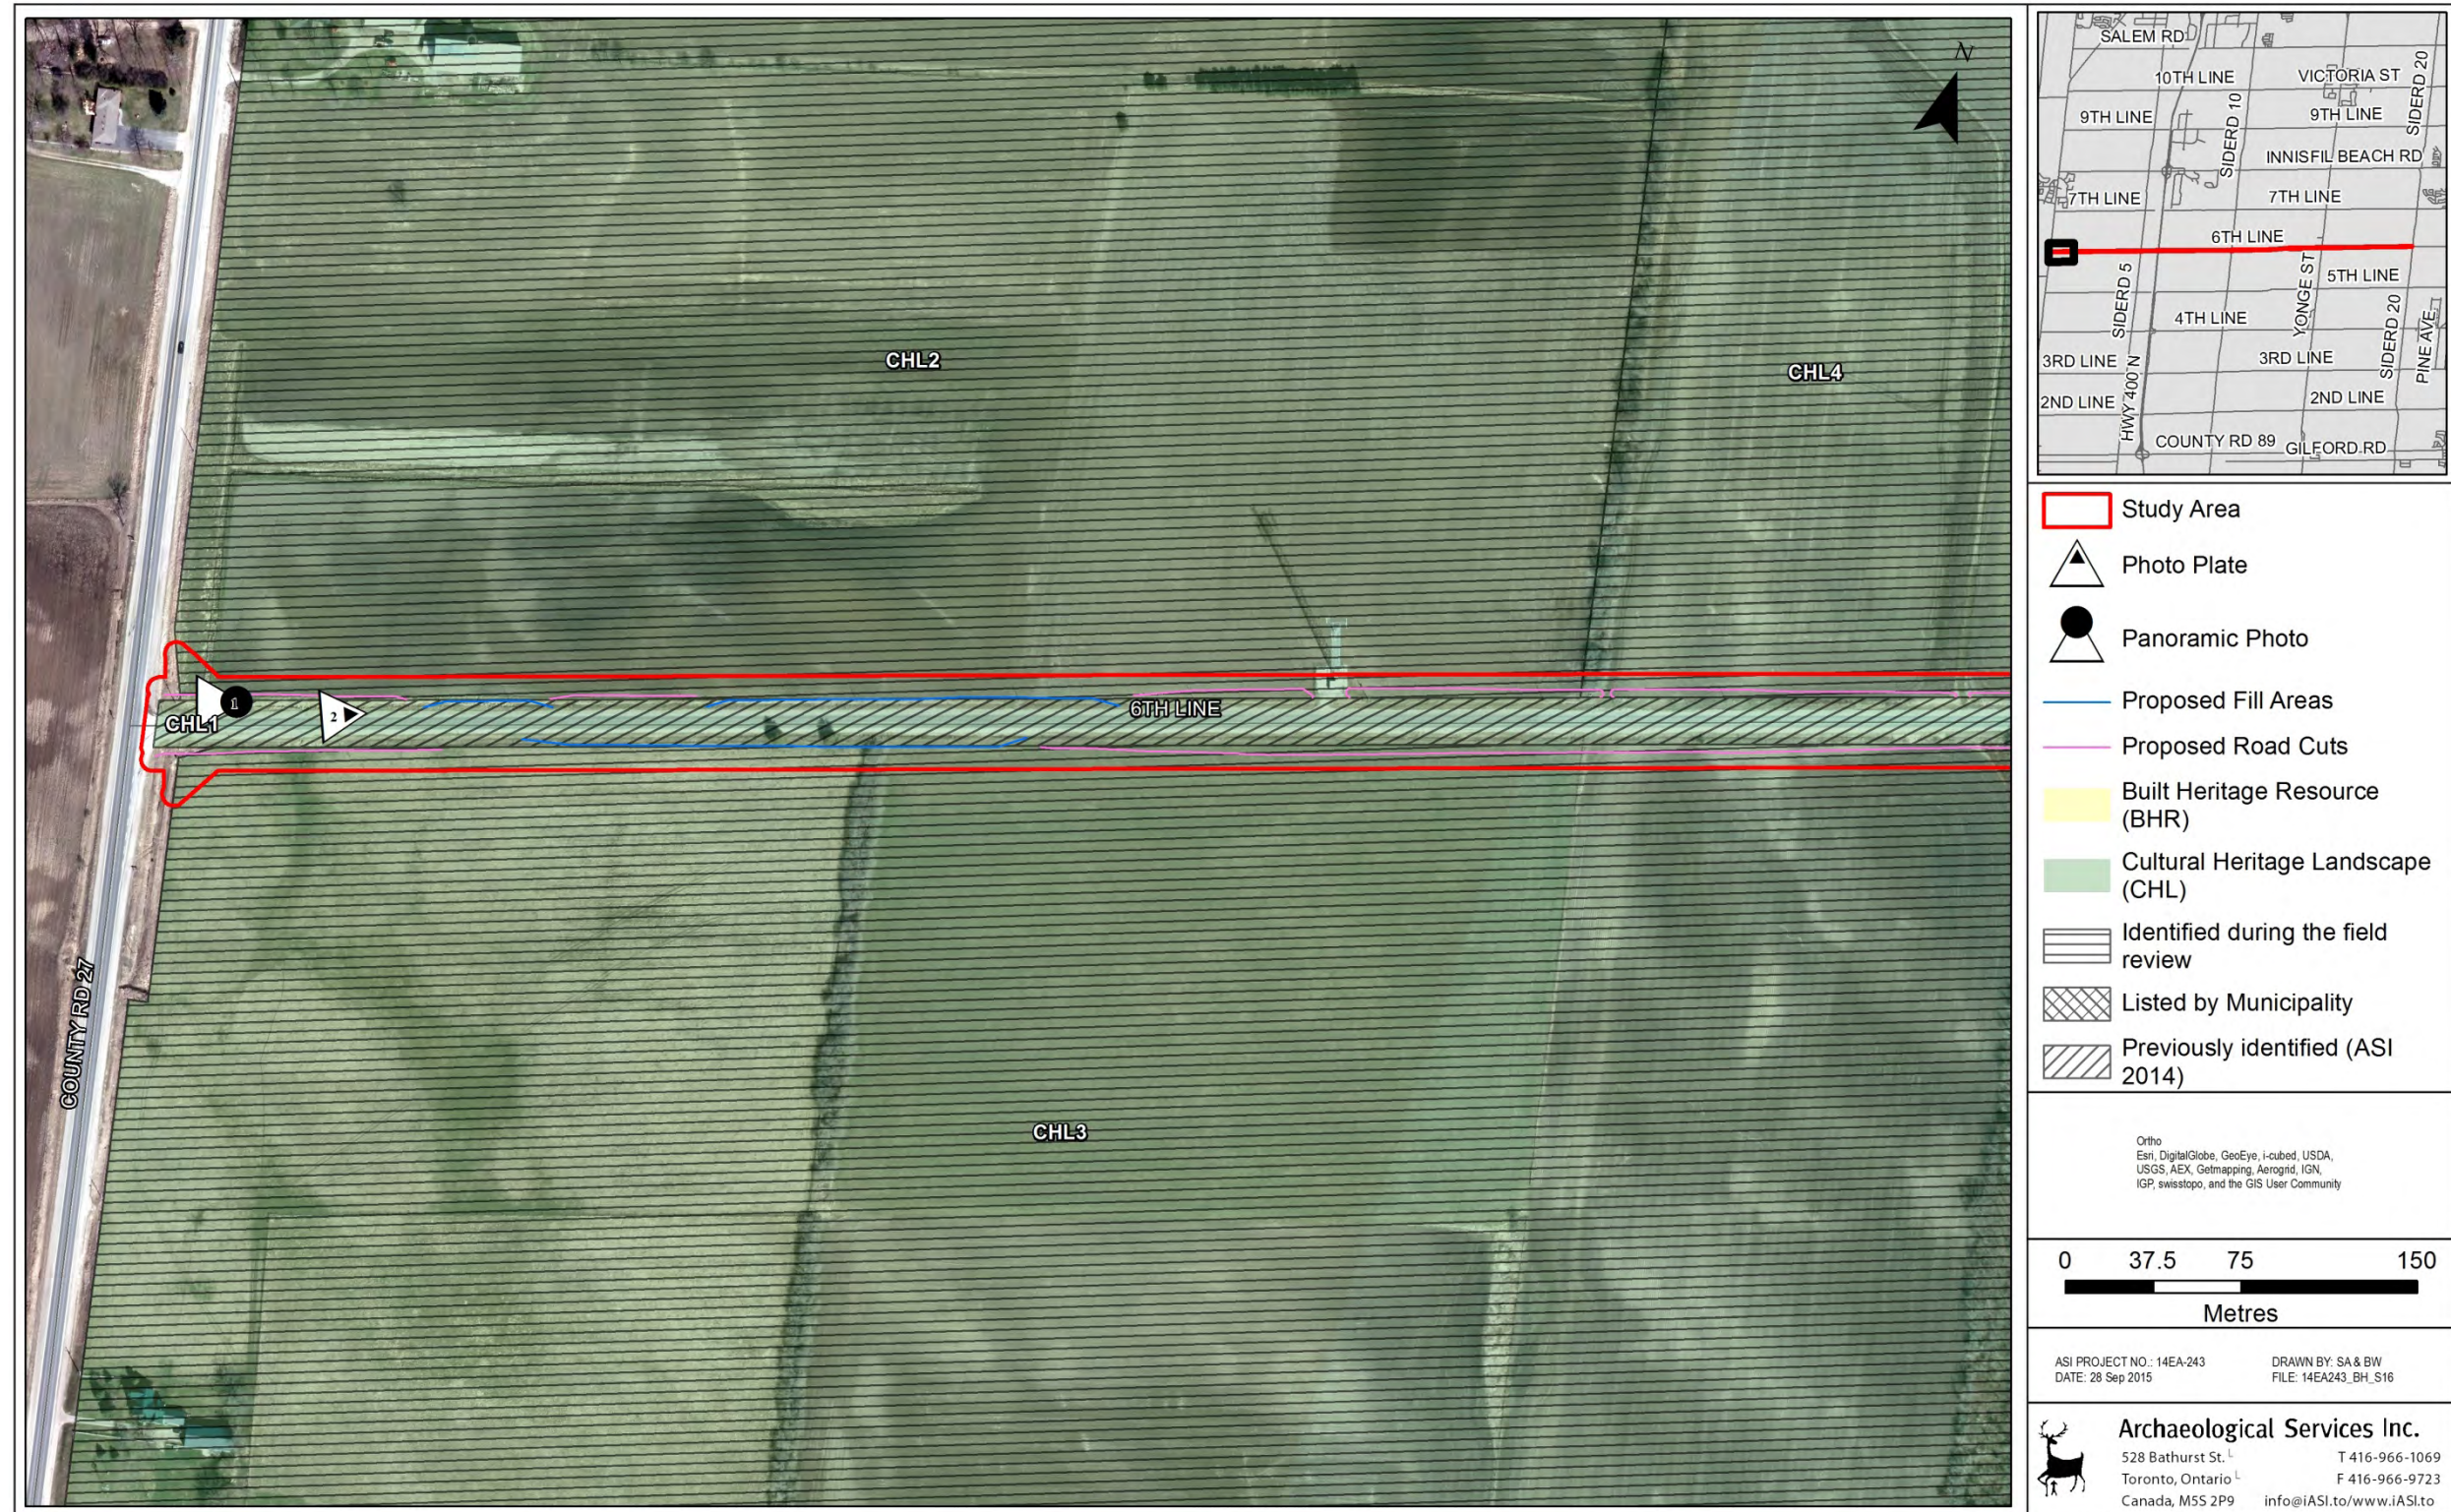
Figure 7: 6th Line (Part B) – Location of Built Heritage Resources (BHR) and Cultural Heritage Landscapes (CHL)

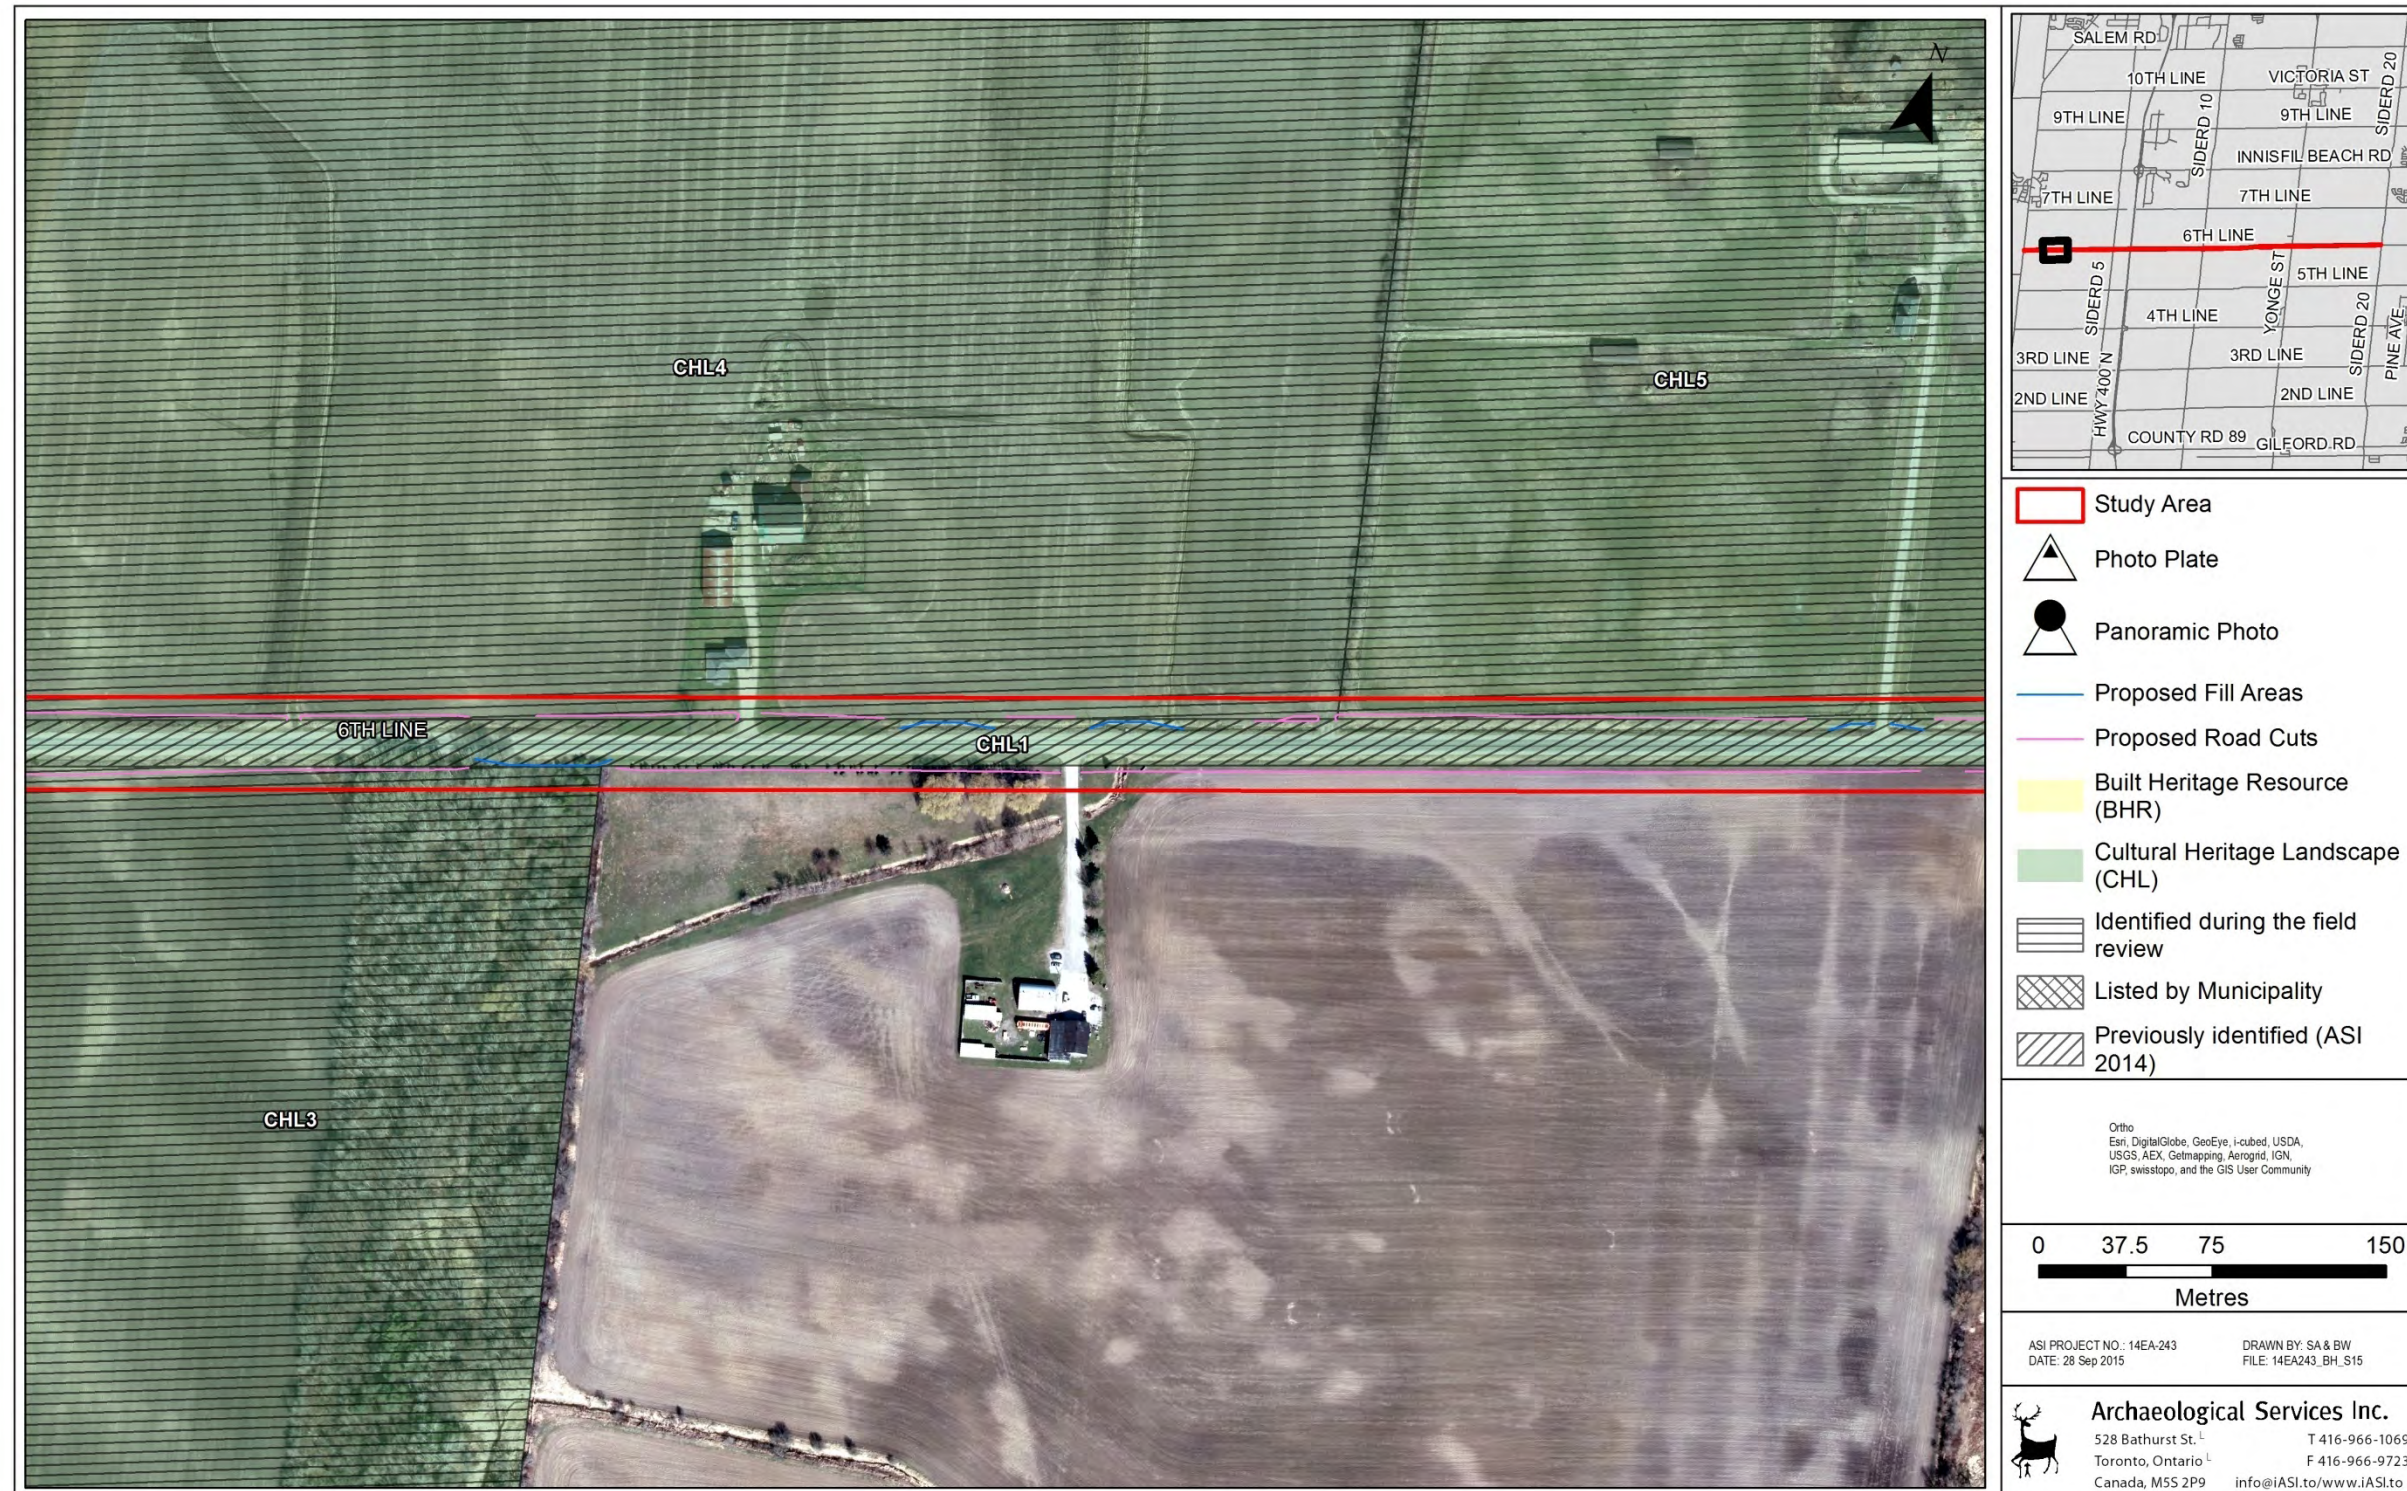
Figure 8: 6th Line (Part B) – Location of Built Heritage Resources (BHR) and Cultural Heritage Landscapes (CHL)

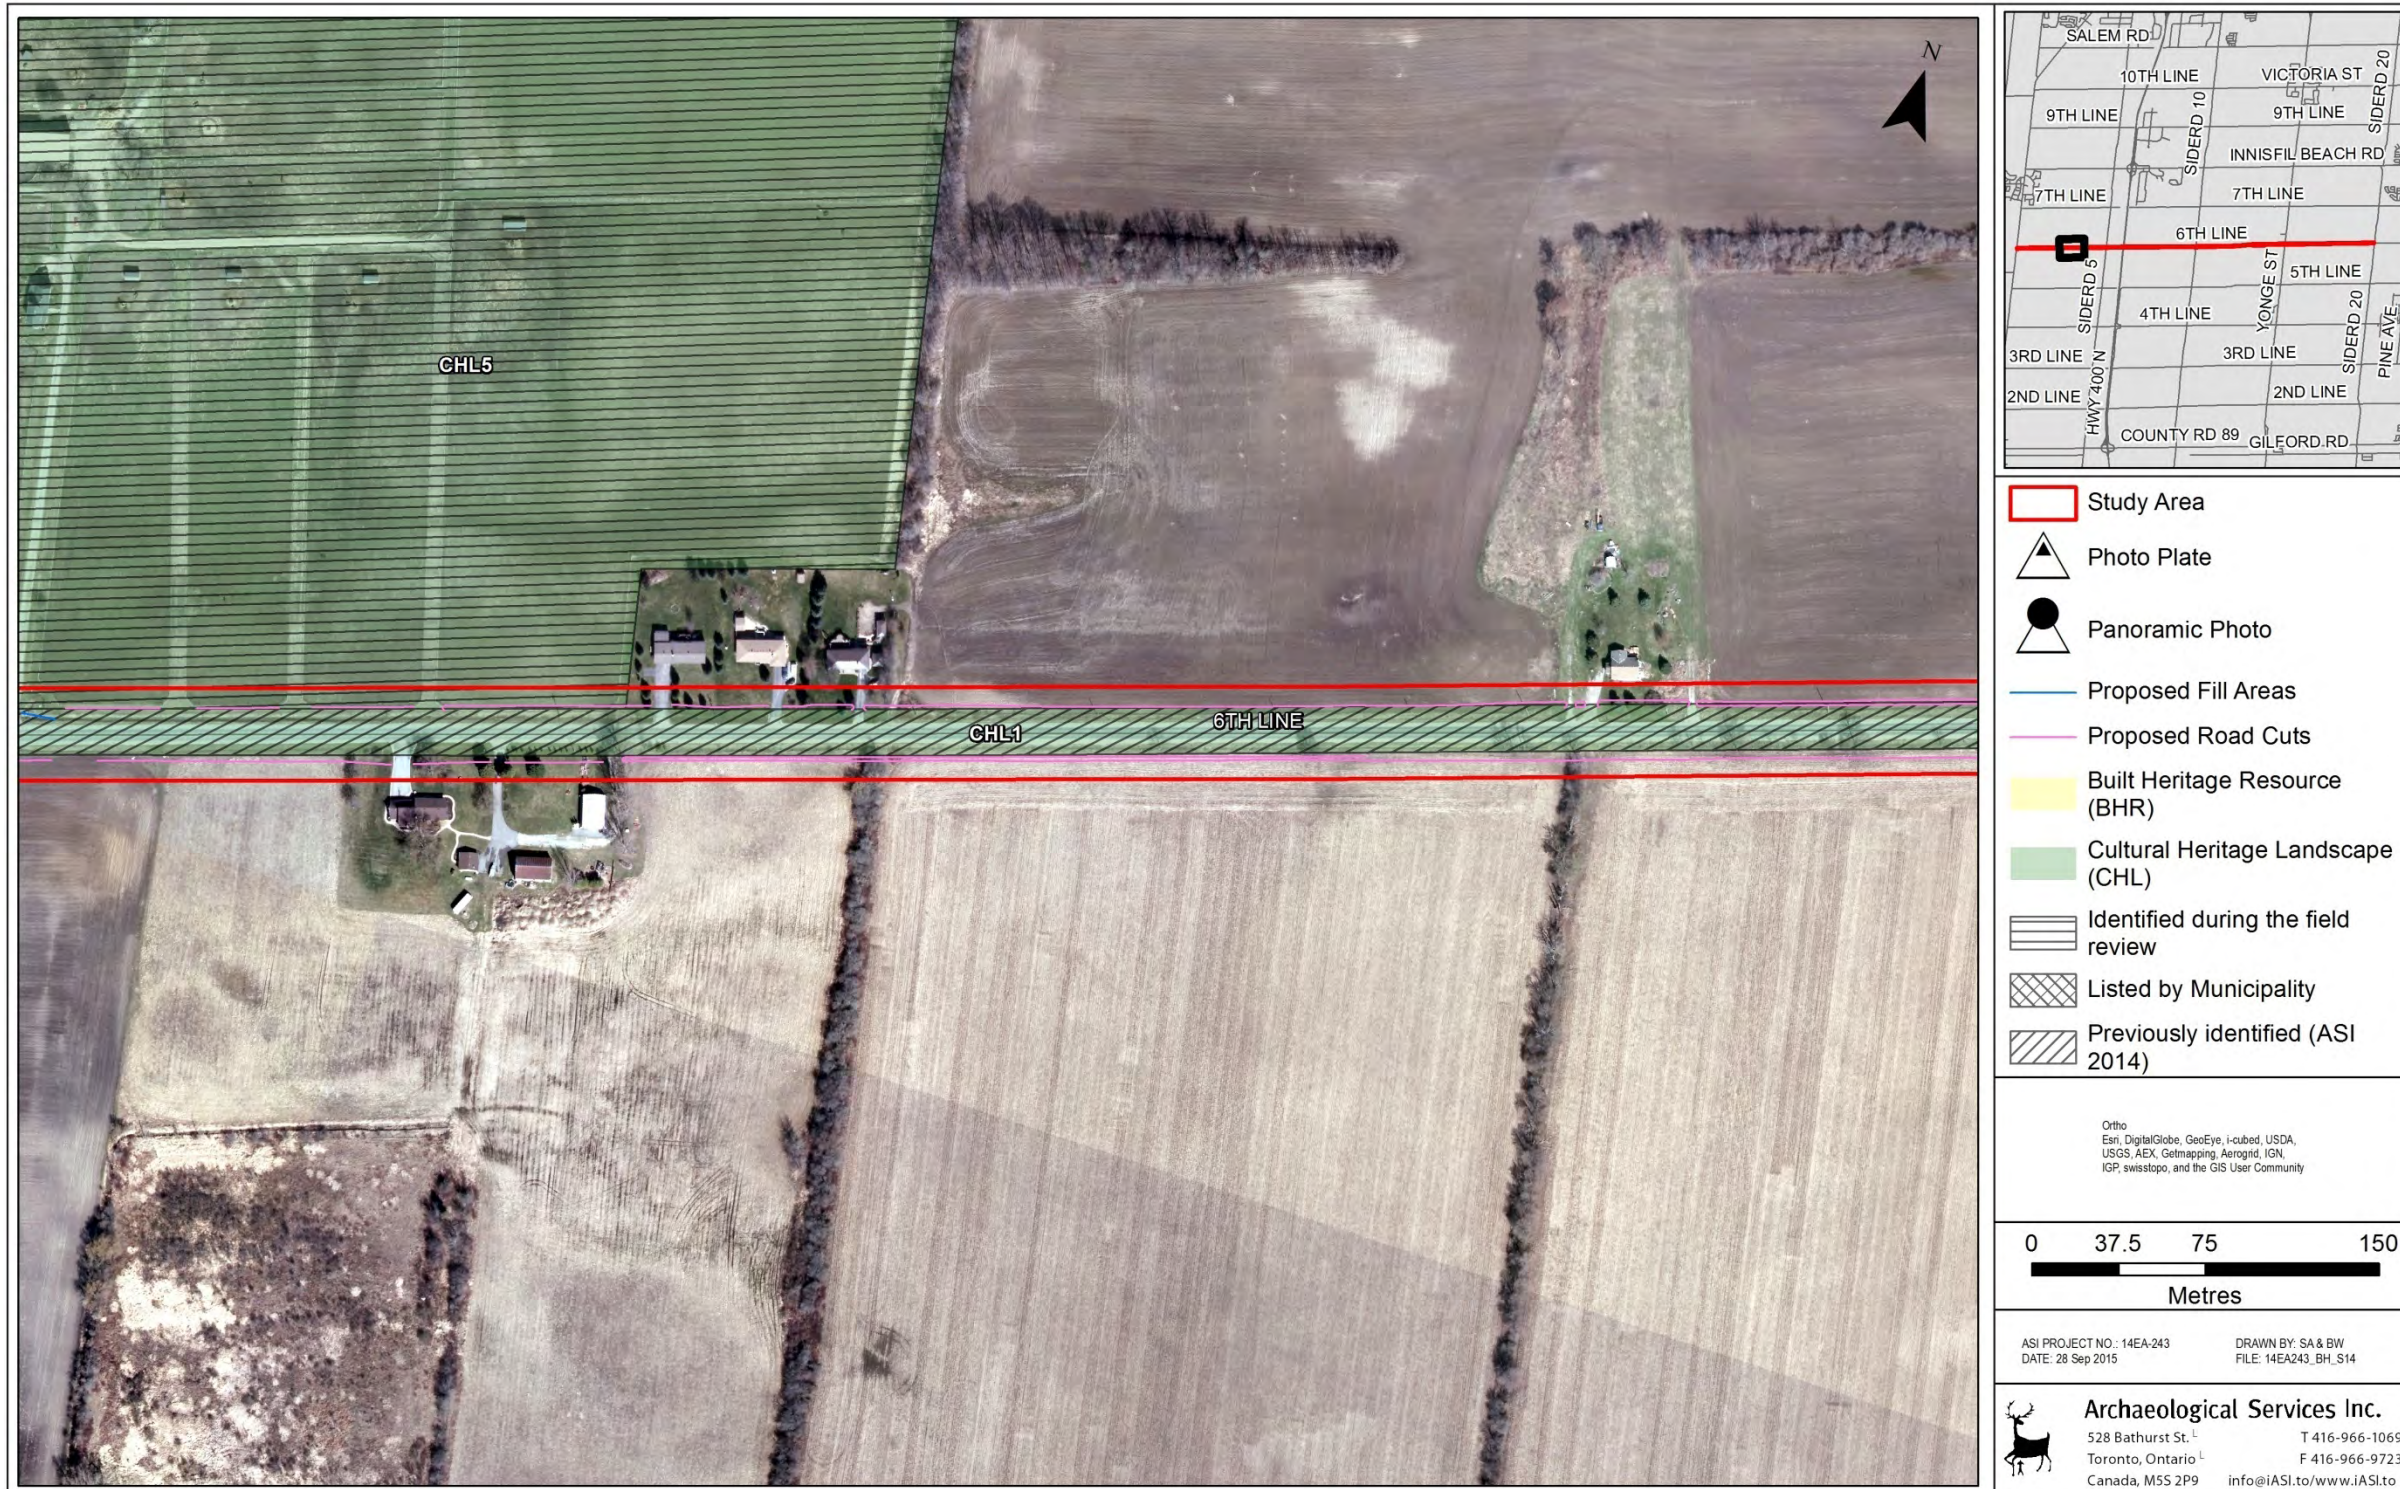
Figure 9: 6th Line (Part B) – Location of Built Heritage Resources (BHR) and Cultural Heritage Landscapes (CHL)

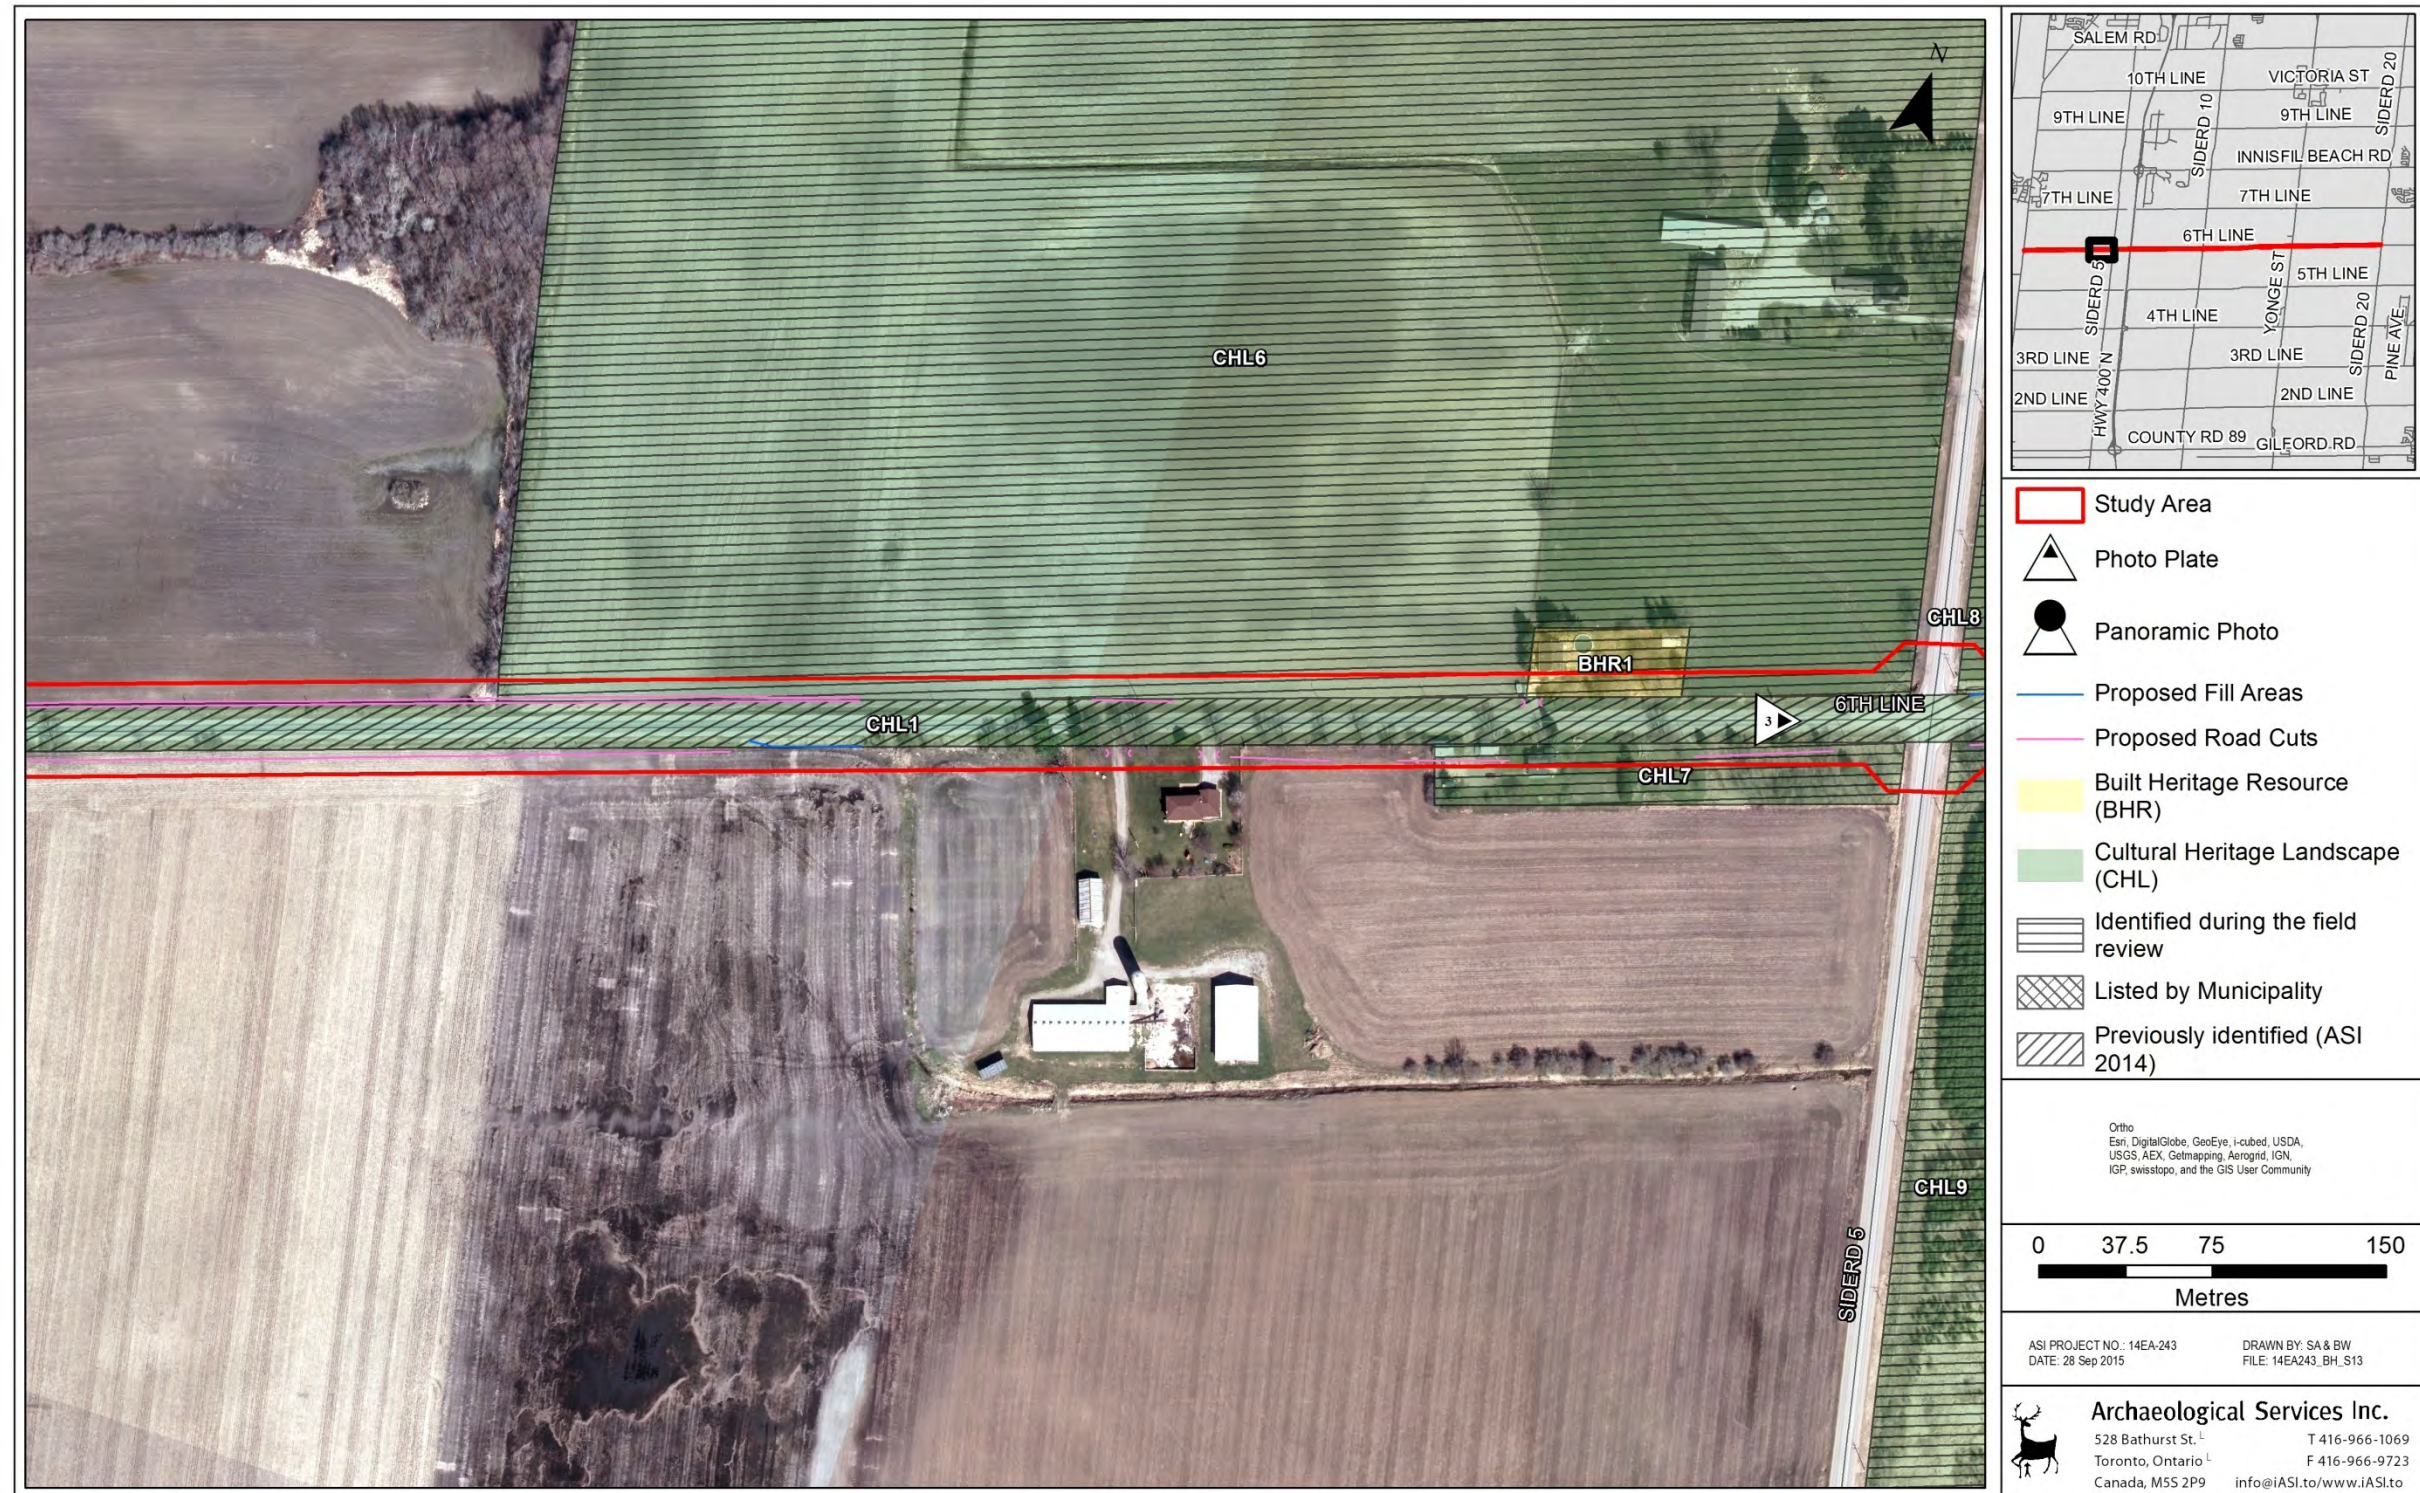
Figure 10: 6th Line (Part B) – Location of Built Heritage Resources (BHR) and Cultural Heritage Landscapes (CHL)

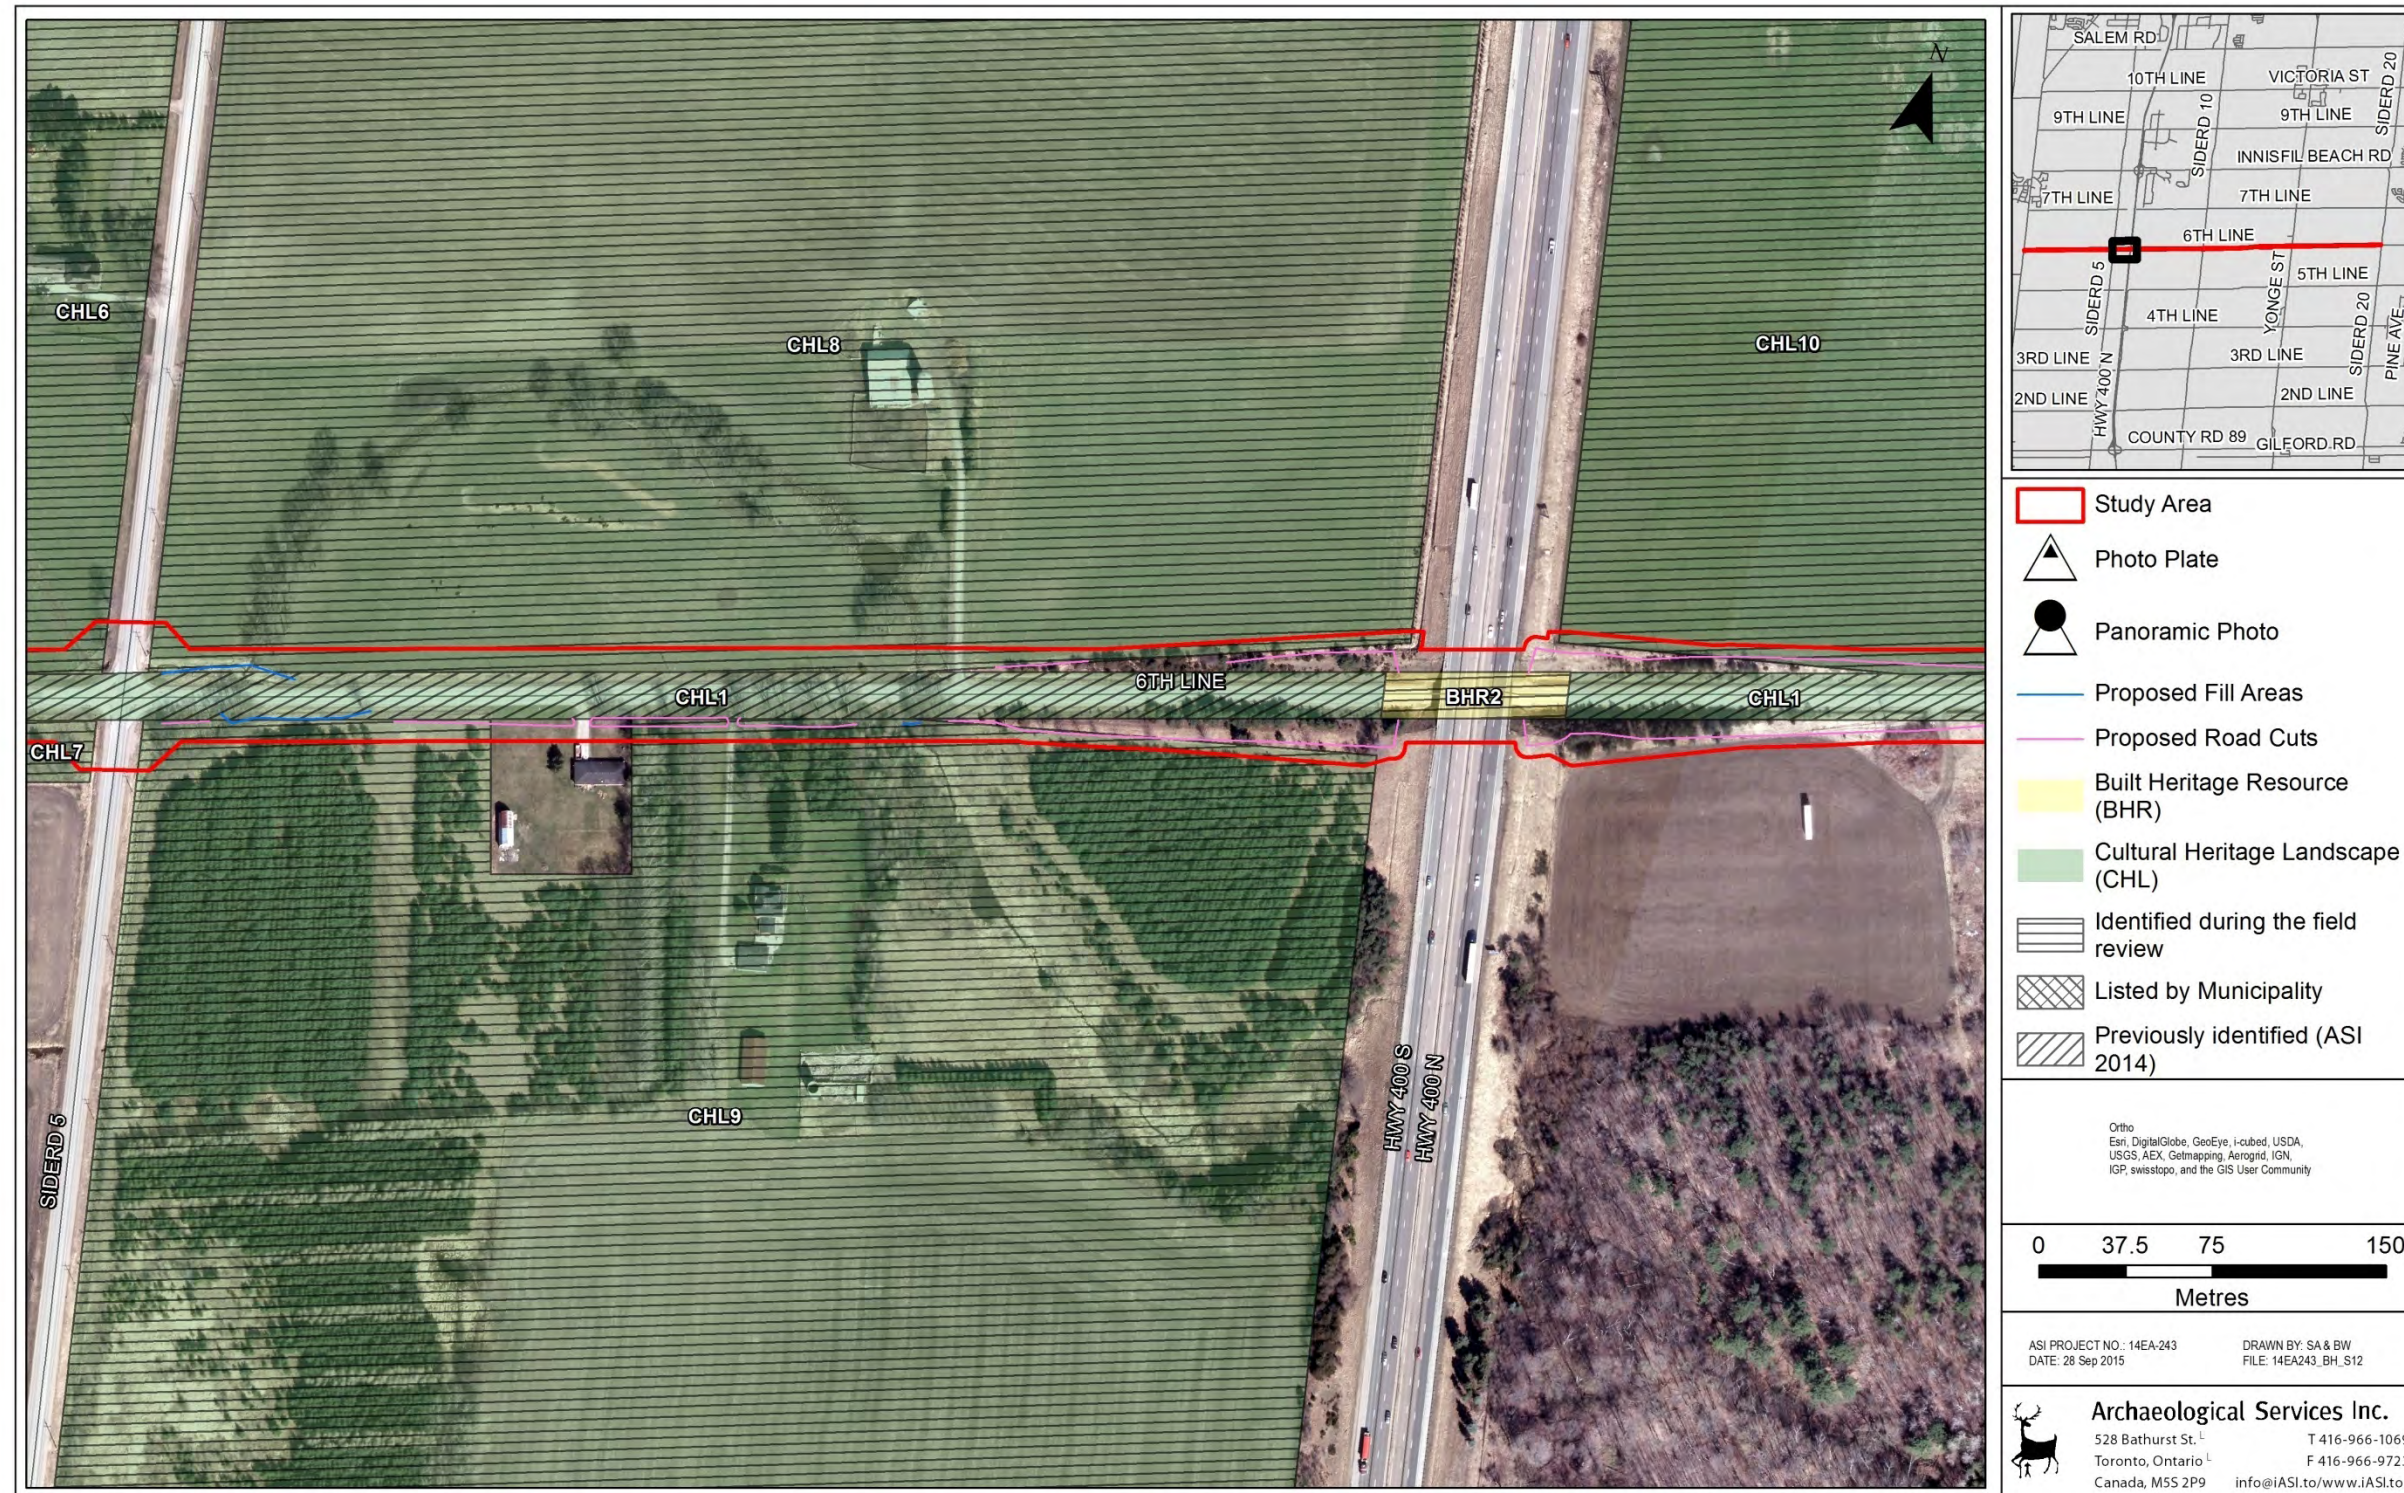
Figure 11: 6th Line (Part B) – Location of Built Heritage Resources (BHR) and Cultural Heritage Landscapes (CHL)
