6th Line Municipal Class Environmental Assessment

County Road 27 to St John's Road
Town of Innisfil, ON

**Cultural Heritage Resource Assessment:
Built Heritage Resources and Cultural Heritage Landscapes**

**6th Line (Part A): 20 Sideroad to St. John's Road
Class Environmental Assessment Study**

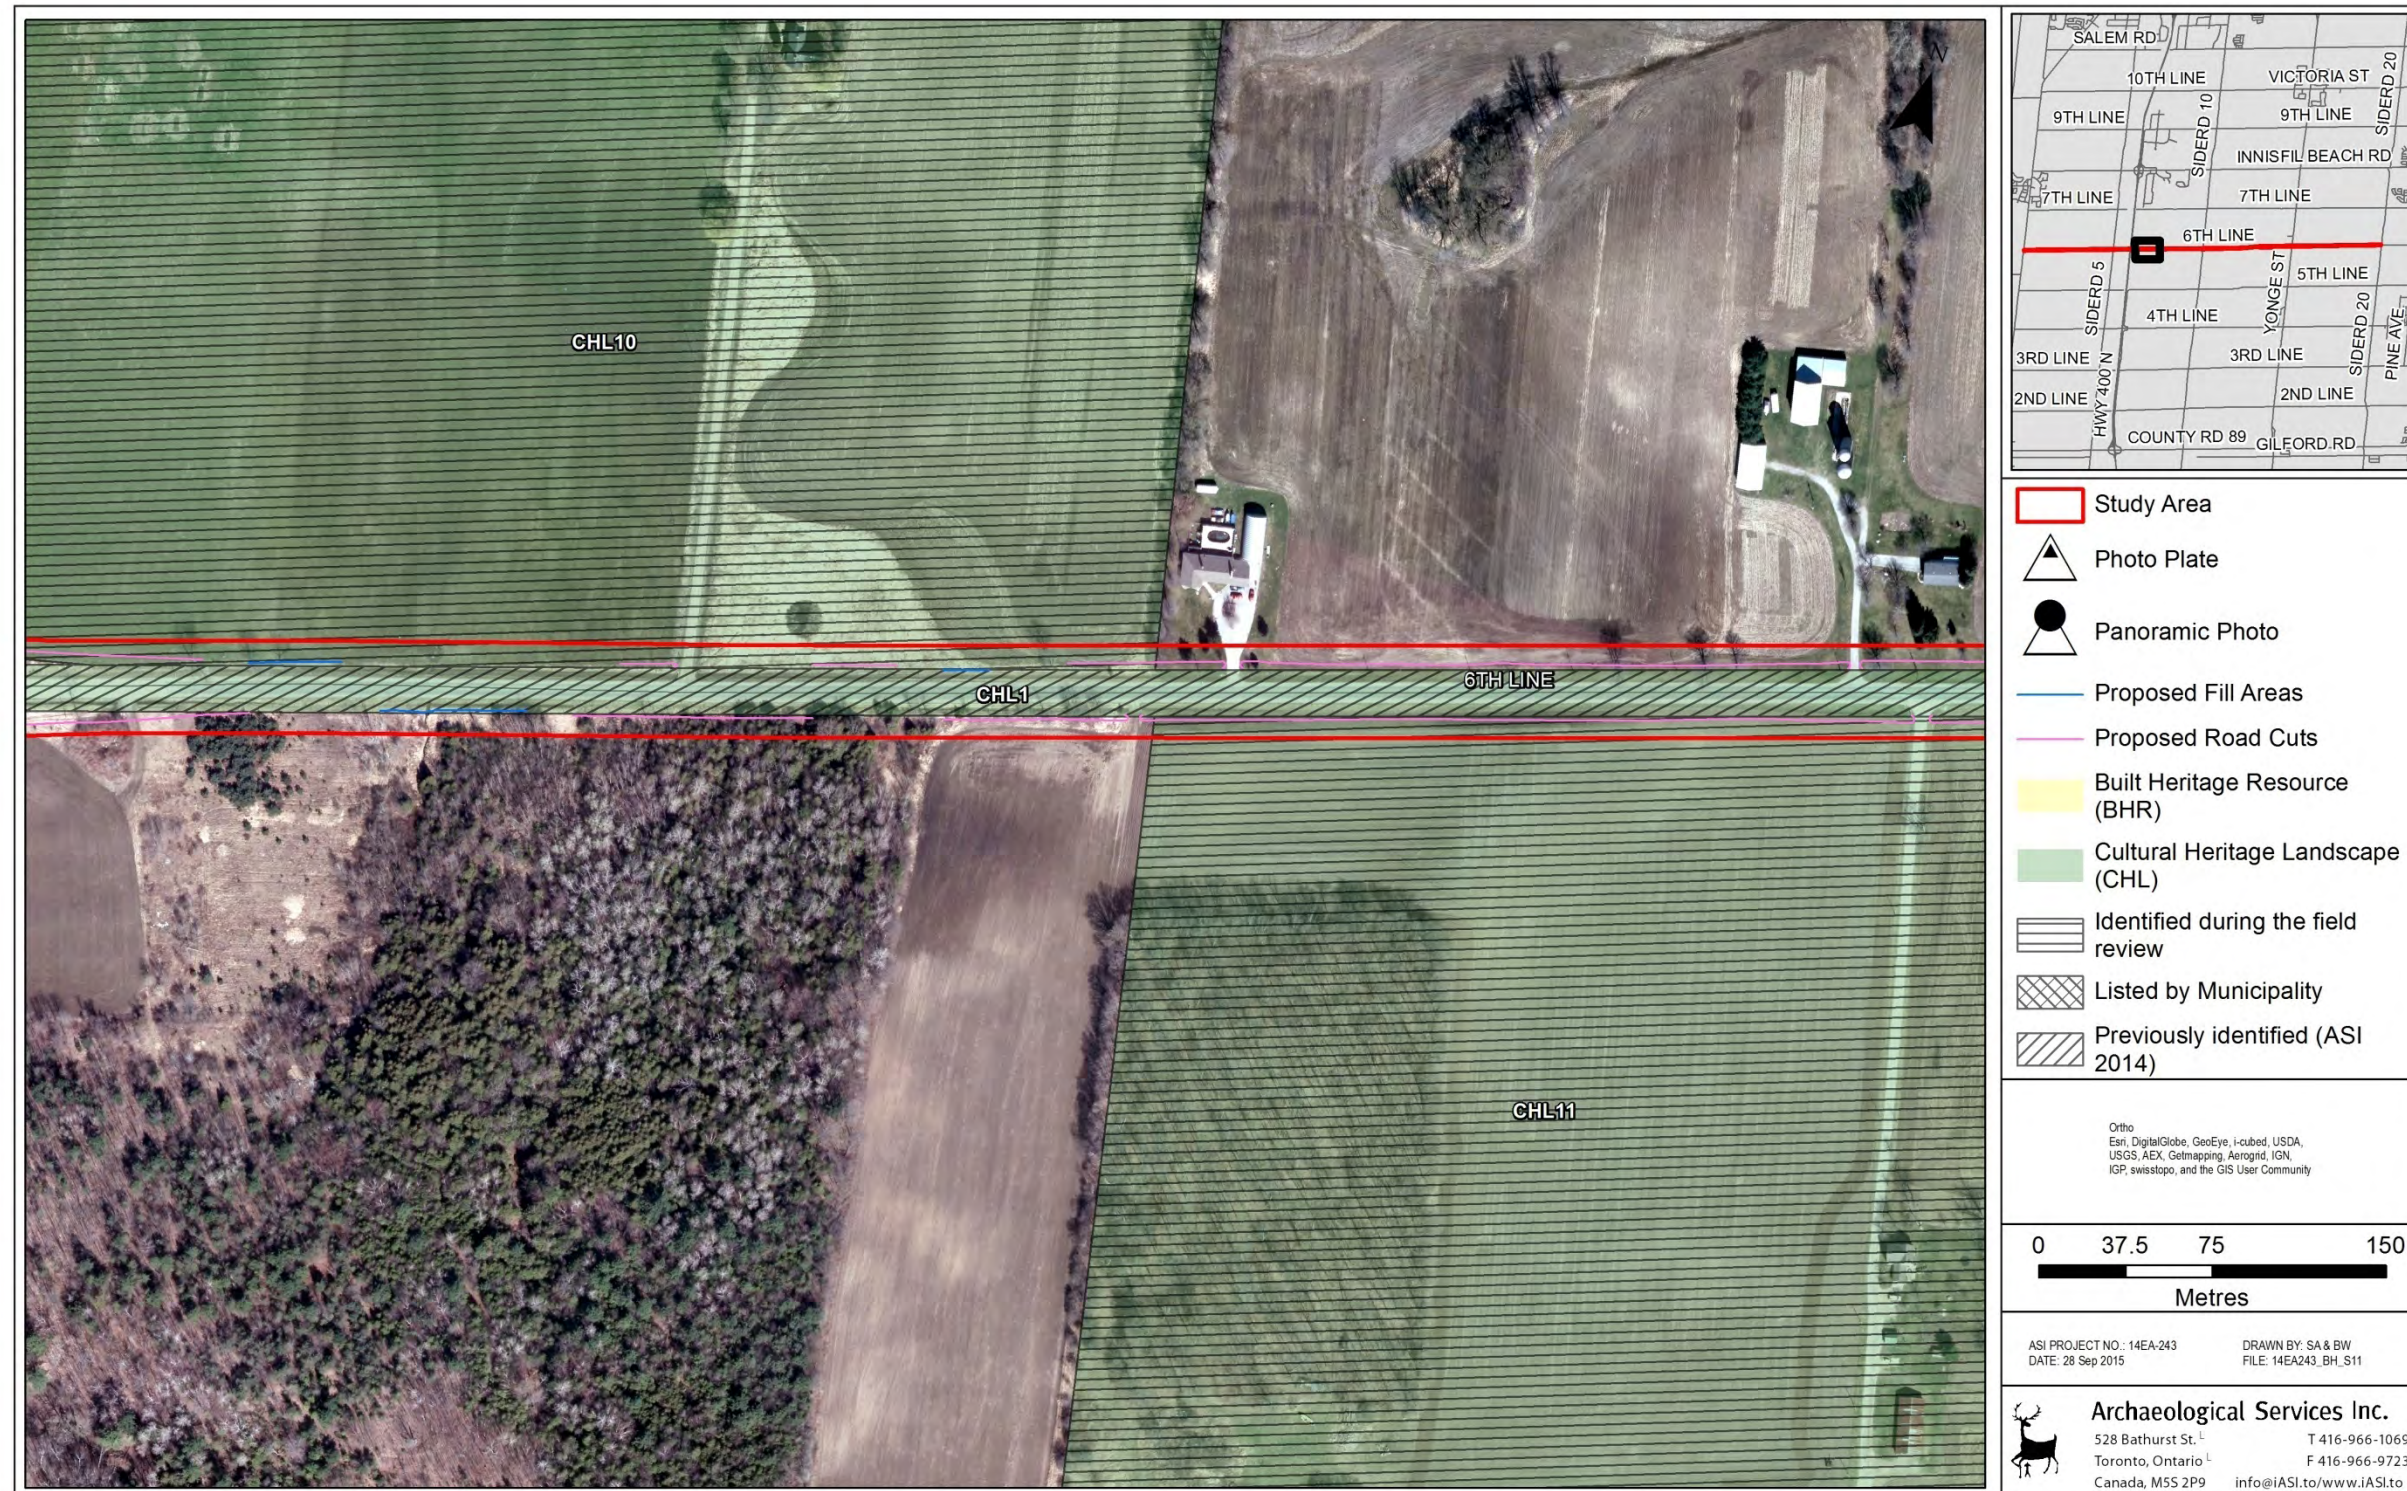
Figure 12: 6th Line (Part B) – Location of Built Heritage Resources (BHR) and Cultural Heritage Landscapes (CHL)

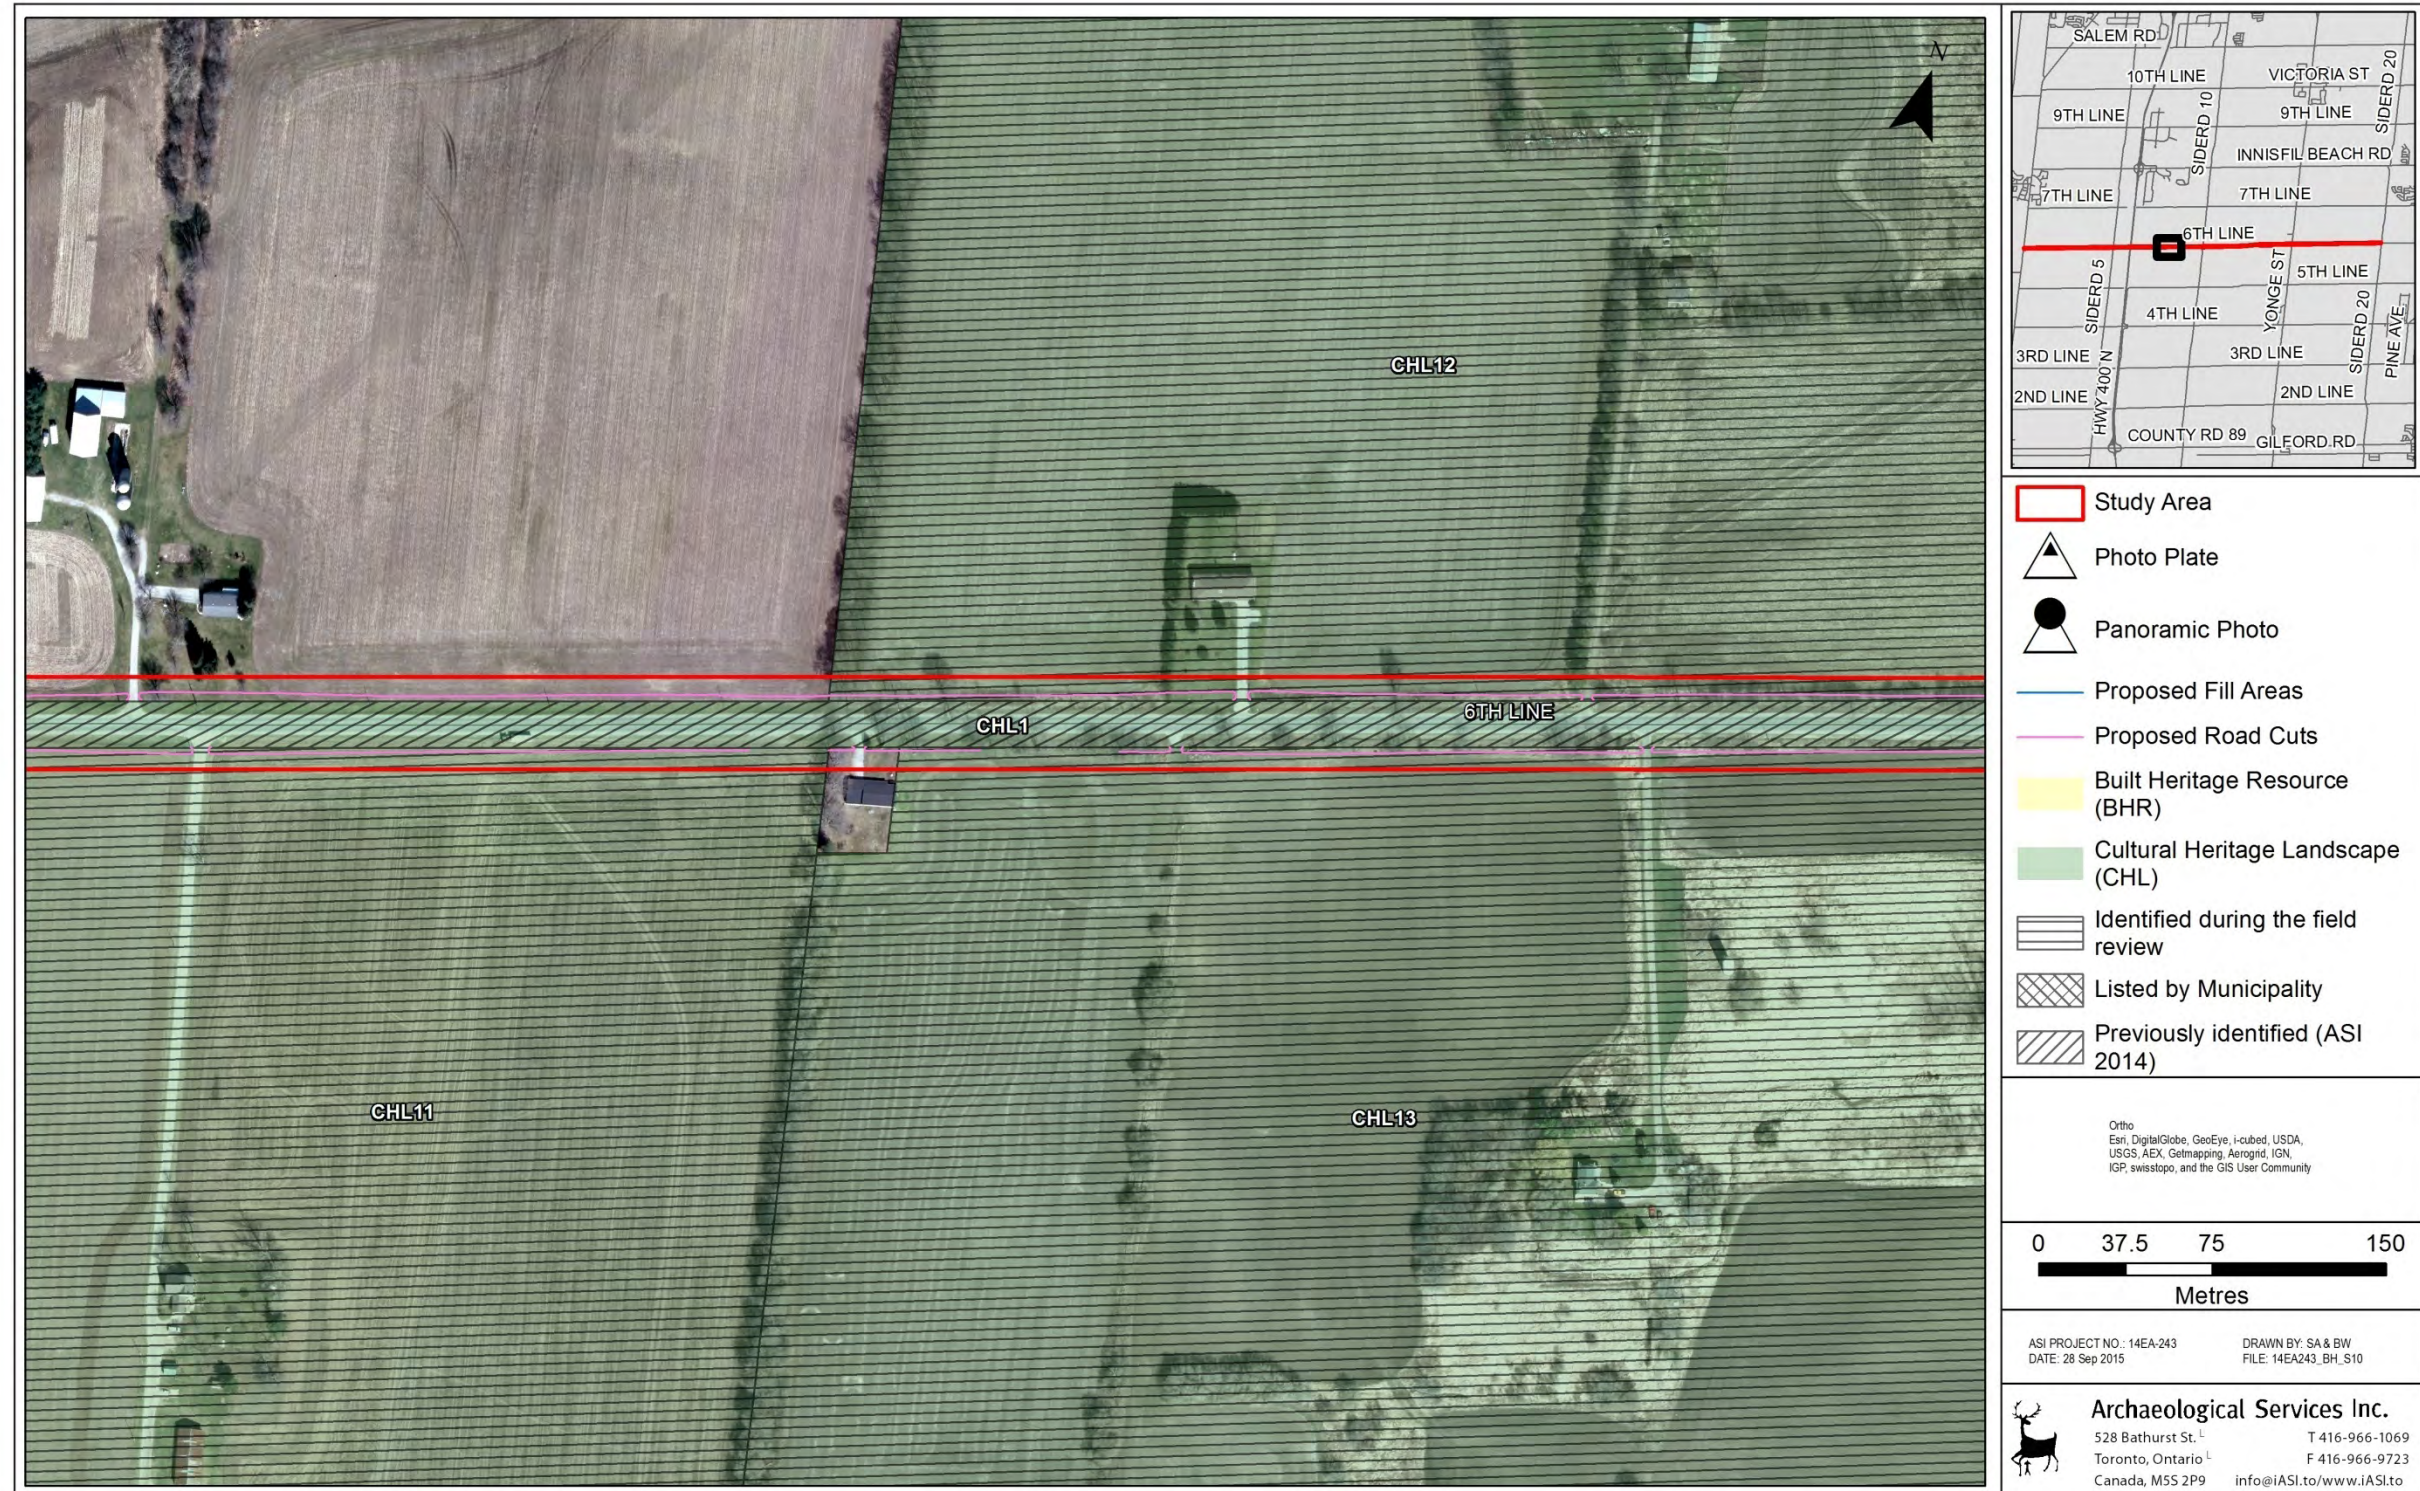
Figure 13: 6th Line (Part B) – Location of Built Heritage Resources (BHR) and Cultural Heritage Landscapes (CHL)

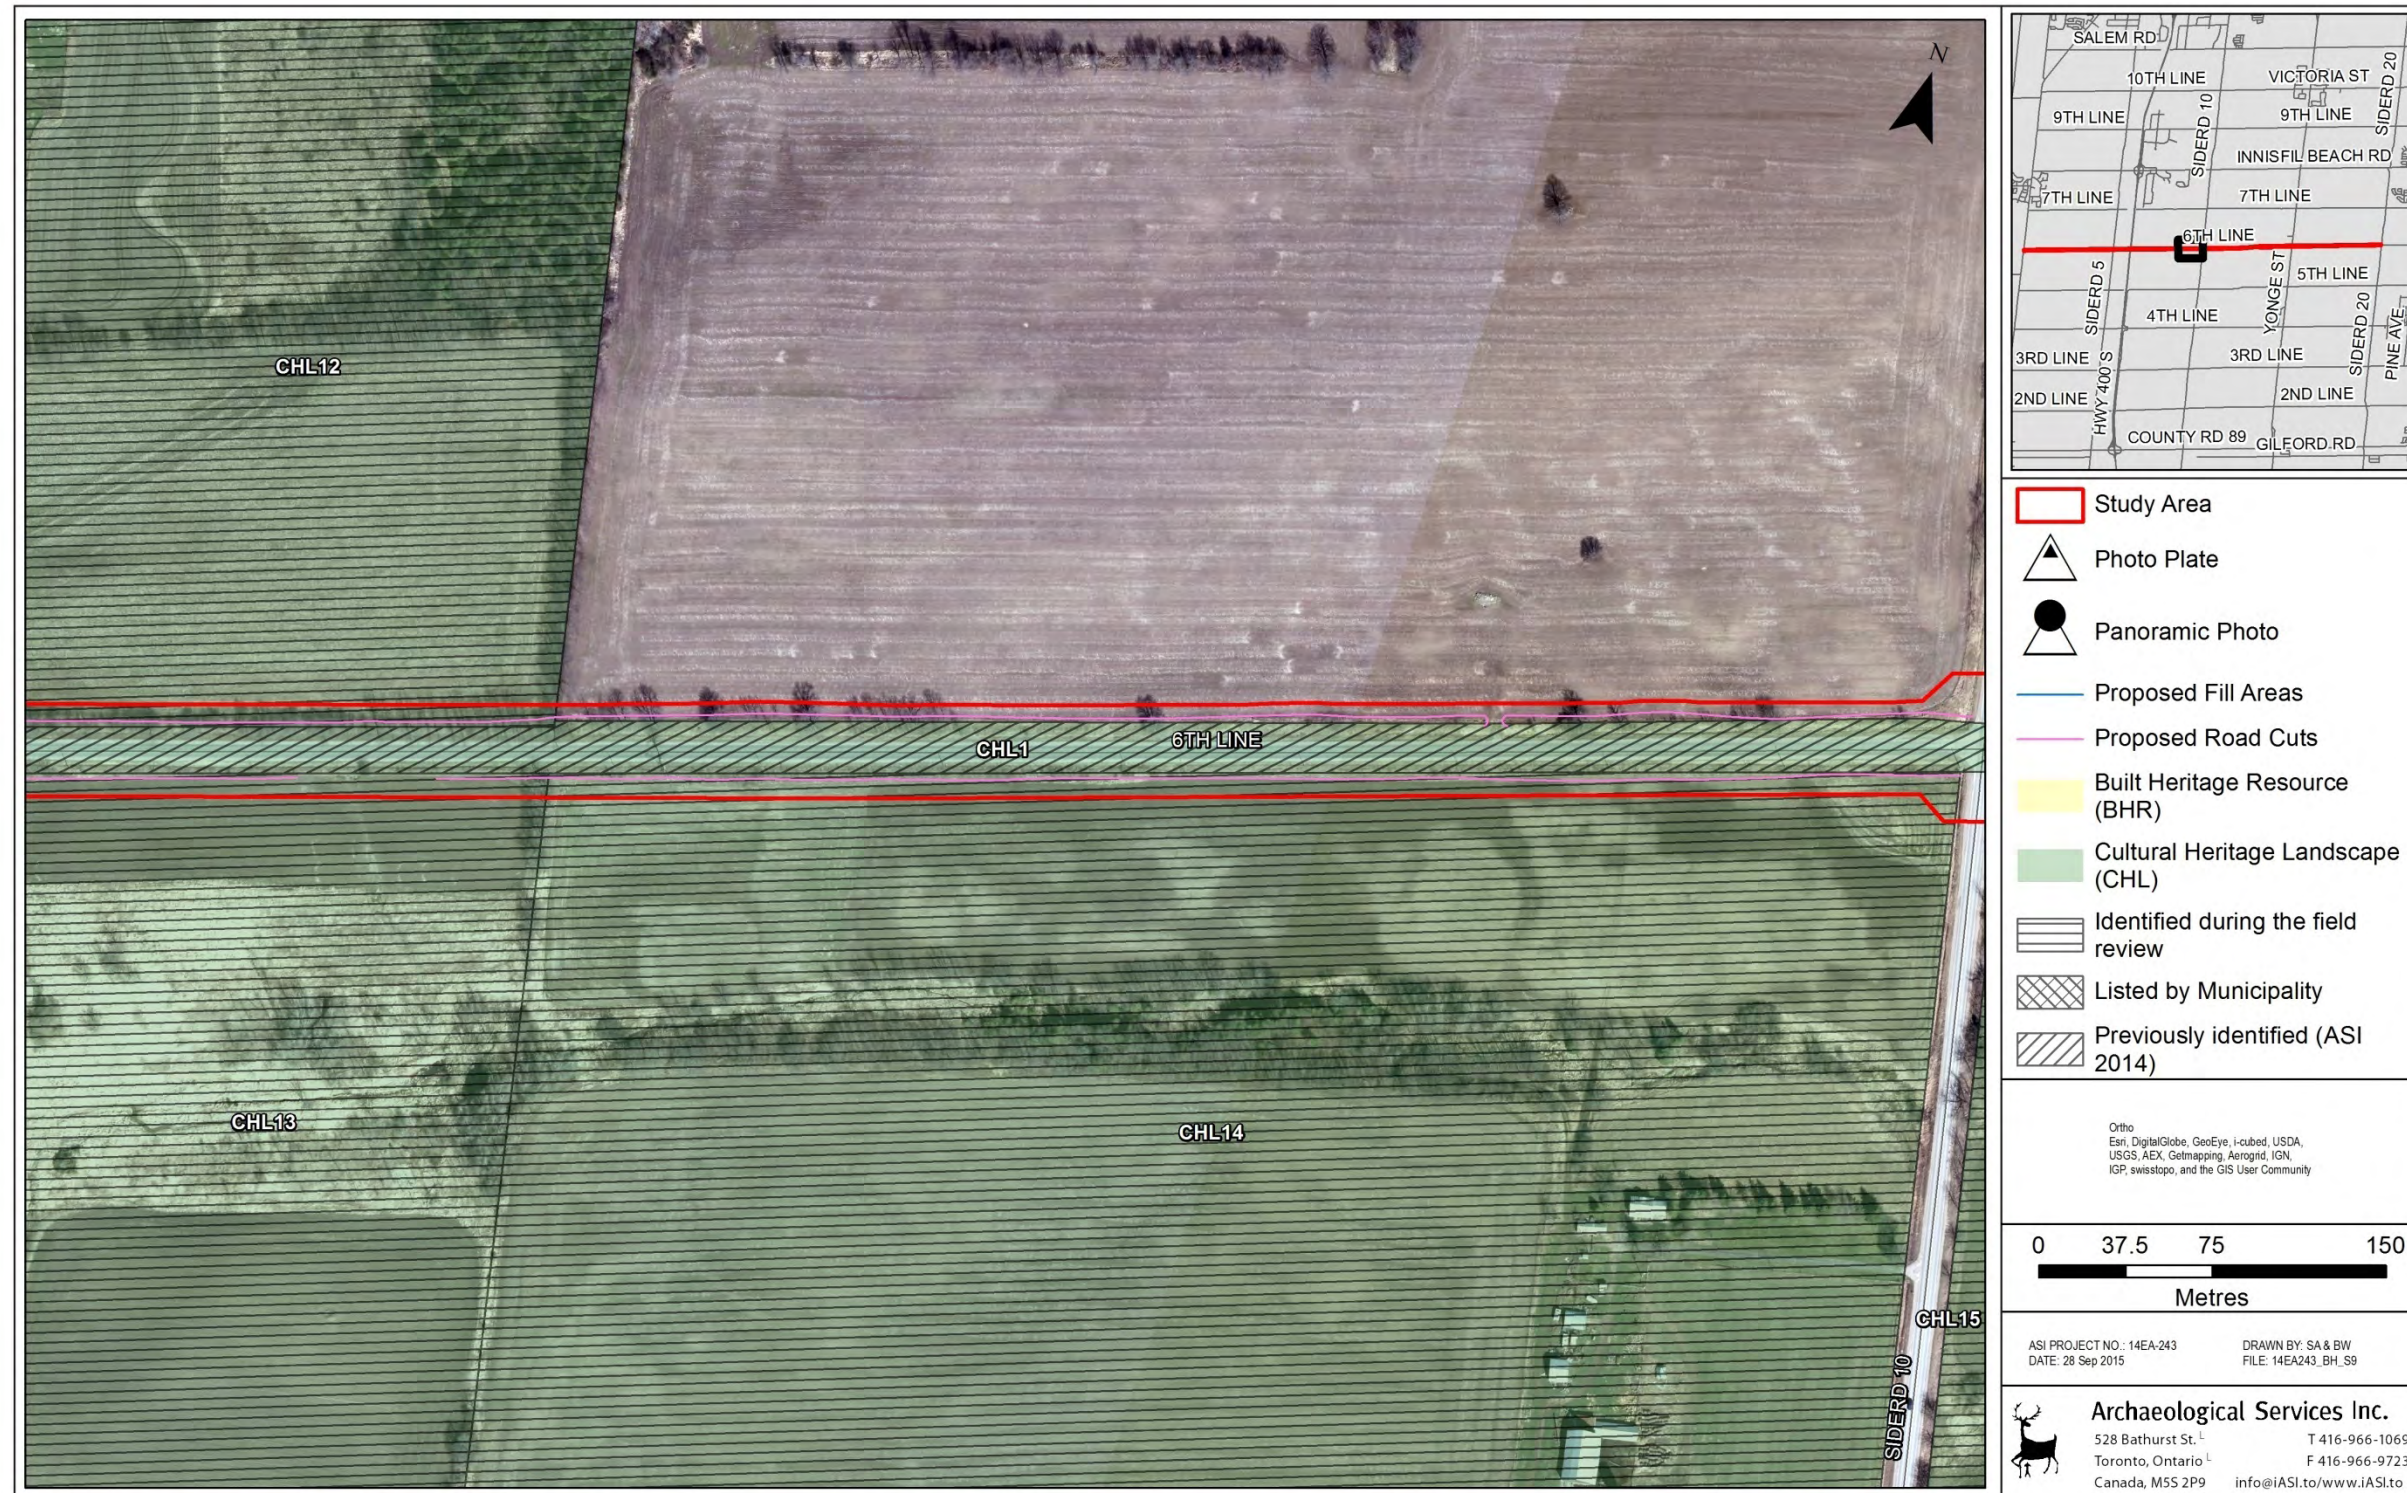
Figure 14: 6th Line (Part B) – Location of Built Heritage Resources (BHR) and Cultural Heritage Landscapes (CHL)

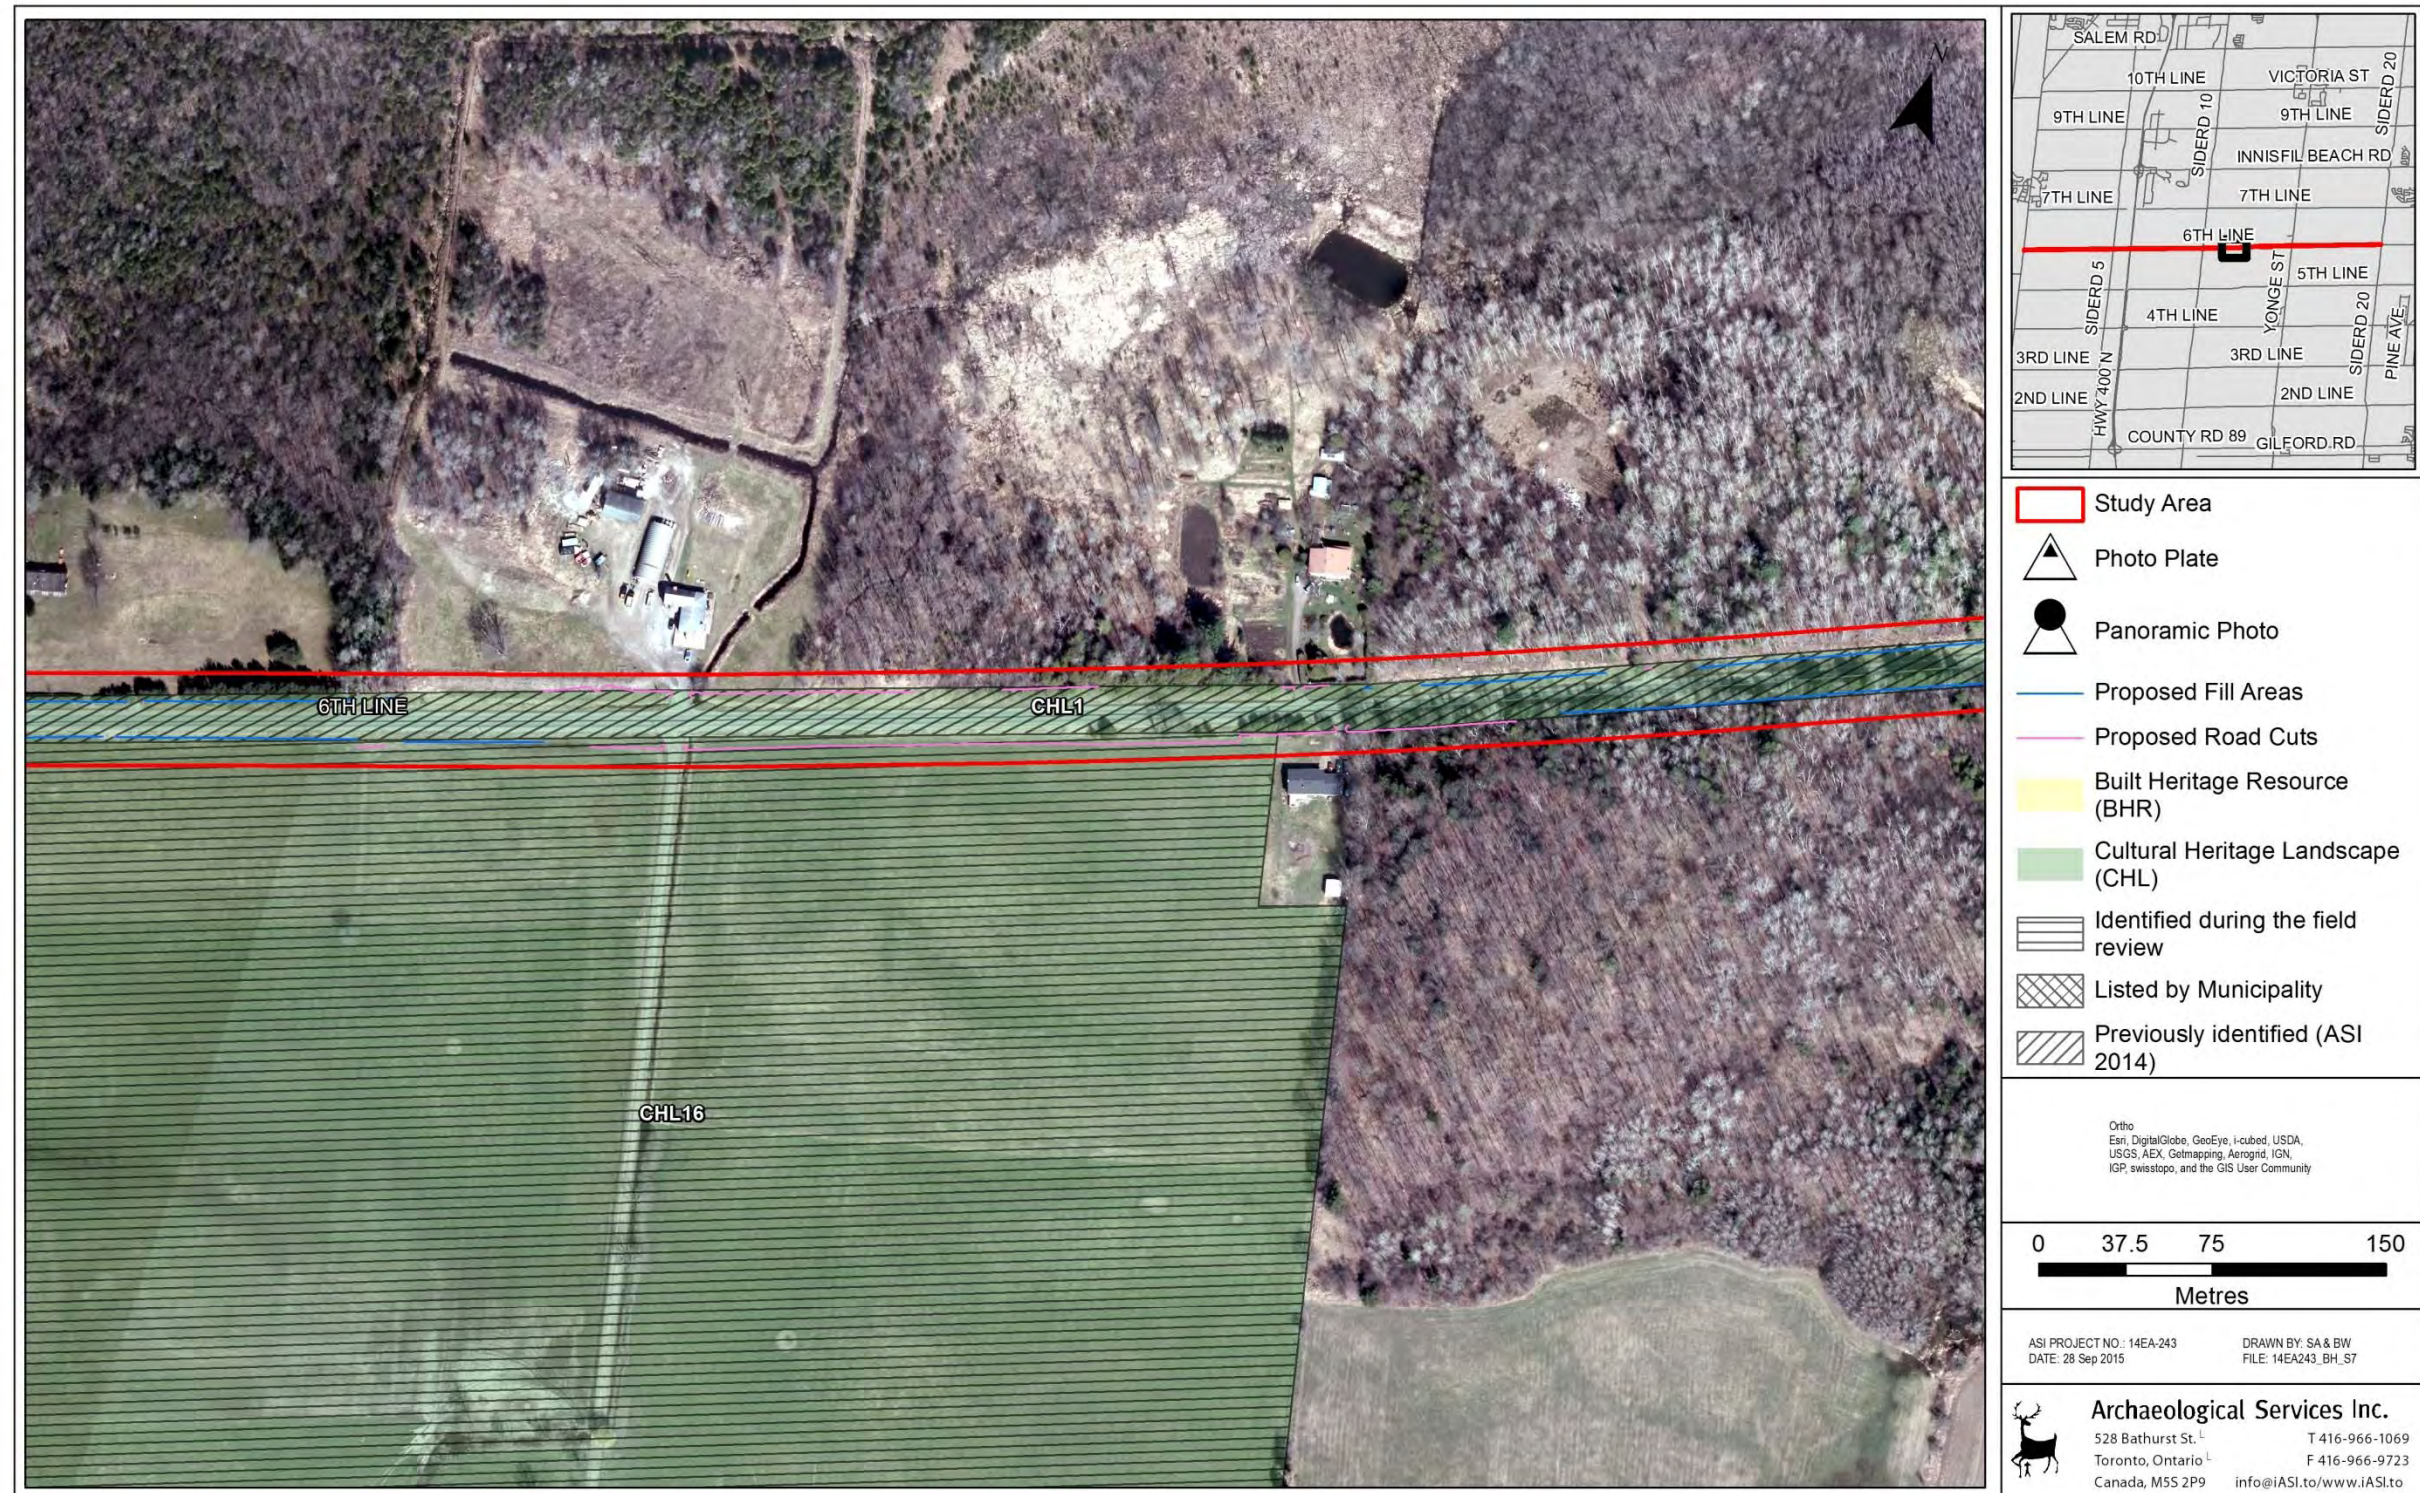
Figure 16: 6th Line (Part B) – Location of Built Heritage Resources (BHR) and Cultural Heritage Landscapes (CHL)

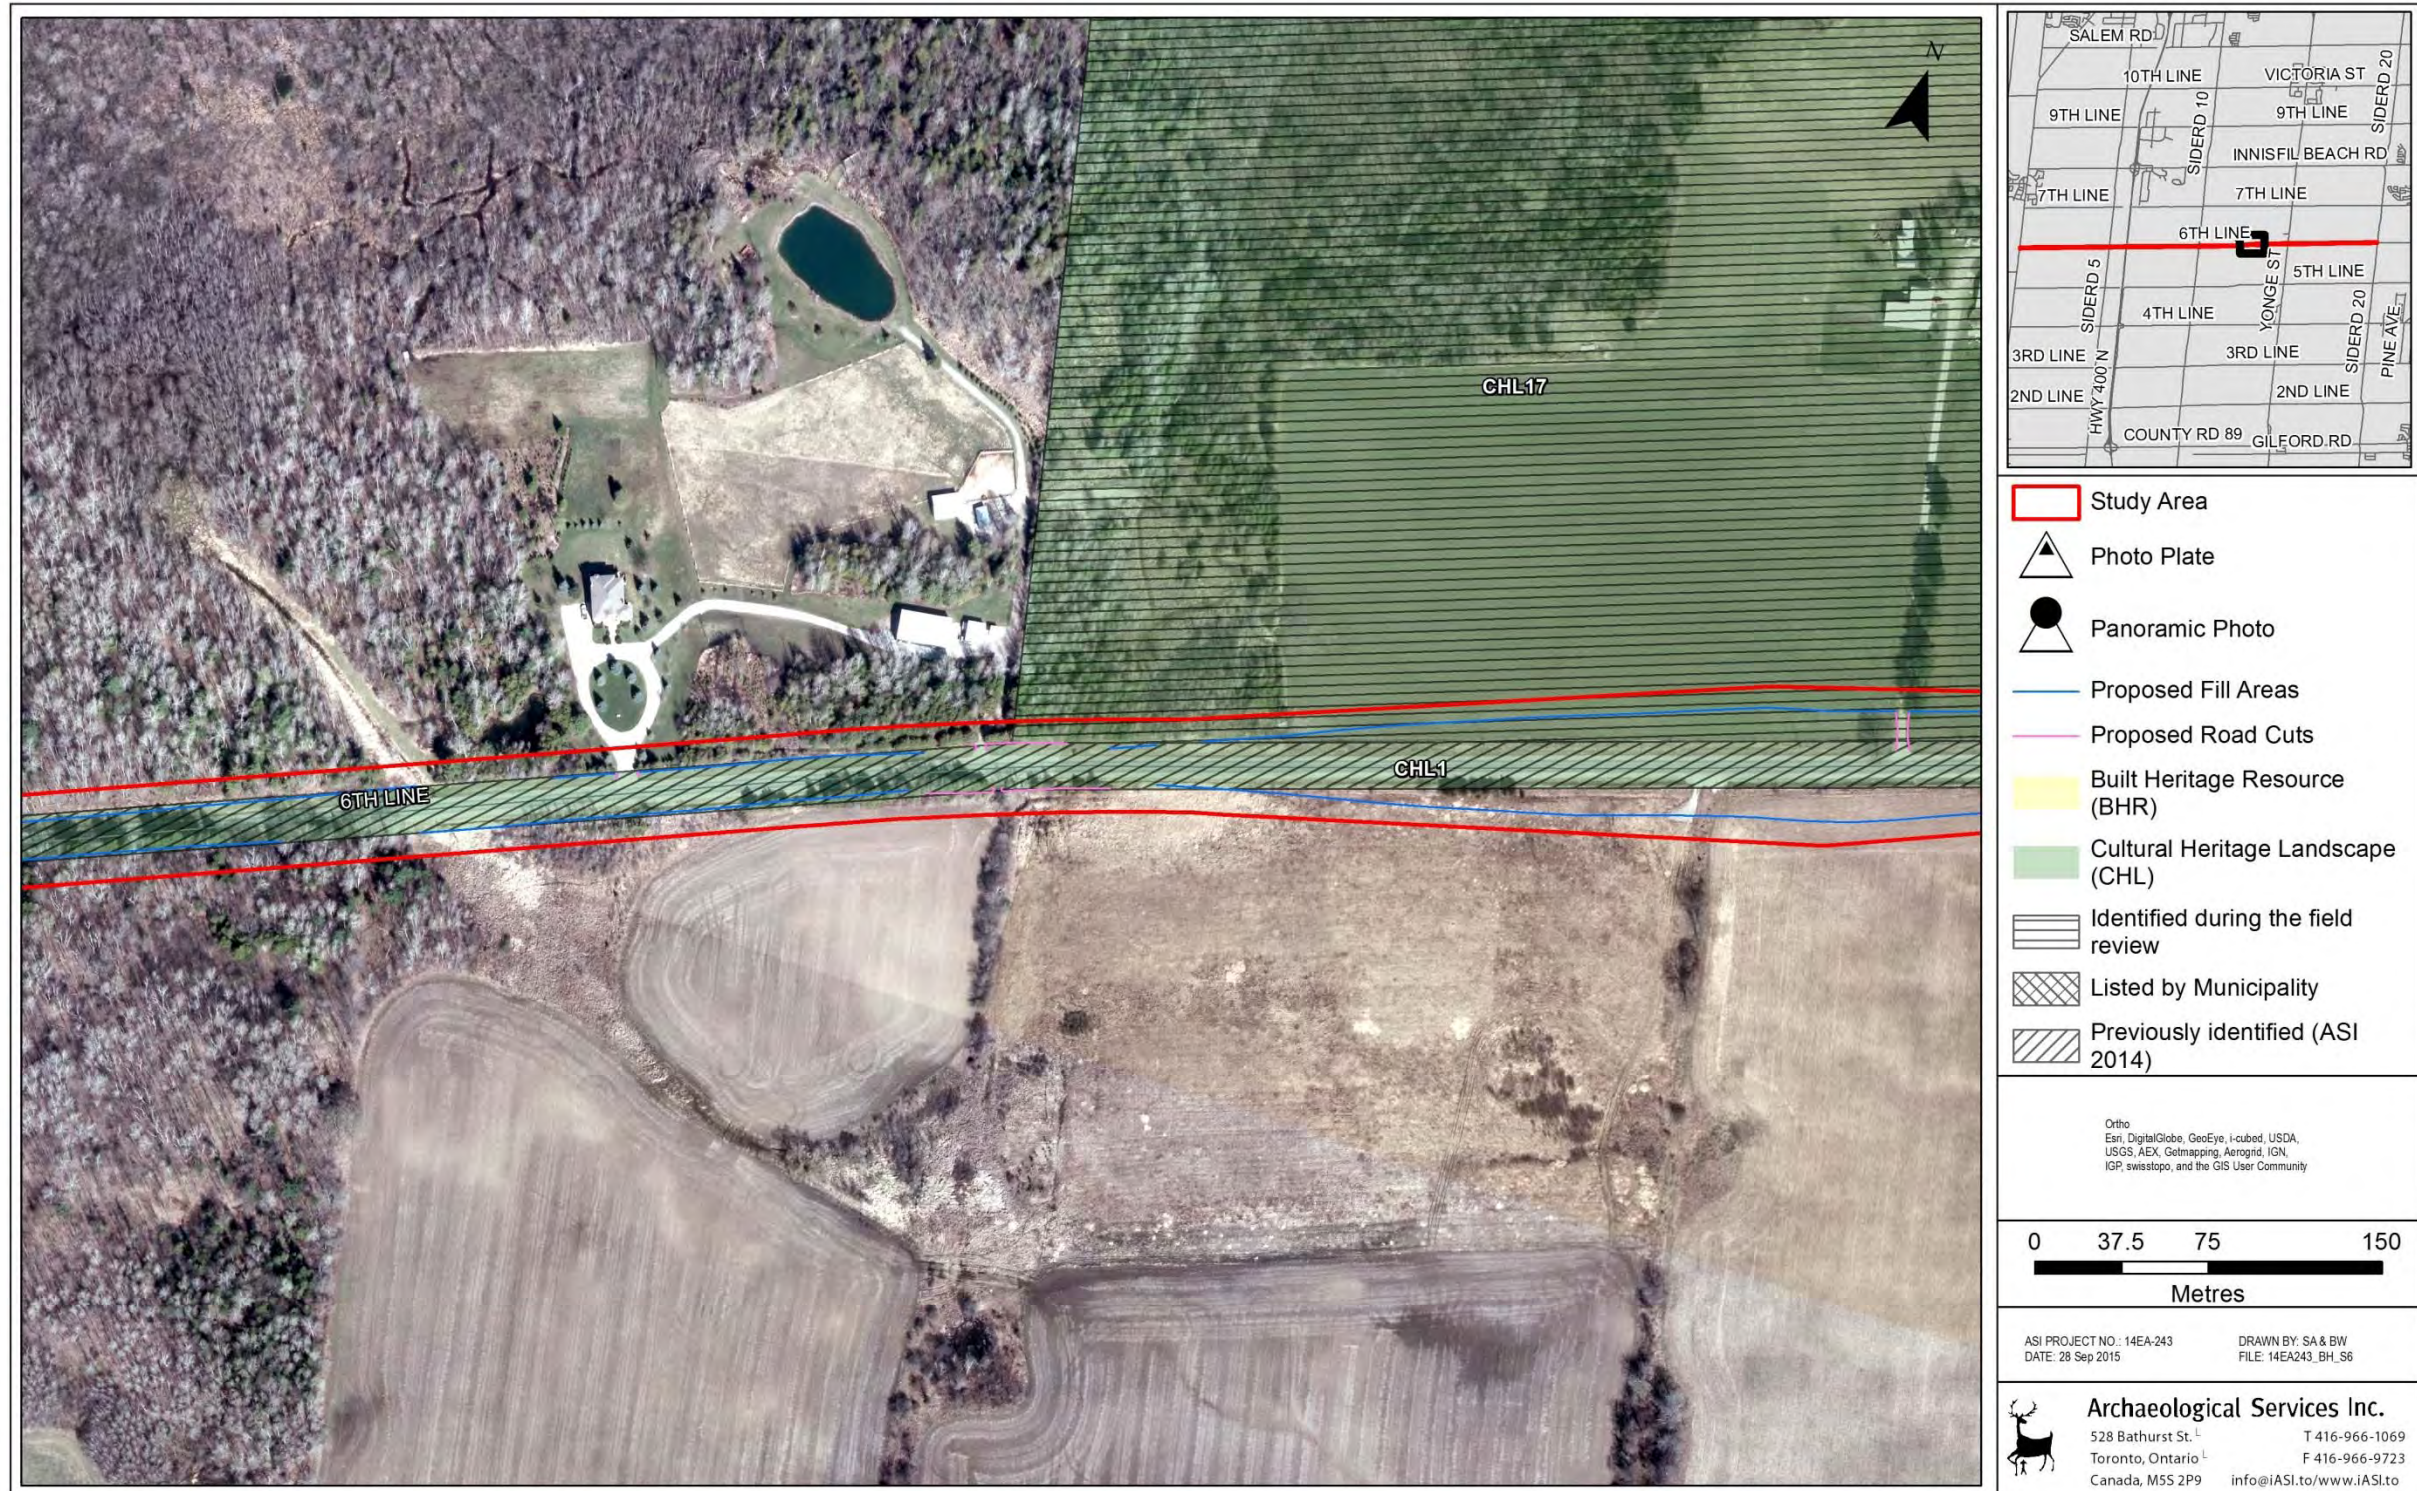
Figure 17: 6th Line (Part B) – Location of Built Heritage Resources (BHR) and Cultural Heritage Landscapes (CHL)

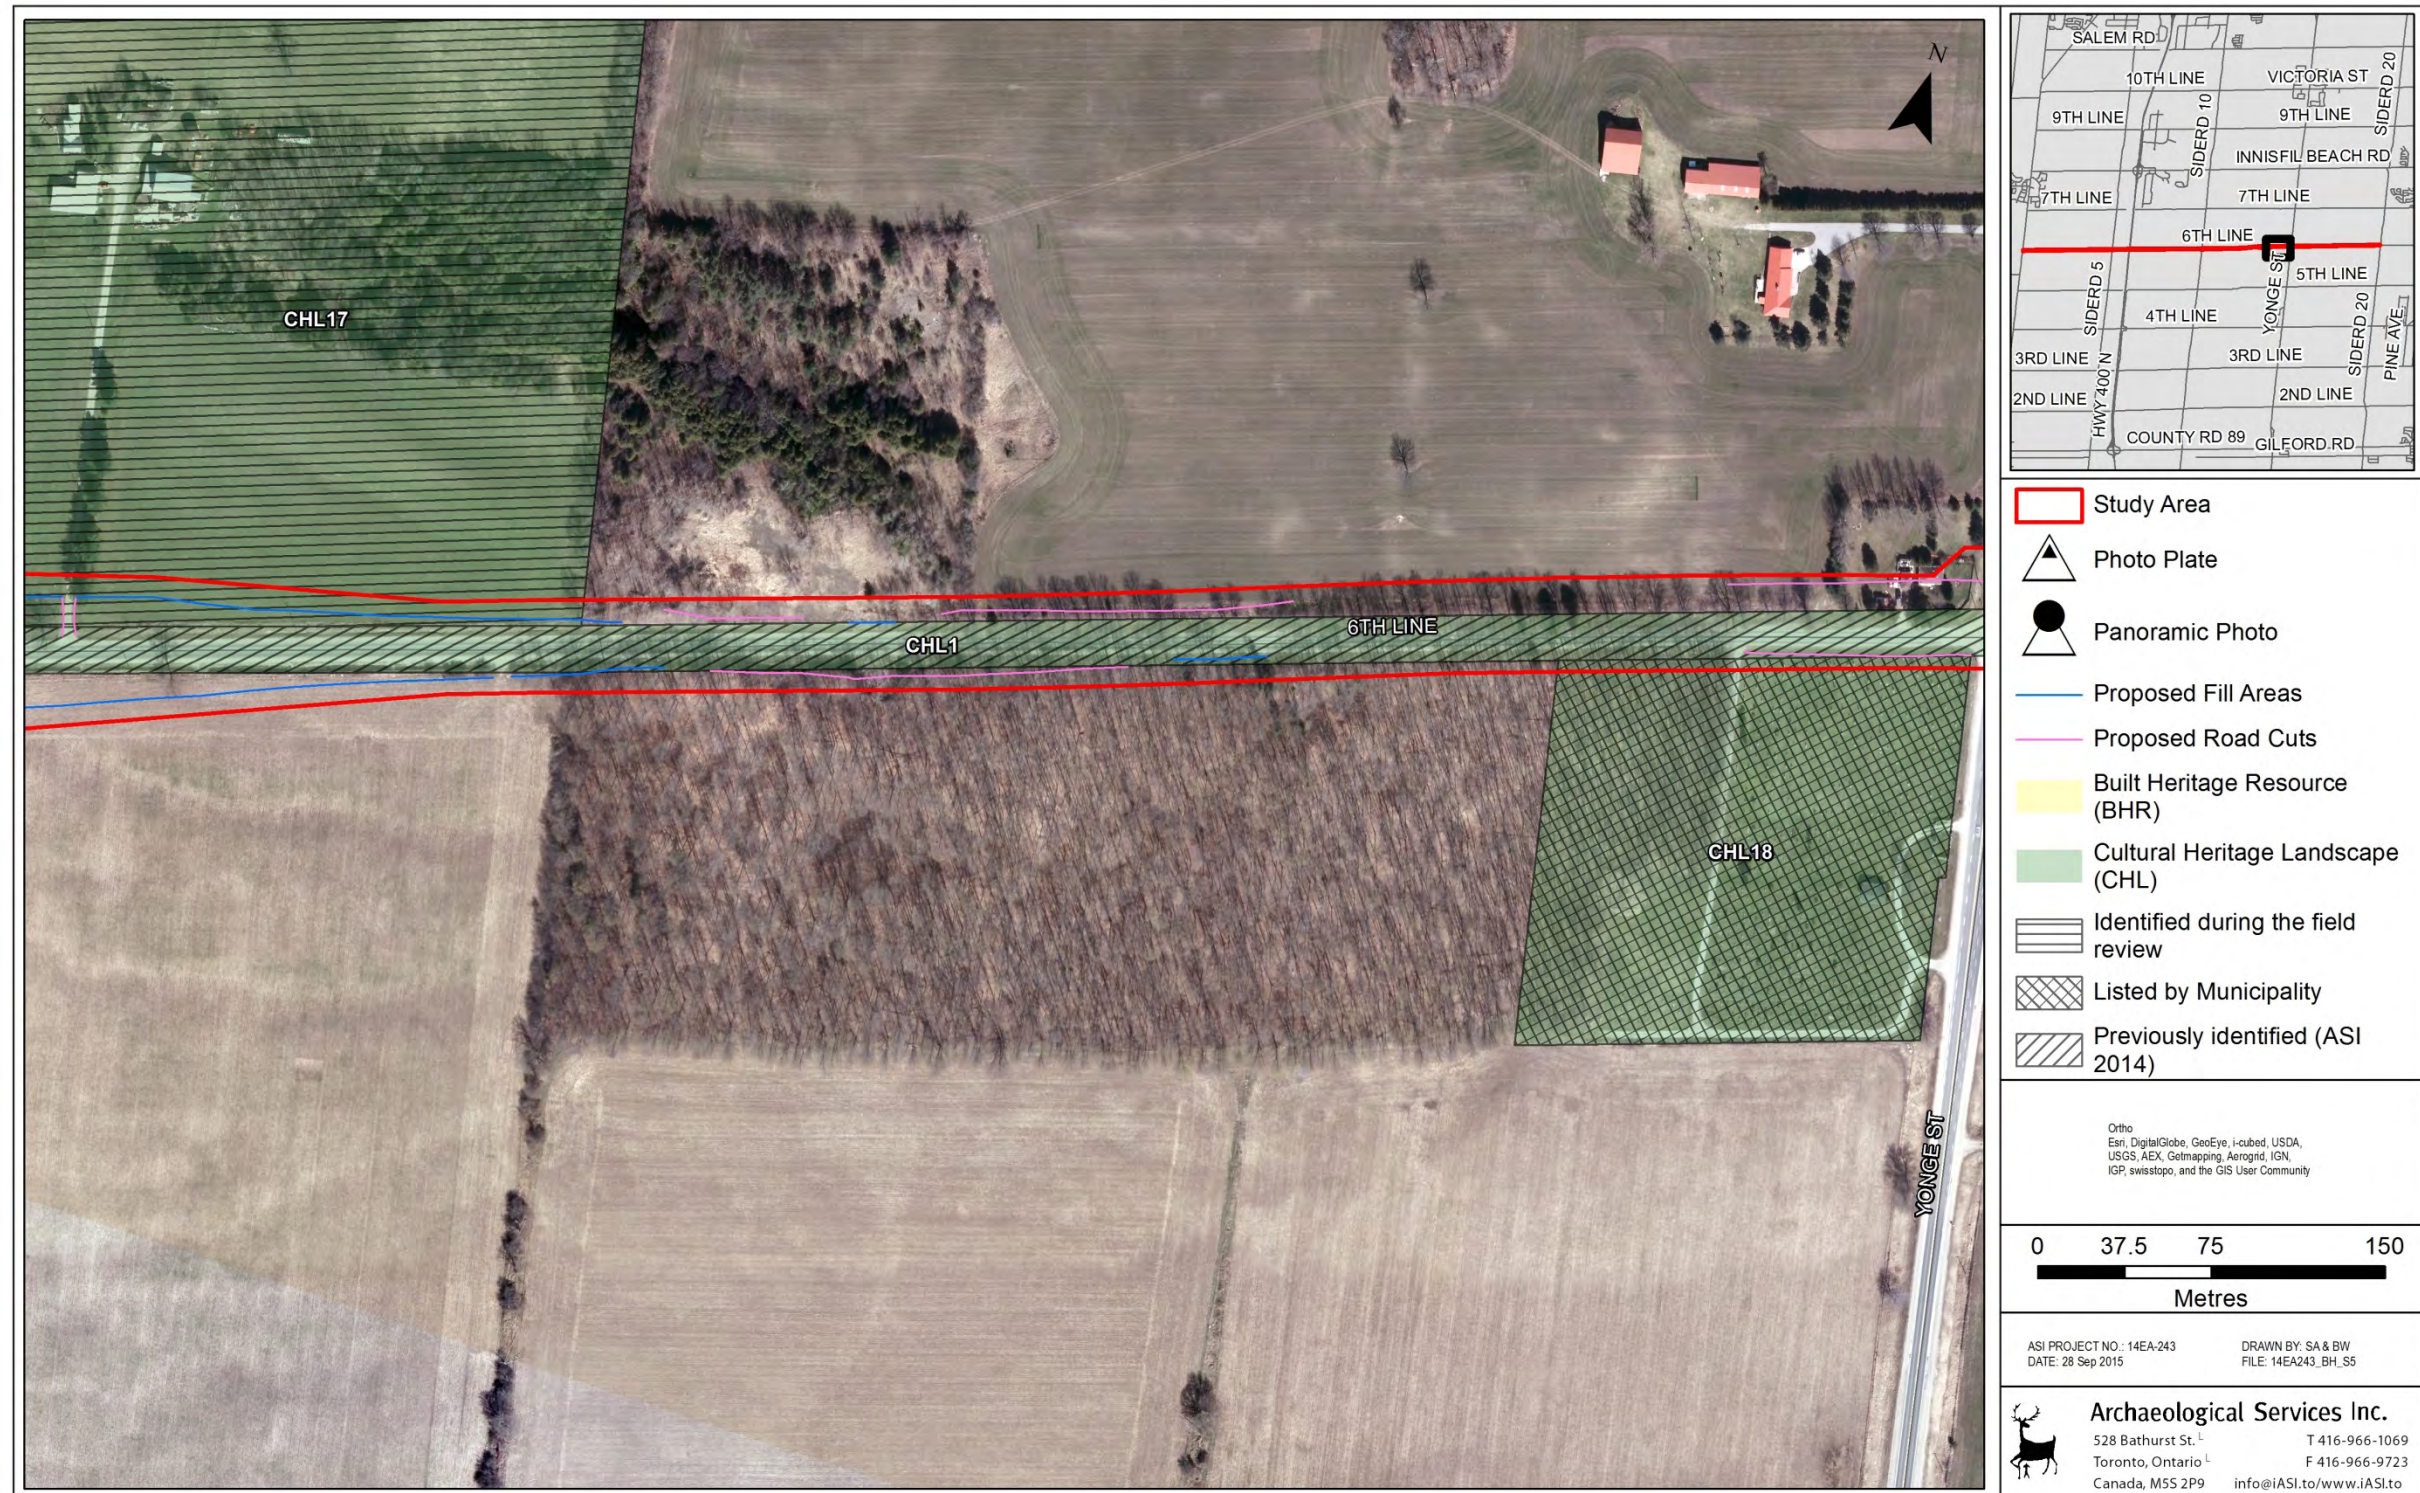
Figure 18: 6th Line (Part B) – Location of Built Heritage Resources (BHR) and Cultural Heritage Landscapes (CHL)
