6th Line Municipal Class Environmental Assessment

County Road 27 to St John's Road
Town of Innisfil, ON

**Cultural Heritage Resource Assessment:
Built Heritage Resources and Cultural Heritage Landscapes**

**6th Line (Part A): 20 Sideroad to St. John's Road
Class Environmental Assessment Study**

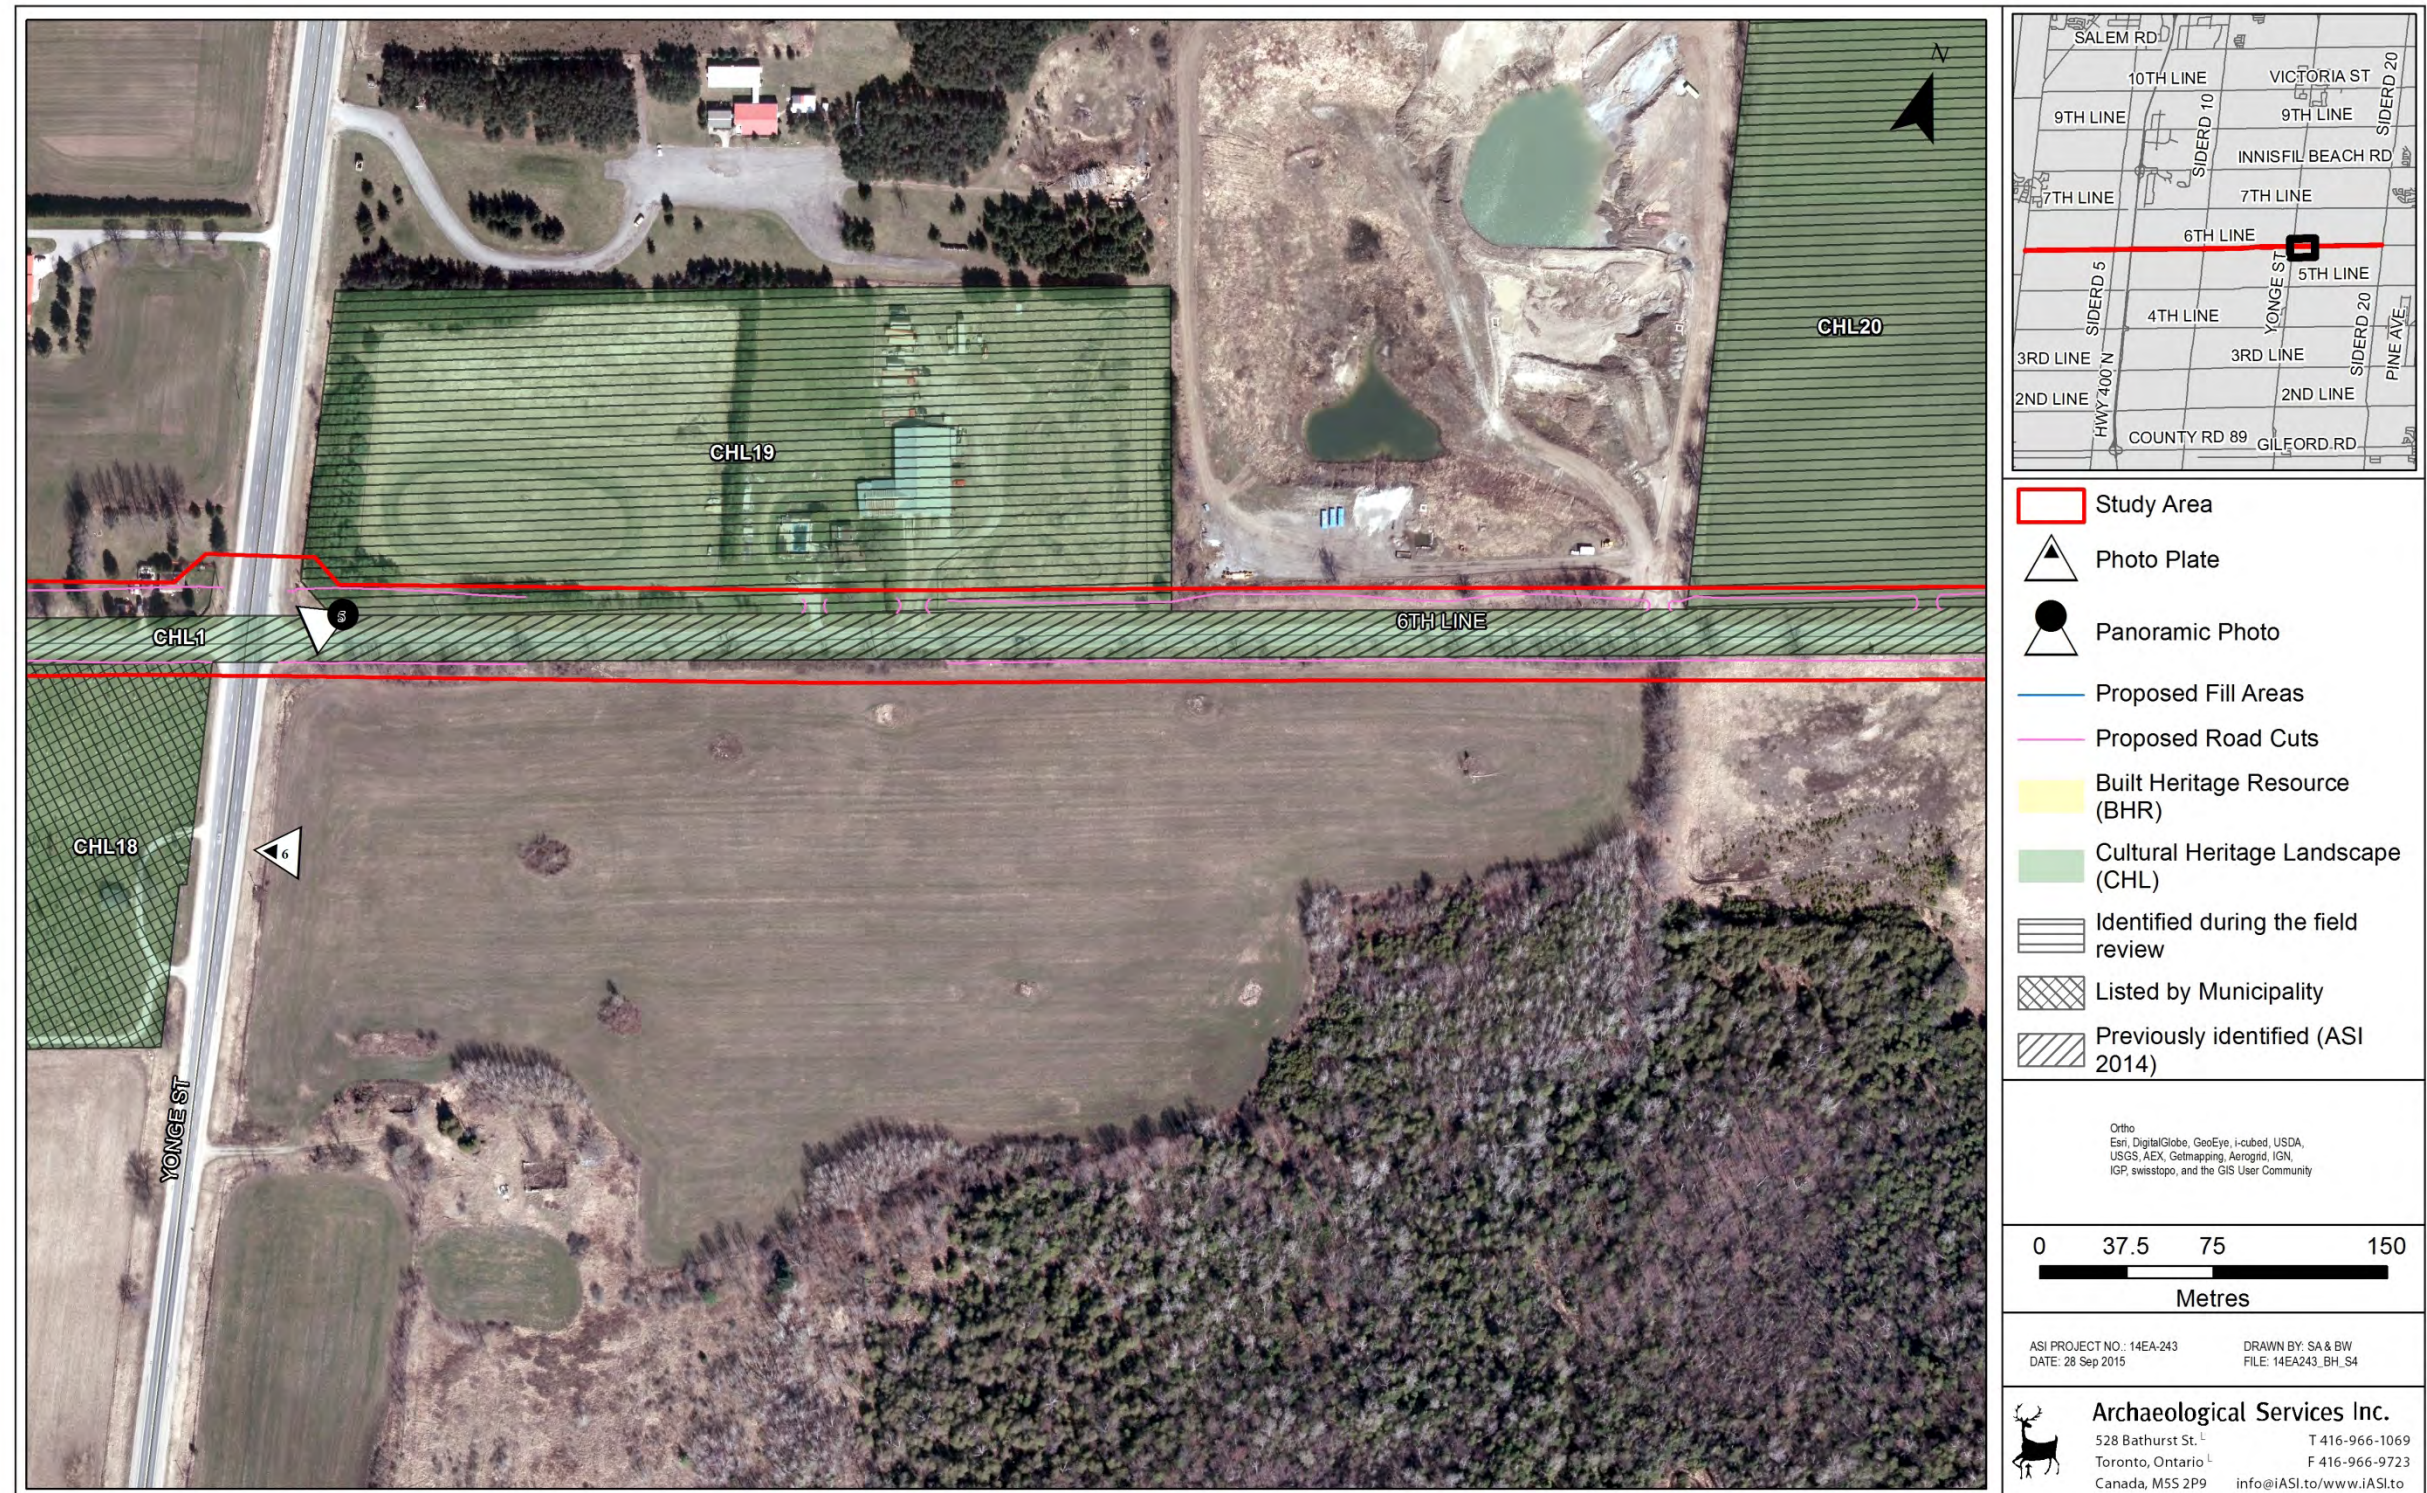
Figure 19: 6th Line (Part B) – Location of Built Heritage Resources (BHR) and Cultural Heritage Landscapes (CHL)

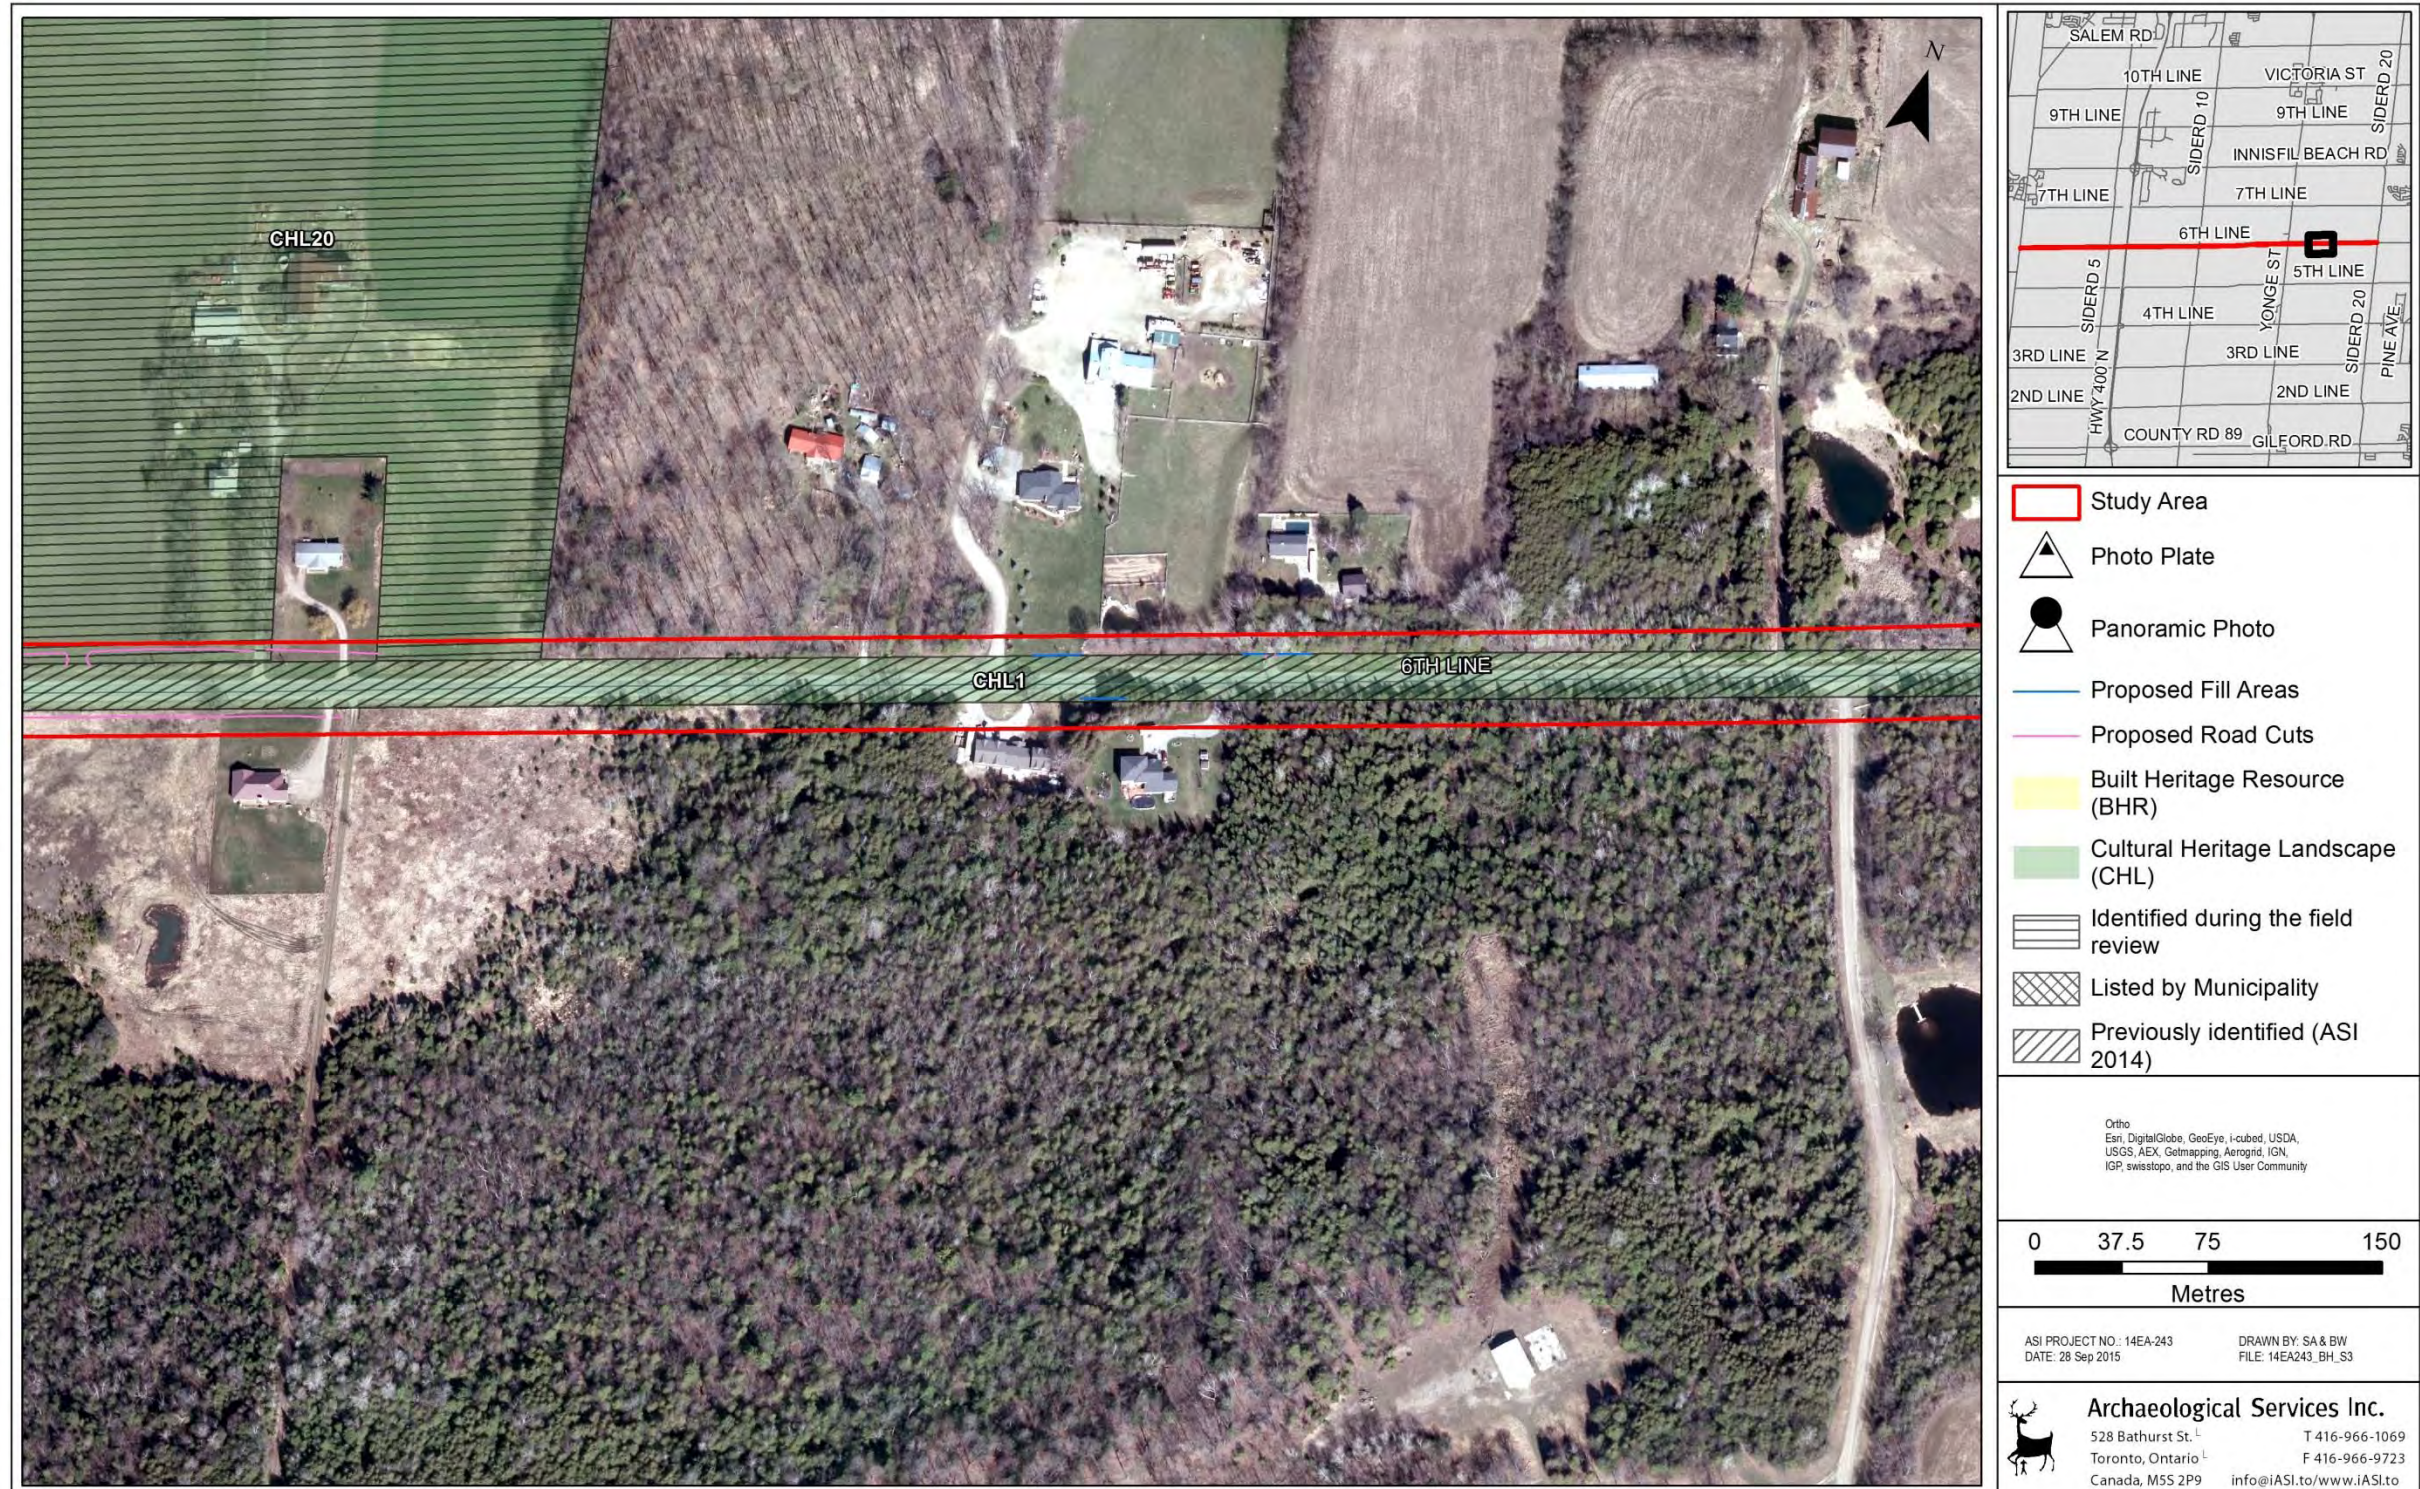
Figure 20: 6th Line (Part B) – Location of Built Heritage Resources (BHR) and Cultural Heritage Landscapes (CHL)

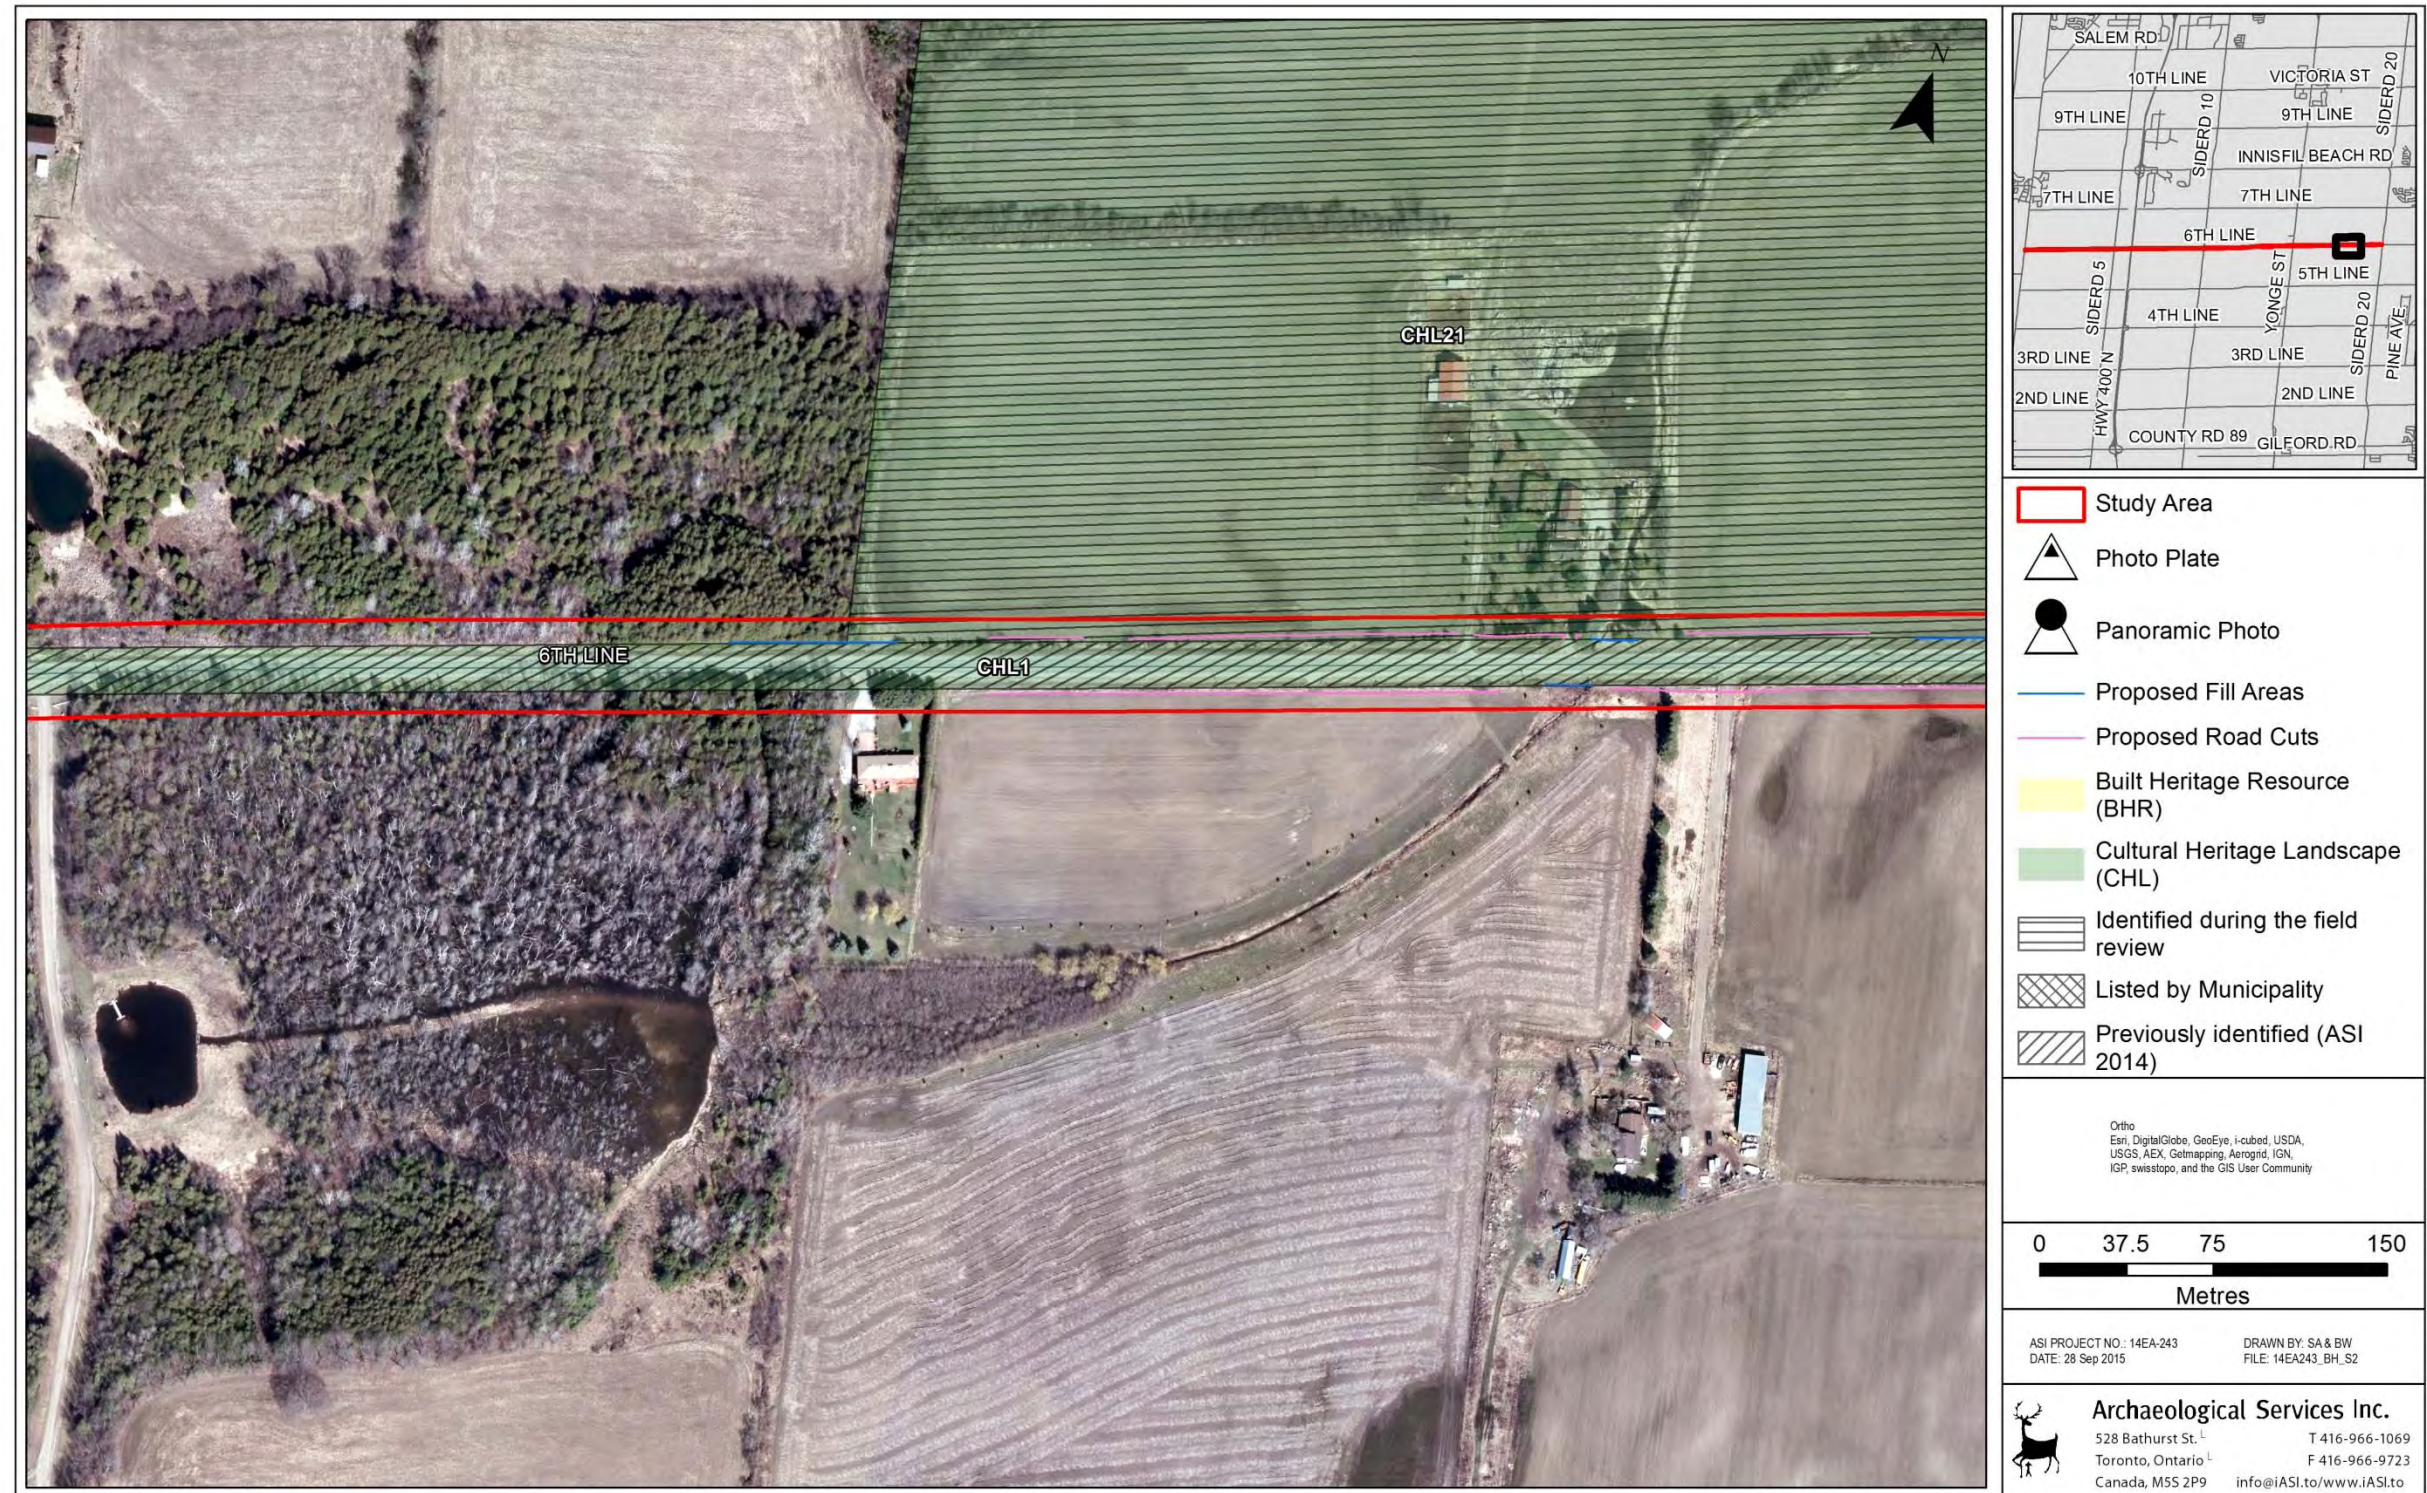
Figure 21: 6th Line (Part B) – Location of Built Heritage Resources (BHR) and Cultural Heritage Landscapes (CHL)

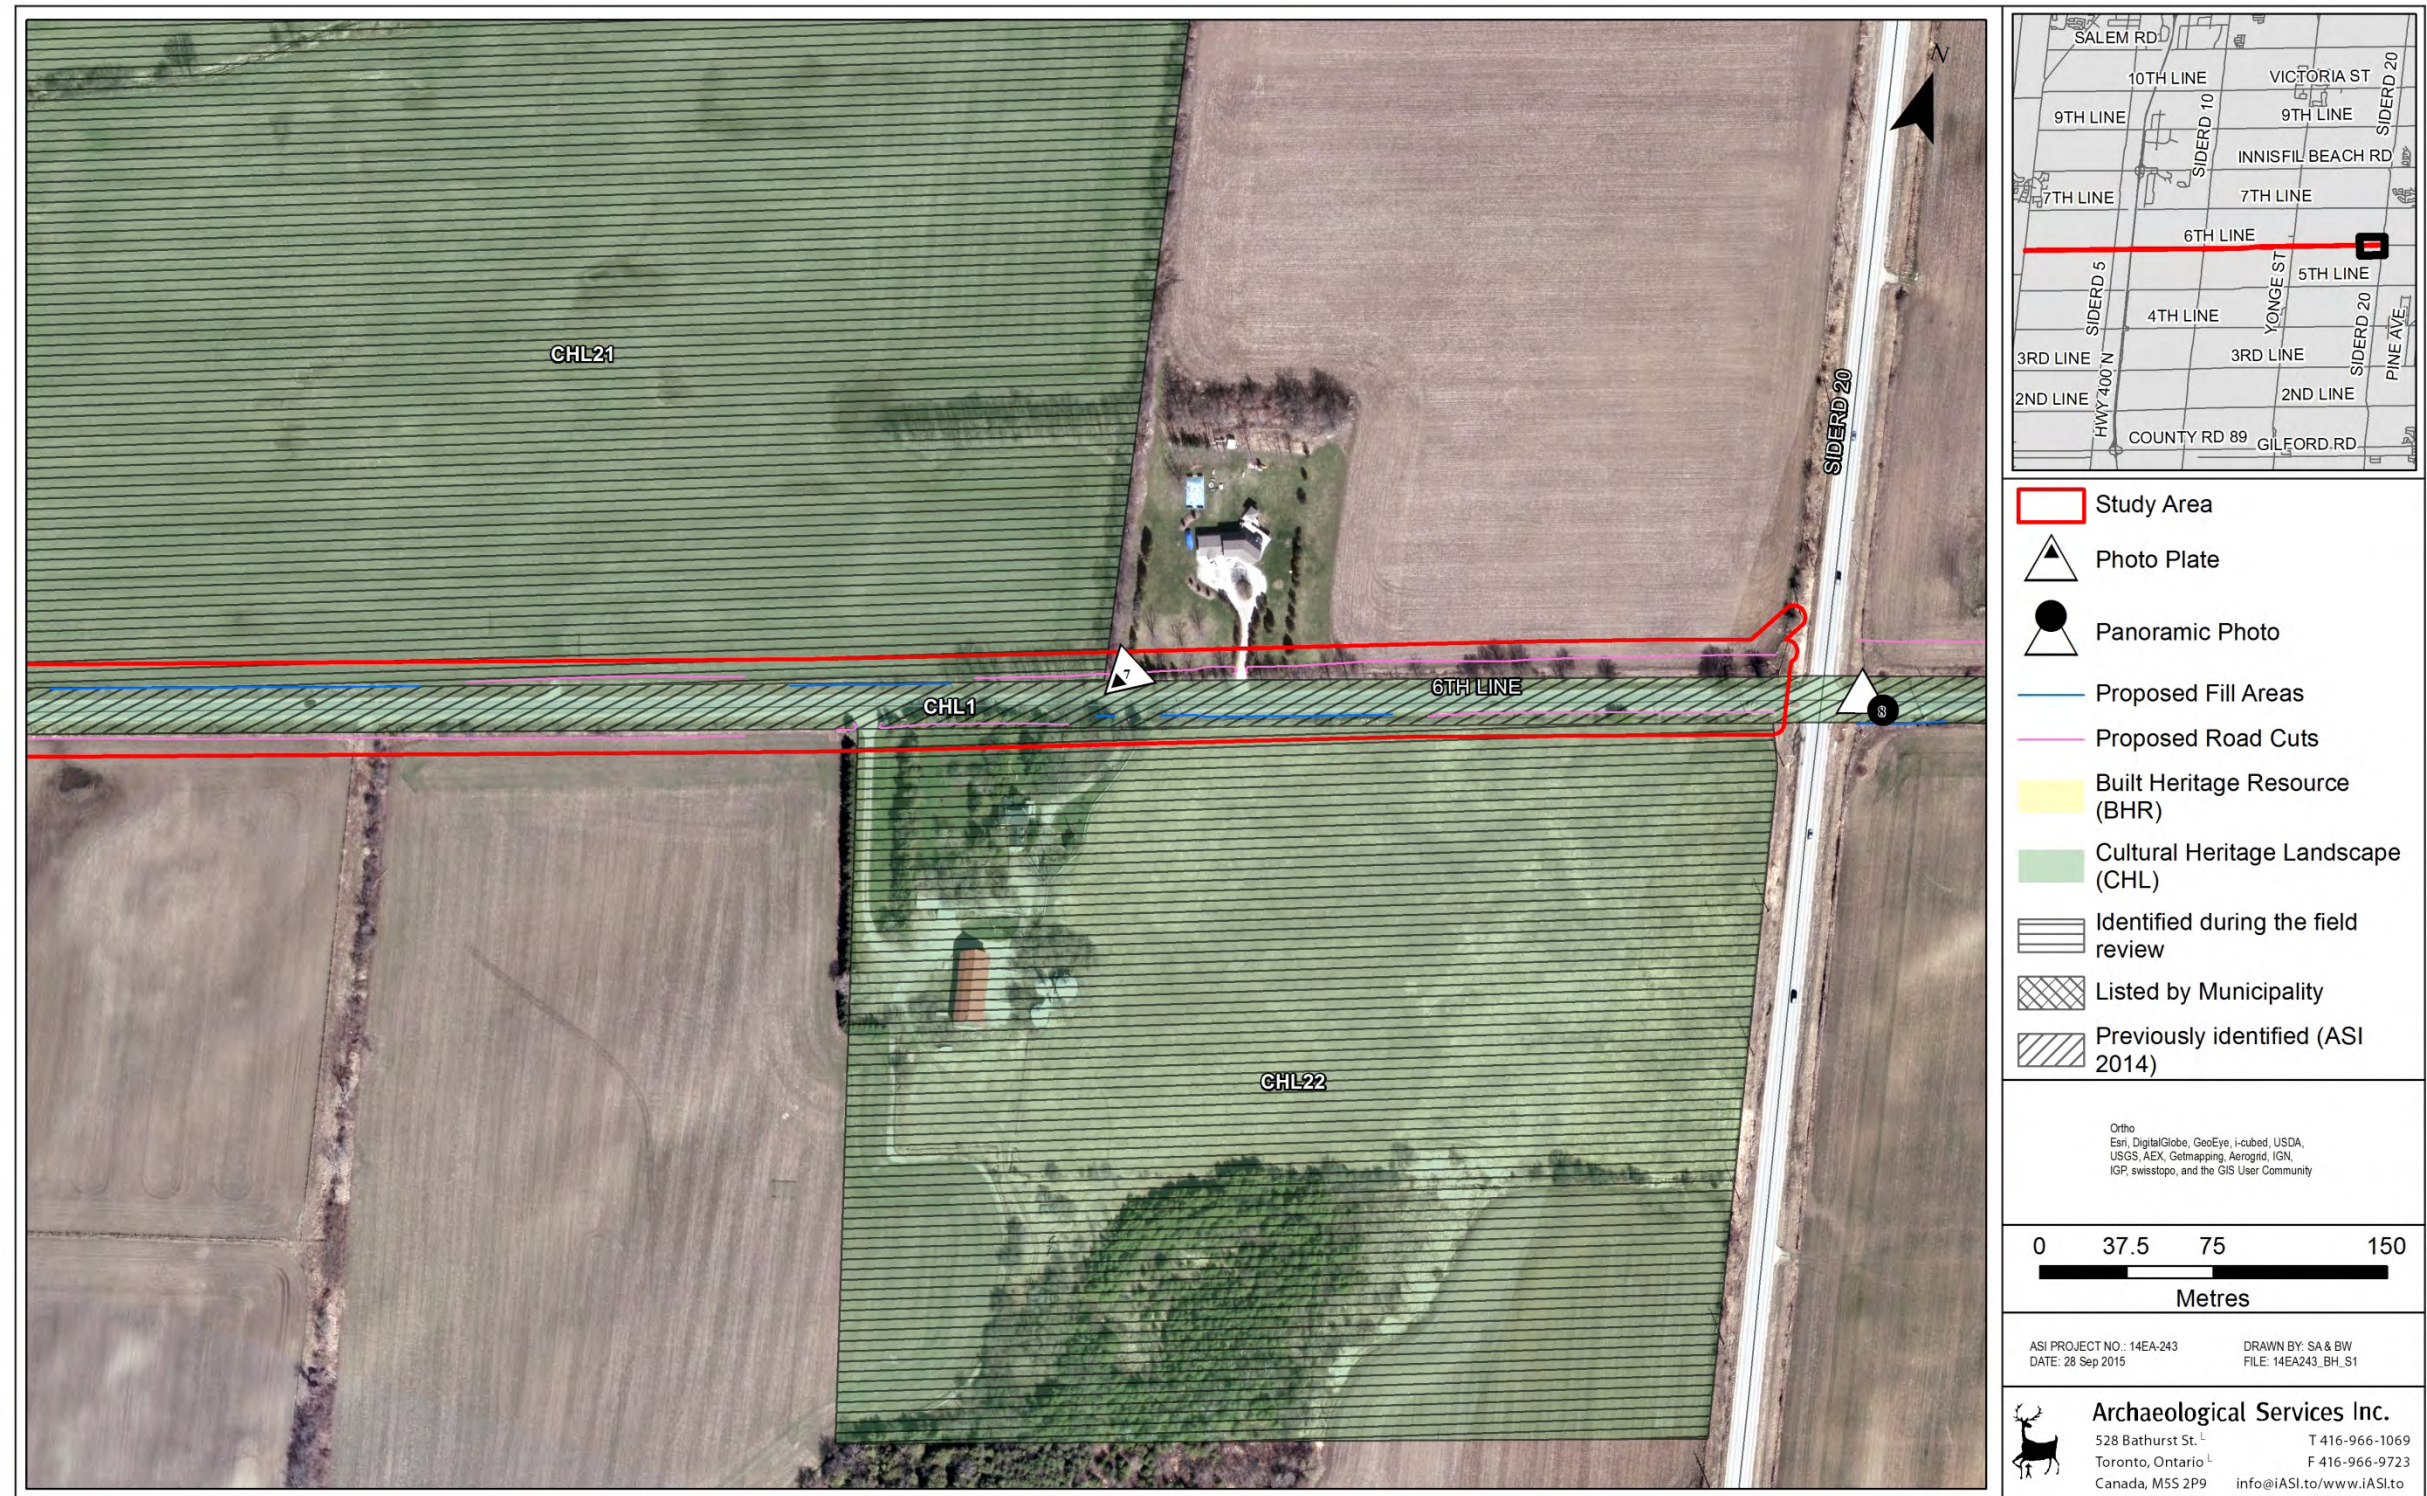
Figure 22: 6th Line (Part B) – Location of Built Heritage Resources (BHR) and Cultural Heritage Landscapes (CHL)
