Town of Innisfil

**Municipal Class Environmental Assessment Addendum
7th Line Storm Drainage Outlet**

MAY 2020

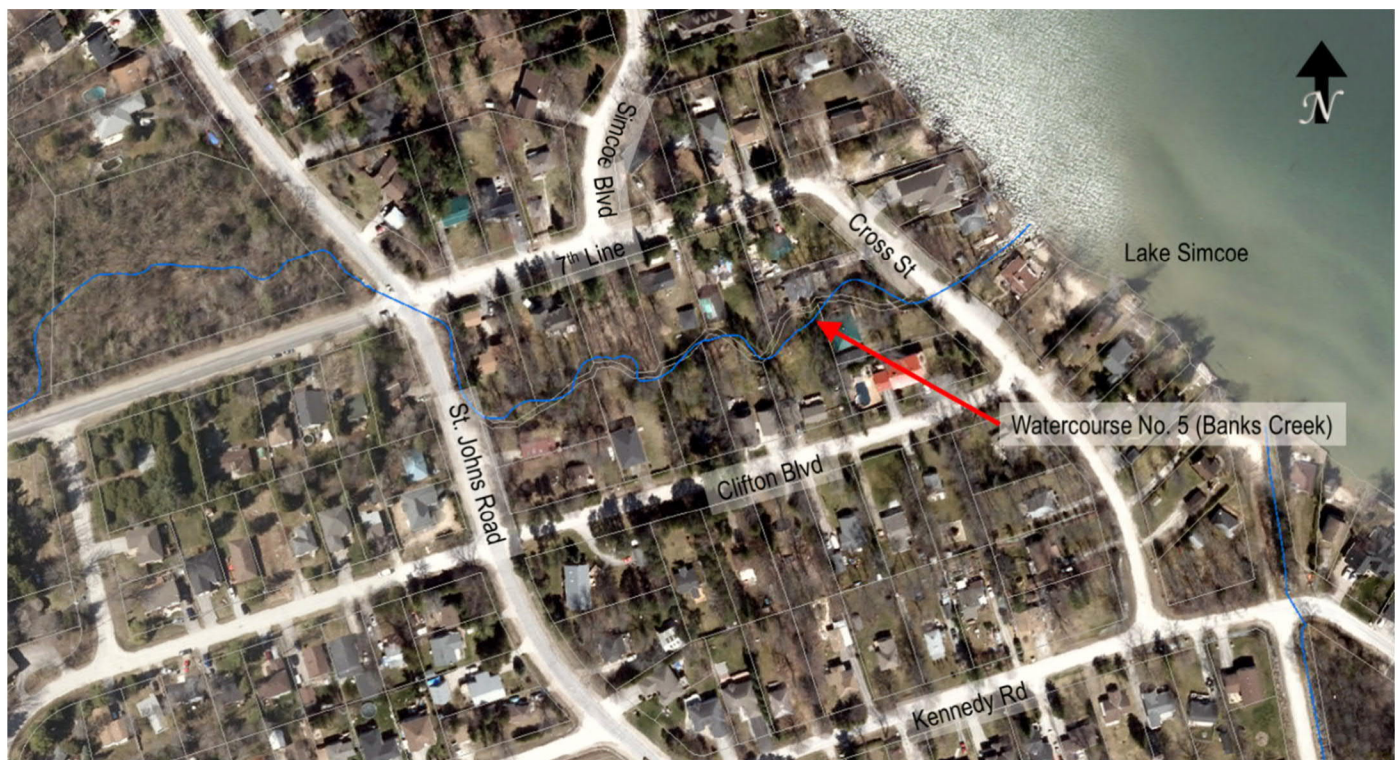
Figure E-1: Watercourse No. 5 (Banks Creek), Town of Innisfil

Within the Town of Innisfil (the Town), Watercourse No. 5, also known as Banks Creek, meanders adjacent to 7th Line then crosses to the south side of the road where it intersects with St. Johns Road, before converging with Lake Simcoe. The section of Banks Creek downstream of St. Johns Road has a history of significant flooding during storm events, causing erosion along the watercourse and impact to private properties. The Town has also expressed concerns regarding access to the watercourse for maintenance.

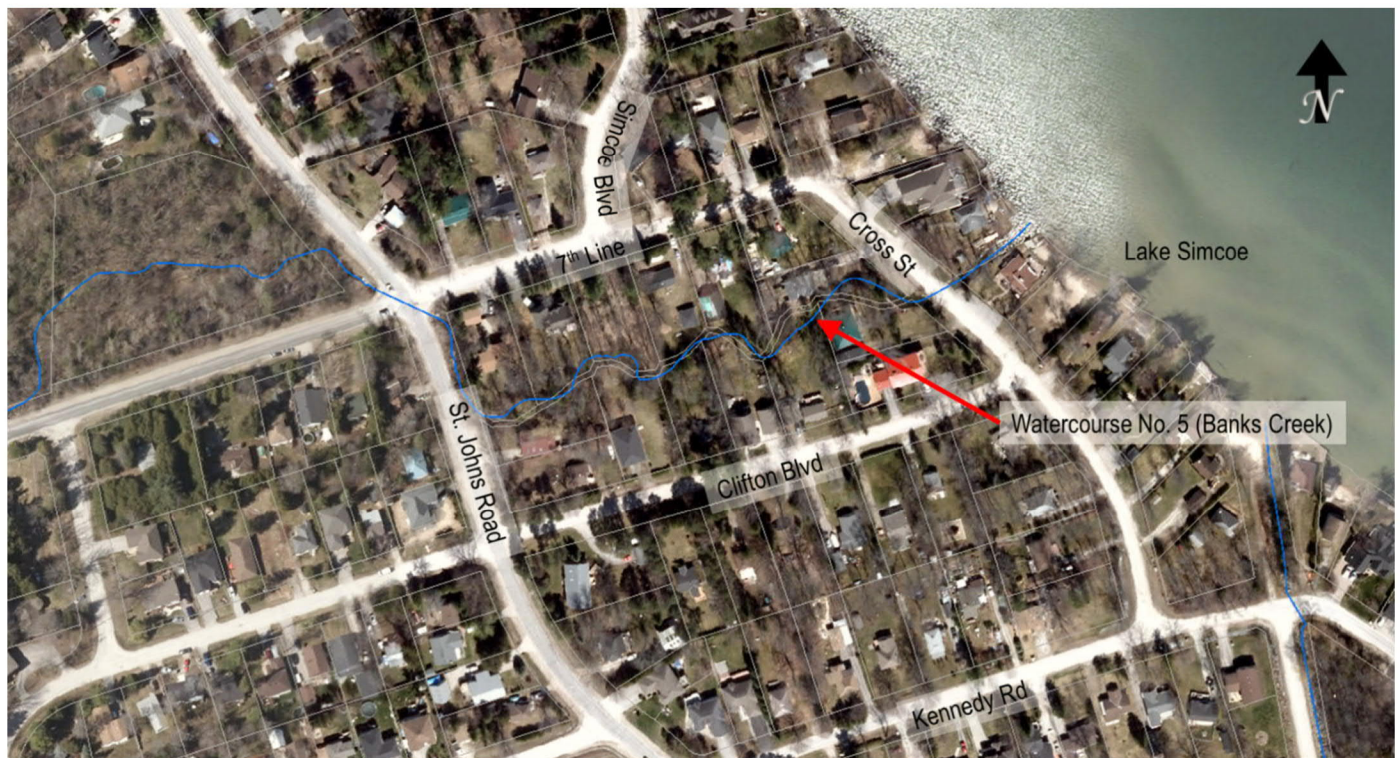
Figure 1-1: Watercourse No. 5 (Banks Creek), Town of Innisfil

Within the Town of Innisfil (the Town), Watercourse No. 5, also known as Banks Creek, meanders adjacent to 7th Line then crosses to the south side of the road where it intersects with St. Johns Road, before converging with Lake Simcoe. The section of Banks Creek downstream of St. Johns Road has a history of significant flooding during storm events, causing erosion along the watercourse and impact to private properties. The Town has also expressed concerns regarding access to the watercourse for maintenance.

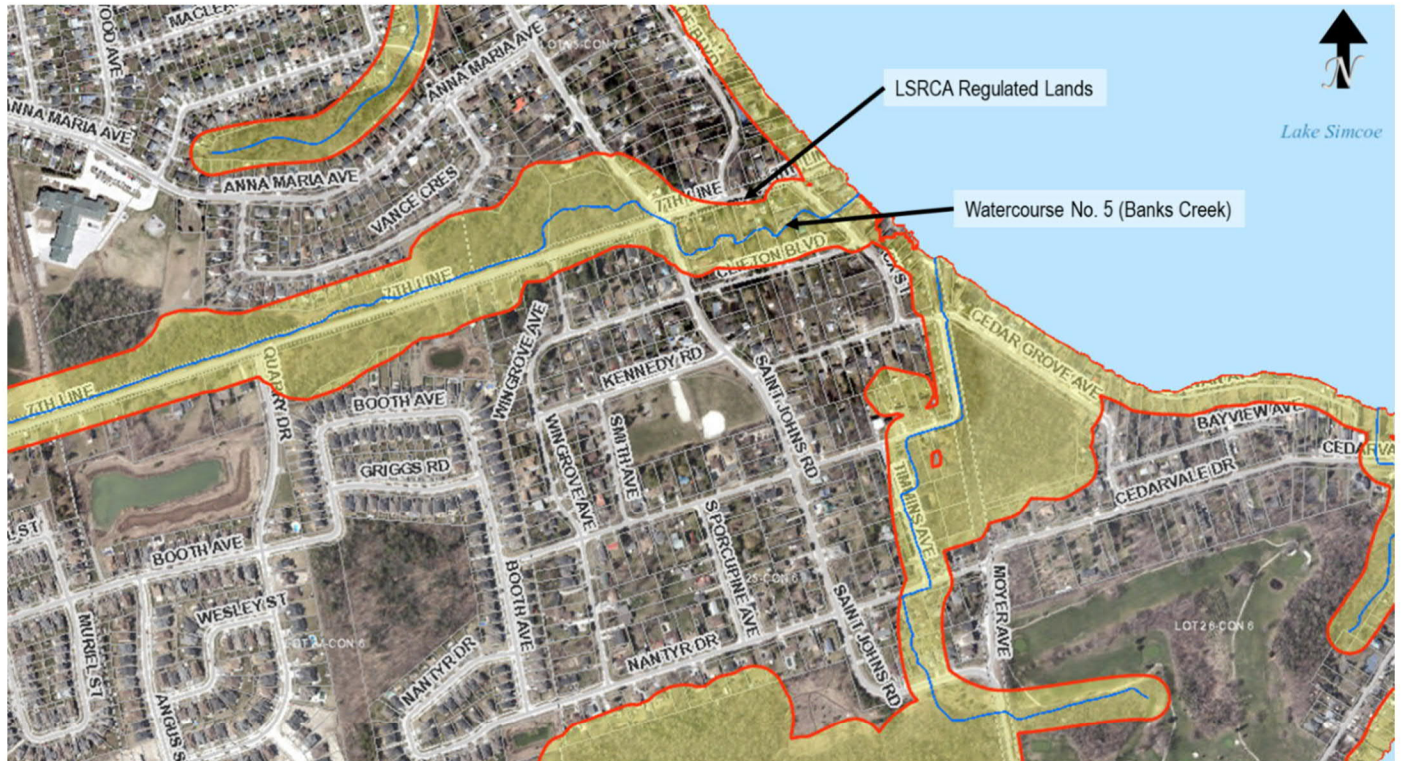
Figure 3-1: Lake Simcoe Region Conservation Authority Regulated Lands

The study area currently supports a residential area and a tributary of Banks Creek which runs east into Lake Simcoe. Due to the presence of the watercourse, associated Regulated Lands within the jurisdiction of the Lake Simcoe Region Conservation Authority (LSRCA) exist (**Figure 3-1**).

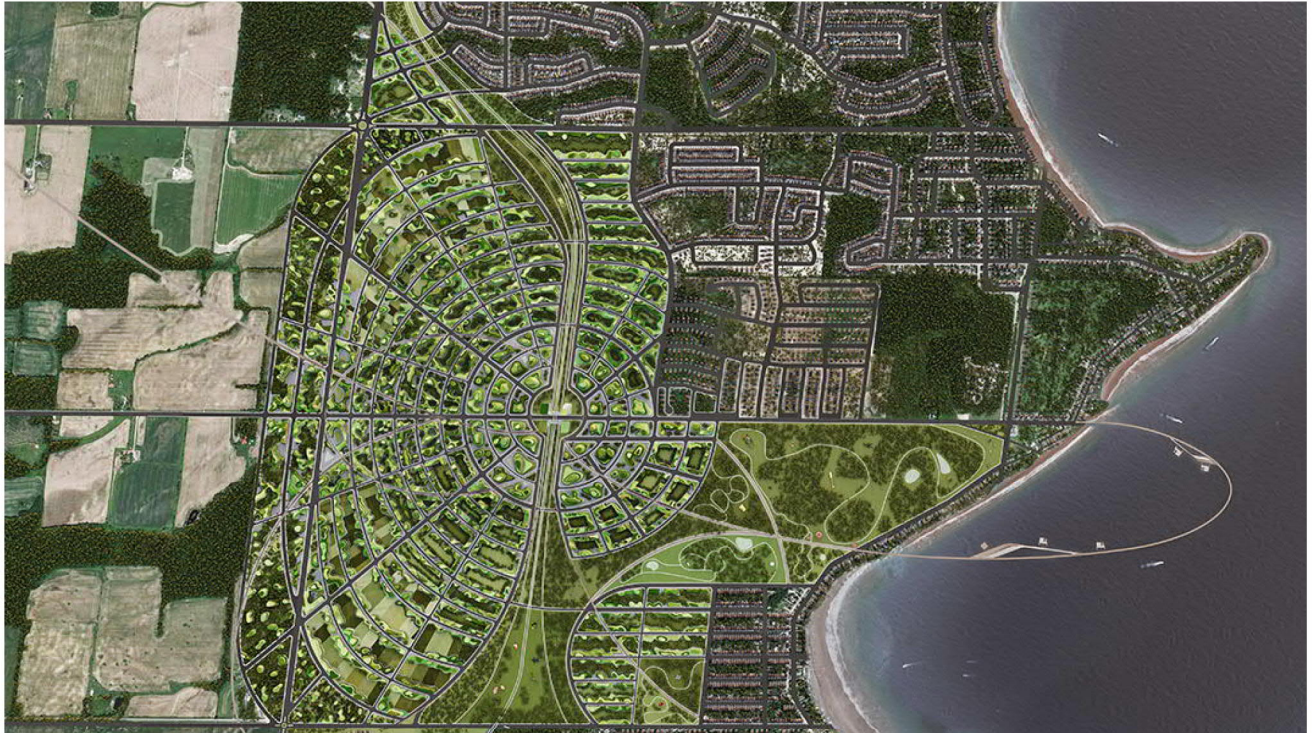
Figure 3-3: Innisfil Mobility Orbit Vision - Proposed Layout

In November 2019, the Innisfil Town Council approved a Staff Report recommending the endorsement of the Mobility Orbit Vision (Orbit) for the Town of Innisfil. Orbit is an innovative vision of providing urban benefits within a rural community. A Metrolinx GO Station is anticipated in Innisfil at 6th Line some time between 2022 and 2025. Orbit is a proposed community concept to be built around the GO Station in the area of the 6th Line and east of 20th Sideroad (Figure 3-3).

Currently, the Town is undertaking a Master Plan for the Orbit community. Although the study area of this EA Addendum is outside of the Orbit area, upstream areas, such as 7th Line, will likely be impacted by the Orbit development.

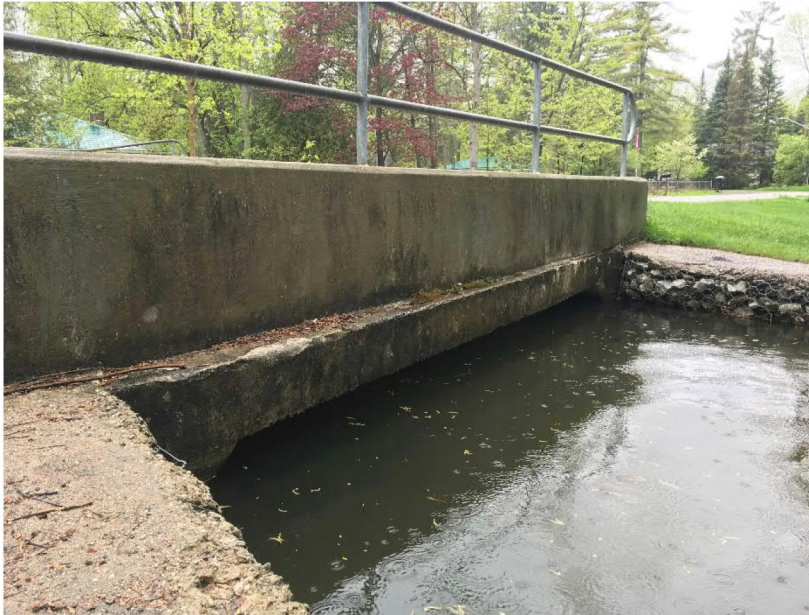
Figure 3-6: Existing Cross Street Culvert Structure

The existing culvert structure at Cross Street (RC2506) is a single cell cast-in-place concrete box culvert (Figure 3-6). The year of construction is unknown, however, existing engineering drawings of the 900mm diameter sewer installation on Cross Street in 1986 show the existing culvert in place. An OSIM (Ontario Structural Inspection Manual) Inspection and Report was completed in 2017 for the structure. The report indicates that, based on inspection and condition of the culvert, that replacement of the culvert should occur in approximately 18 years. The culvert was identified as being in good condition with a BCI (Bridge Condition Index) of 73.5 (a BCI of 100 represents a new structure). The inspection identified only typical concrete defects such as scaling, small spalls and cracking.

Alternative #2, the replacement of the Cross Street culvert, was the preferred solution from the 2007 MCEA study. During various investigations and assessments conducted at project onset for the culvert replacement, it was determined that culvert replacement alone would not eliminate the occurrence of flooding within the study area (refer to Sections 1.2 and 3) at this time.

It is recommended that at the end of the culvert's service life (roughly 18 to 20 years) when the culvert requires replacement, the replacement structure is enlarged to provide additional conveyance capacity for the watercourse. This increased capacity will help alleviate some flooding during more frequent storm events and will help with the potential ice jamming that is occurring at the structure.

Based on existing conditions, a closed bottom concrete box culvert (6m x 1.9m) would be a suitable replacement structure to provide an additional capacity of 4.65m² at the Cross Street crossing. It is recommended that at the time of replacement a review and update of the hydraulic and hydrology assessment be completed to ensure that the identified replacement structure is suitable for current conditions (i.e.: consideration of climate change and increased storm events). The estimated present-day value of replacement is \$802,500. Preliminary design drawings of the future culvert replacement are provided in **Appendix D**.

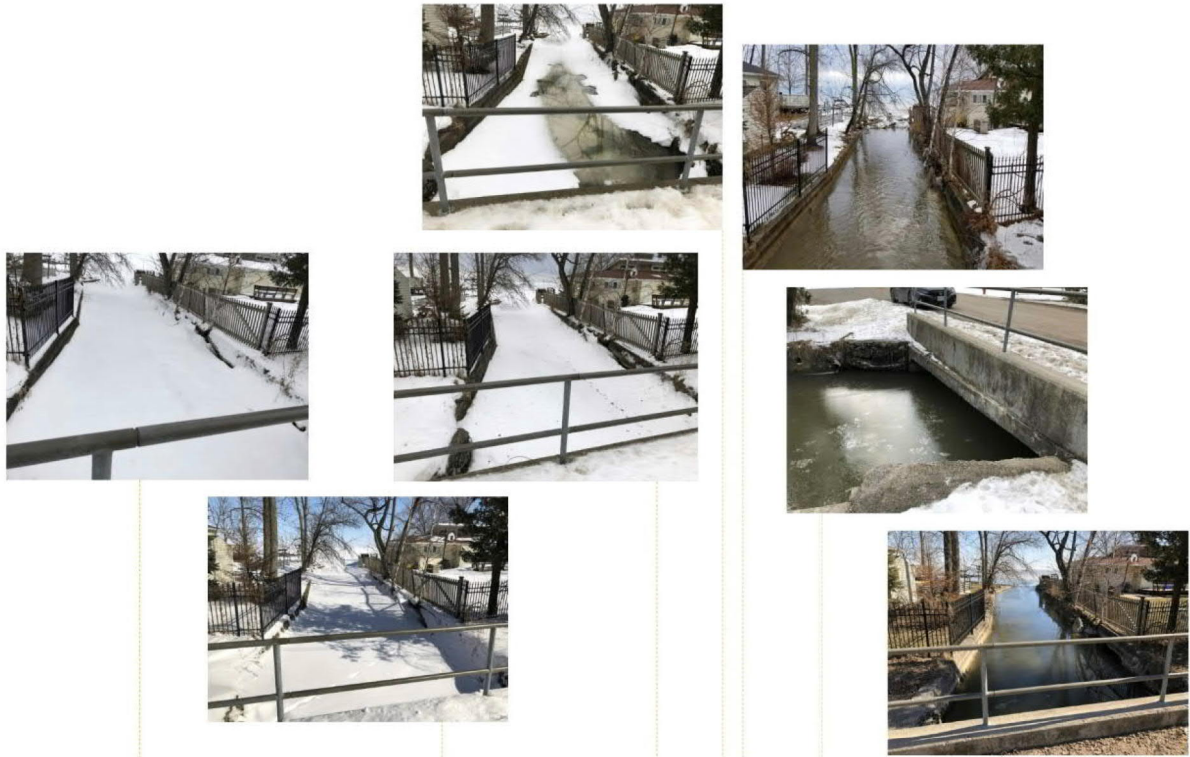
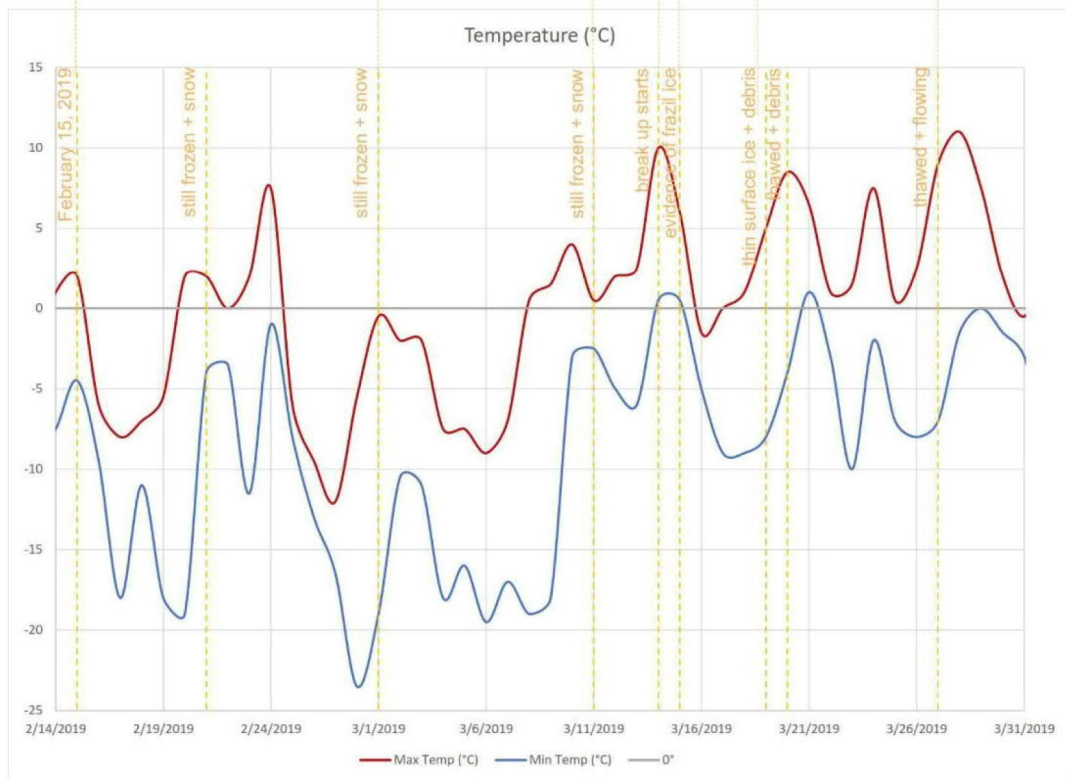
Figure 3-8: Ice Break up in Spring 2019
(temperature data from Environment Canada; photos from Town of Innisfil)

Ice impacts and hydraulic restrictions due to ice formation were monitored in the Spring of 2019 by the Town of Innisfil Public Works Department. During this time, the Town took photos and visually monitored the formation and breakup of ice. To supplement the qualitative analysis completed by the Town, a compilation of maximum and minimum temperatures (recorded at nearby Environment Canada Shanty Bay station) and corresponding field data (photos) collected during this period is provided in **Figure 3-8** to help characterize ice break up characteristics.

Based on the available information, it appears that Lake Simcoe froze to the Cross Street culvert and remained frozen for most of the winter season. During the springtime, the surface ice broke up and thawed within the span of a couple of days. During this time, visual inspections were completed, and photos were collected. No flow data was recorded during the monitoring period, and no measurements were made. During the monitoring period border and frazil ice were observed, but no ice jams occurred during breakup. However, even though an ice jam was not observed during the Town's spring 2019 ice observations, doesn't mean that ice jams do not happen, and does not mean they will not occur in the future.

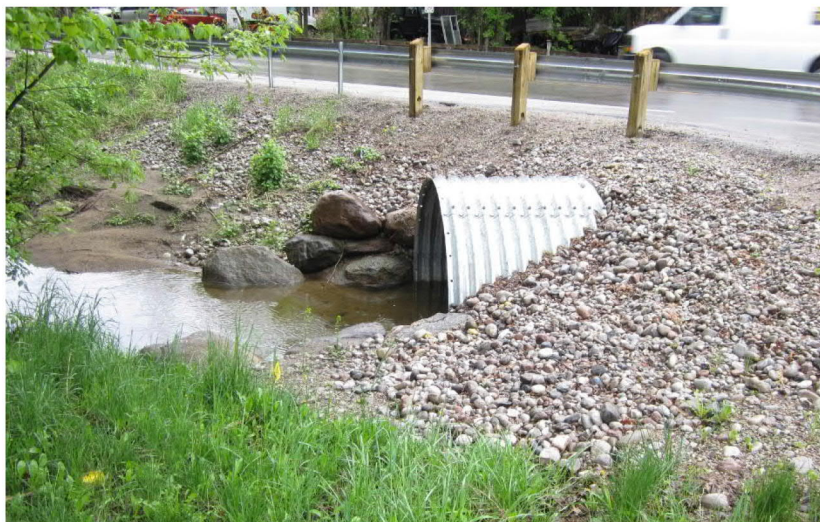
Figure 5-1: Existing CSP Culvert at St. Johns Road and 7th Line

In addition, review of the MCEA Environmental Study Report (ESR) for the 7th Line Improvements (completed in 2019), indicates stormwater from 7th Line (between 20th Side Road and St. Johns Road) currently is untreated and discharges overland directly to Banks Creek. Banks Creek runs along the north side of 7th Line in the form of a roadside ditch which then crosses under the intersection of St. Johns Road and 7th Line through a large CSP culvert (Figure 5-1) and flows downstream to Lake Simcoe through the study area.
