6th Line Municipal Class Environmental Assessment

County Road 27 to St John's Road
Town of Innisfil, ON

Culvert Inspection Report

October 3, 2015

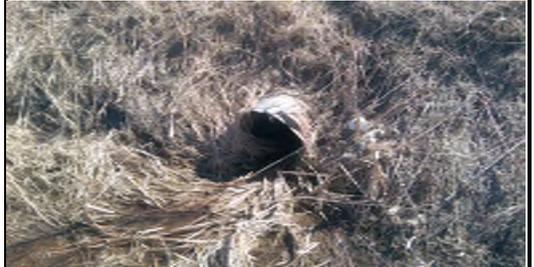
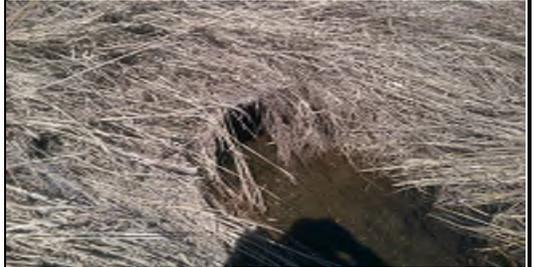
Inspection Date	02-Apr-15	Culvert No.	01-09	Inspector	M.Darling
Township	Innisfil				
Road	6th Line				
Culvert Crossing Type	HIGHWAY C/L				
Culvert Type	CSP				
Culvert Shape	CIRCLE				
Culvert Bottom	Steel				
Culvert Flow Direction	North				
Culvert Length (m)	12.4				
Culvert Size (mm)	500				
Fill Over Culvert (m)	0.7				
Fill Material Type	Granular				
Depth of Water In Culvert (mm)	200				
Blockage In Culvert	None				
Culvert Condition	Rusting - Fair				
Inlet Condition	Fair				
Outlet Condition	Fair

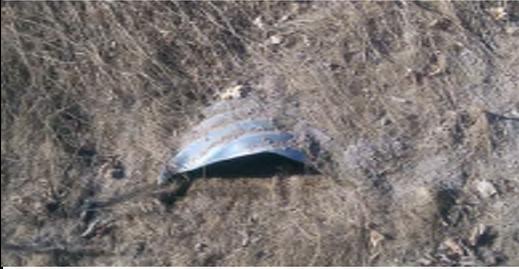
PHOTO OF OUTLET

Inspection Date	19-Jun-15	Culvert No.	01-10	Inspector	S. Percy
Township	Innisfil				
Road	6th Line				
Culvert Crossing Type	HIGHWAY C/L				
Culvert Type	CSP				
Culvert Shape	CIRCLE				
Culvert Bottom	Steel				
Culvert Flow Direction	South				
Culvert Length (m)	17.0				
Culvert Size (mm)	400				
Fill Over Culvert (m)	0.5				
Fill Material Type	Granular				
Depth of Water In Culvert (mm)	50				
Blockage In Culvert	Water/Sediment 70-80%				
Culvert Condition	Poor				
Inlet Condition	80% Buried				
Outlet Condition	70% Buried

Additional Comments
channel needs cleared

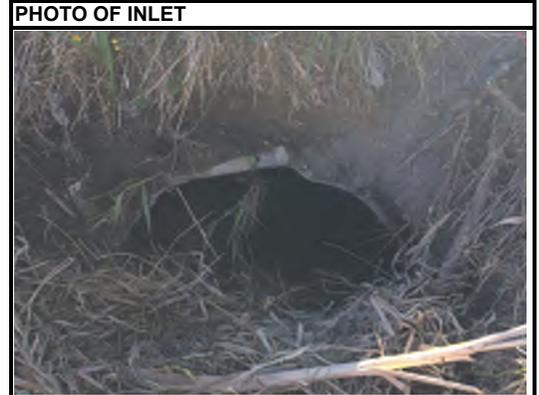
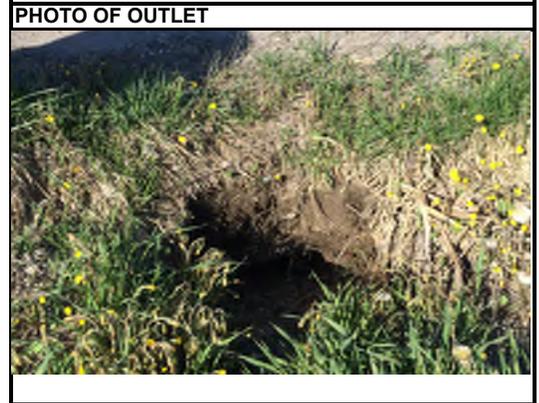
Inspection Date	19-Jun-15	Culvert No.	03-03	Inspector	S. Percy
Township	Innisfil				
Road	10th Sideroad				
Culvert Crossing Type	HIGHWAY C/L				
Culvert Type	CSP				
Culvert Shape	CIRCLE				
Culvert Bottom	Steel				
Culvert Flow Direction	South				
Culvert Length (m)					
Culvert Size (mm)	400				
Fill Over Culvert (m)	700				
Fill Material Type	Granular				
Depth of Water In Culvert (mm)	60% Blocked				
Blockage In Culvert	15% Sediment				
Culvert Condition	poor				
Inlet Condition	Buried				
Outlet Condition	Buried
