Erosion Hazard and Crossing Assessment Leonard's Creek

Multi-Use Trail from Jack Crescent to Goodfellow Public School, Innisfil

May 11, 2020
PN20020

Project Number: PN20020

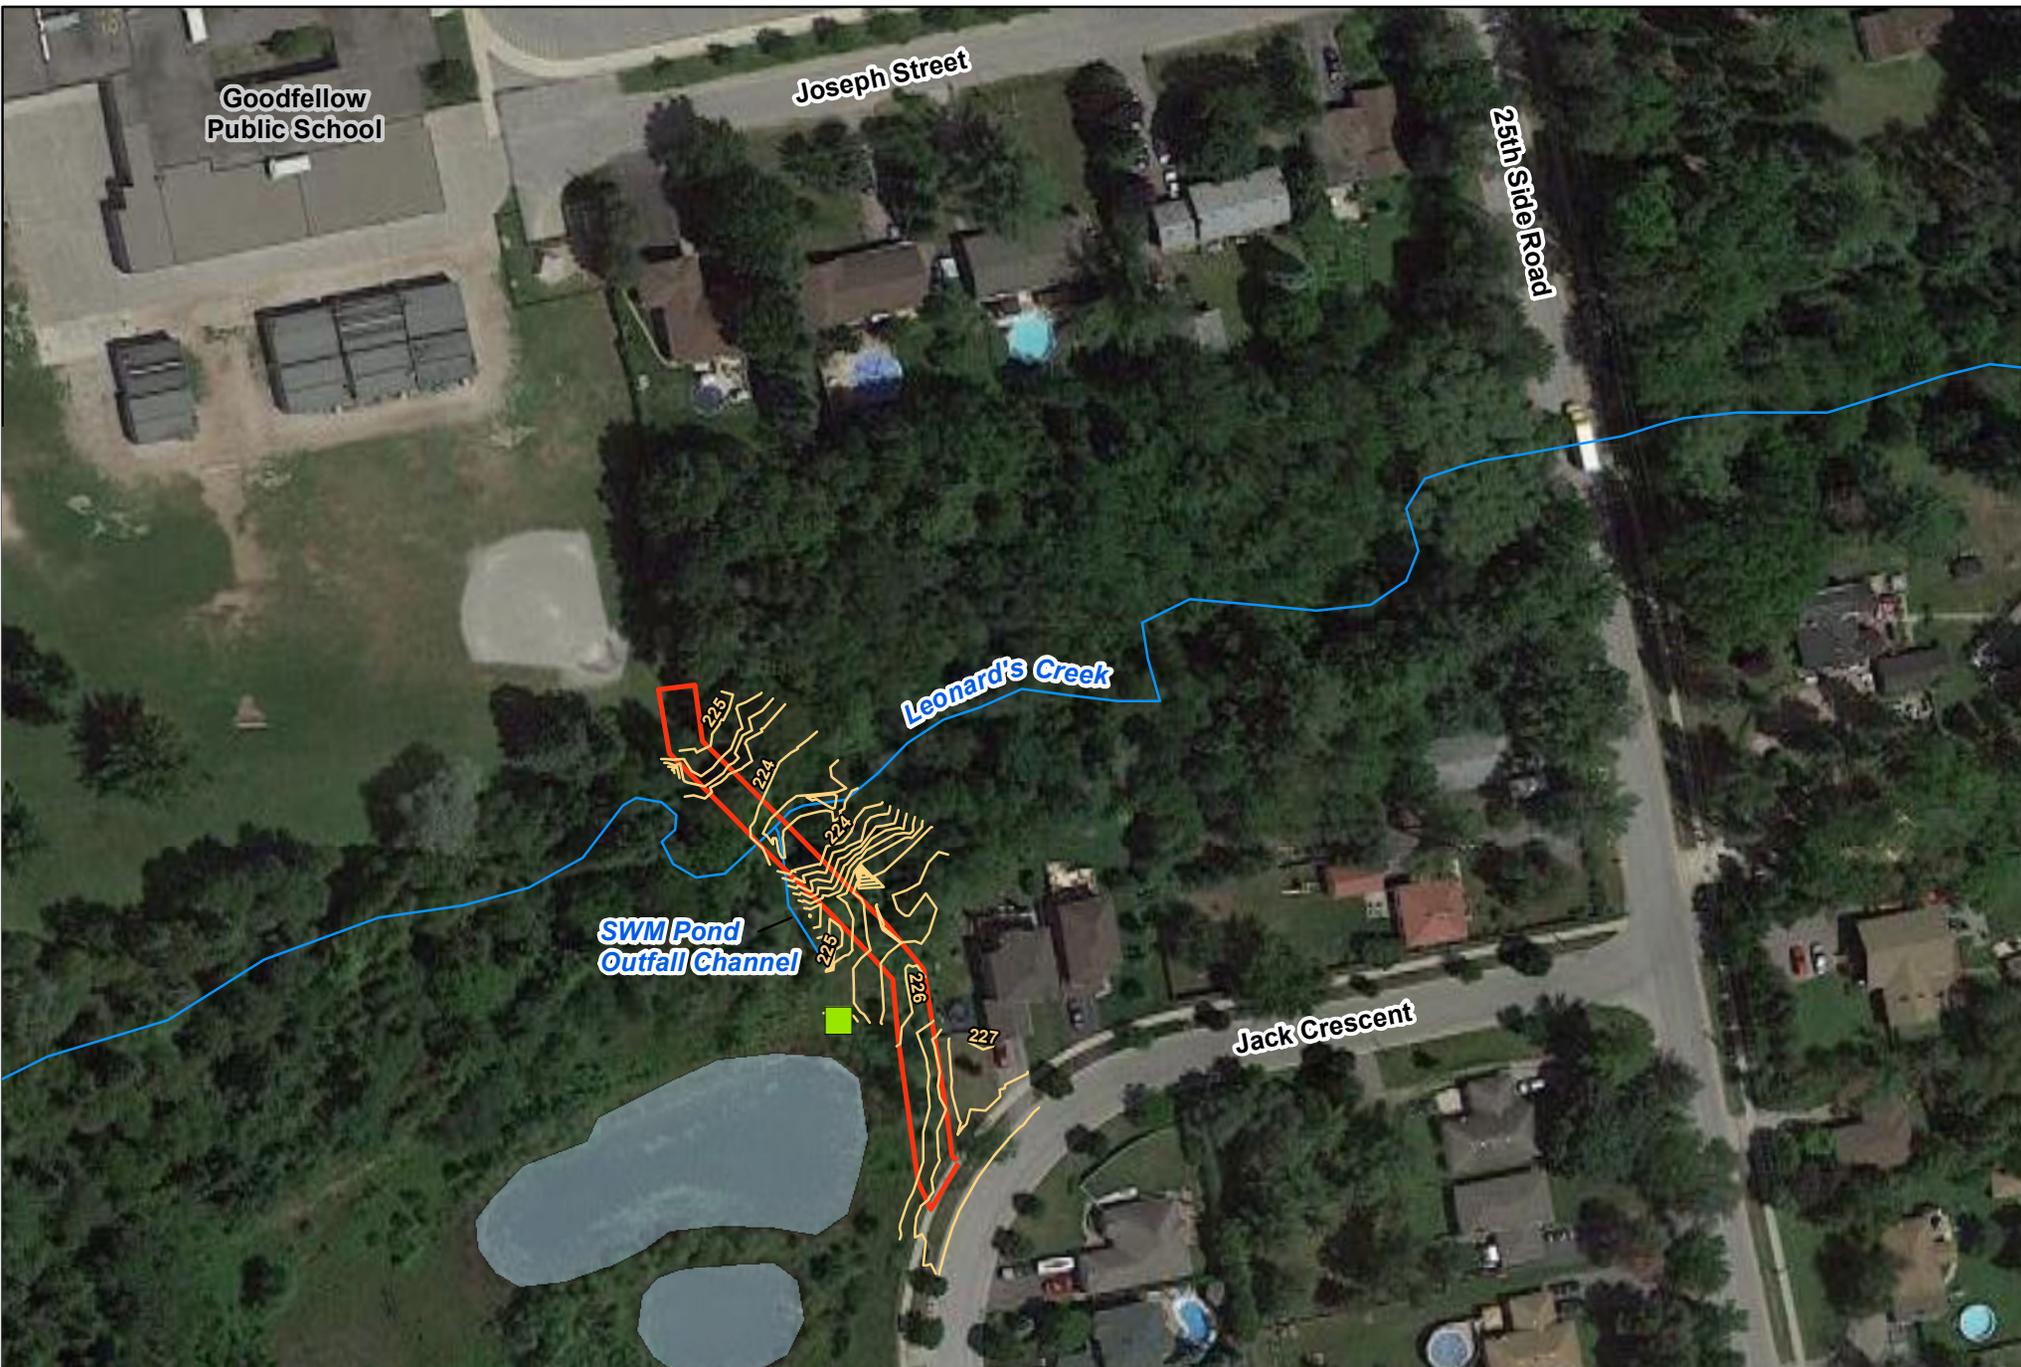
To address the concerns of the LSRCA, and provide appropriate design considerations and protection recommendations, a fluvial geomorphological and erosion assessment will be completed at the subject reach. A study site map is provided for reference in **Appendix B**.
